POLICE ATHLETIC FACILITY BUILDING

SEACOR
ENVIRONMENTAL INC.

Client: City of Ottawa	Job Number: 216.07926.00
Year Built: 1966 est.	Location: 1463 Prince of Wales, Ottawa
Building Description: Single Storey – Concrete Building	Usage: Youth Centre
Photographer: D. Morroz	Date: 4/26/2006

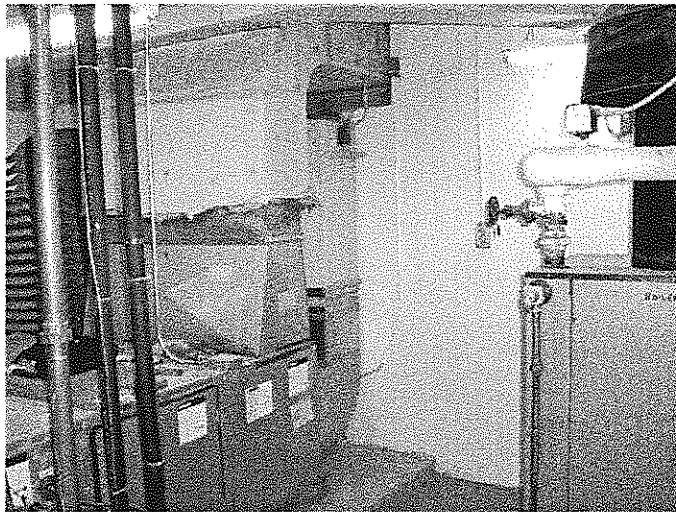
View of ACM mechanical insulation on ductwork observed in the basement.

Asbestos was confirmed (SA-15) in mechanical duct insulation located throughout the basement mechanical room.

Repair or remove damaged ACMs as per Ontario Regulation 278/05 "Regulation respecting Asbestos on Construction Projects and in Building and Repair Operations".

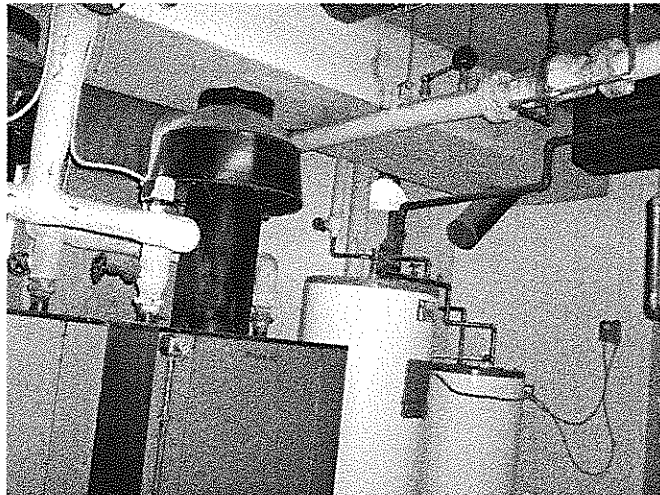
View of ACM mechanical insulation on duct and piping.

Asbestos was confirmed (SA-9) in mechanical pipe insulation on pipe fittings and straight runs located throughout the basement and was also observed within wall and ceiling cavities on the main and basement levels. One fitting observed in the ceiling space of the laundry room was identified in poor condition.

Some ACMs may be concealed in wall and ceiling cavities. Any work activities that will require access into these spaces should be completed with this understanding, and once accessible the ACMs should be removed according to the above regulatory protocols.
