# TYPE II - BUILDING CONDITION AUDIT

Police Youth Center: Boys and Girls Club

1463 Prince of Wales Drive

Date: September 10, 2014

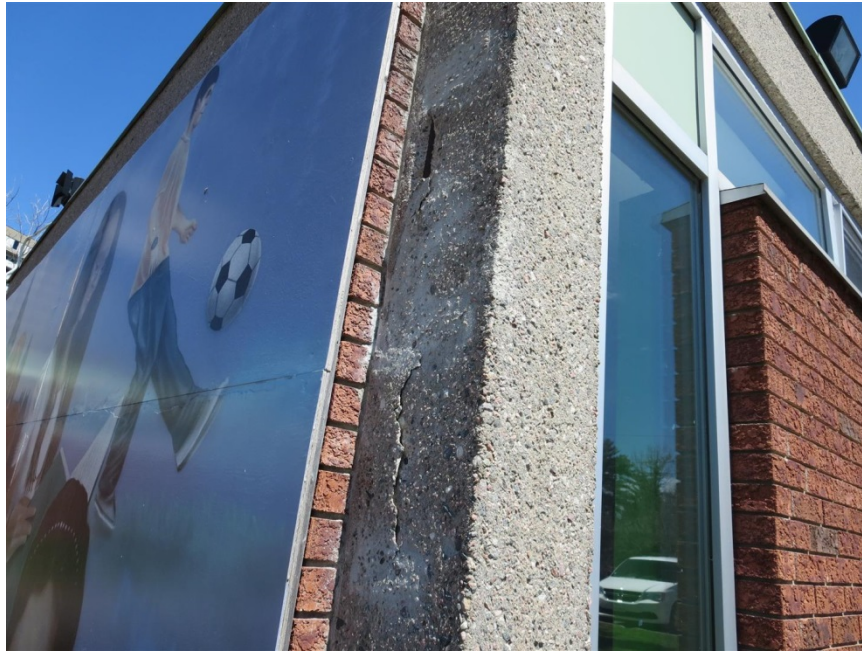
We noted about 10-12 locations of delaminated and spalled concrete at various locations around the building exterior. Typically, these are small areas; however, we did note more extensive concrete delamination along the entrance doors at the 50's Club. It appears that several concrete repairs have been completed over the years as we noted mismatched patches of lighter concrete along cracks and above some windows.

Overall, the walls are in fair condition.

**Photo 3:** Concrete deterioration

1-3yrs: Based on the concrete deterioration noted, we recommend budgeting for a concrete repair program. Our budget includes a painting allowance to paint all concrete sections, otherwise the building will appear to have a very 'patchy' and uneven appearance.

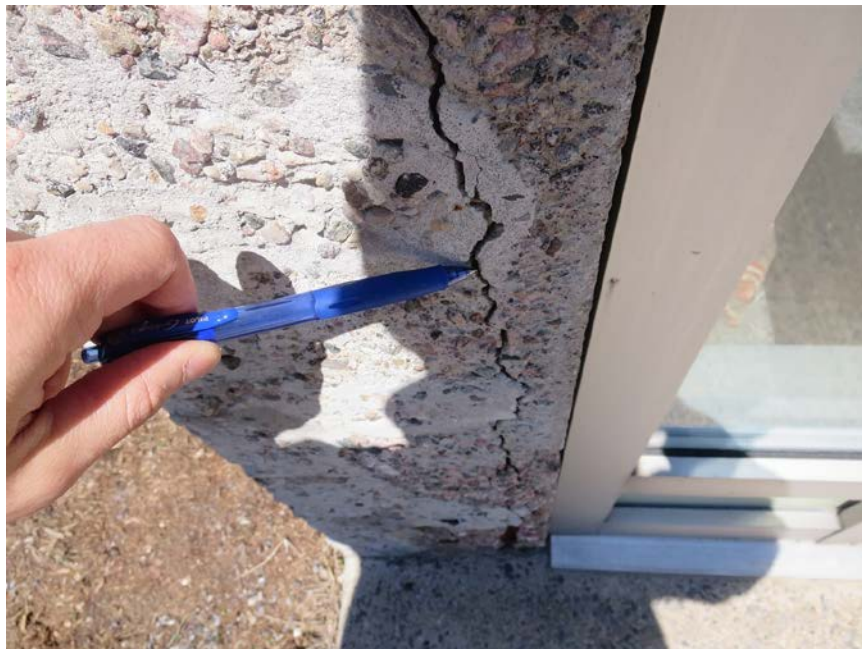
**Photo 4:** Crack at 50s Club door

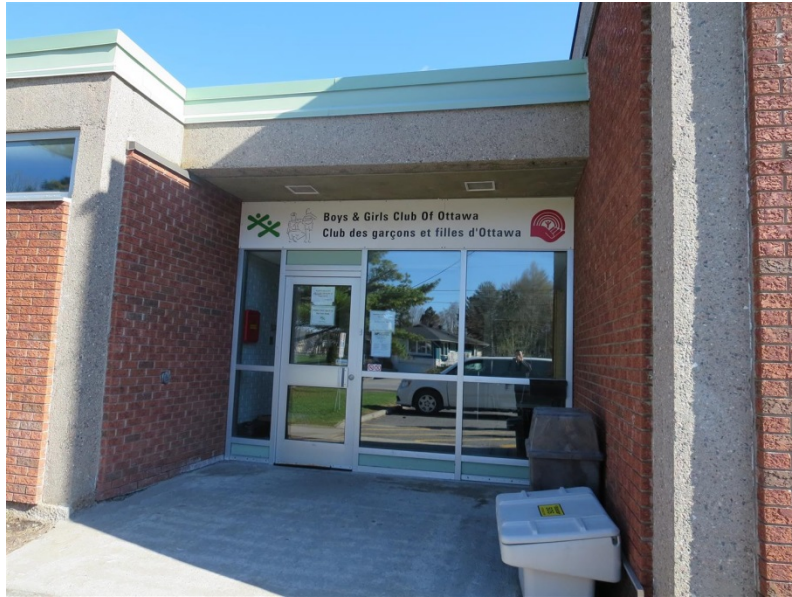
The doors appear to be in good working order with no obvious signs of deterioration. We did note one failed IGU within the 50's Club door. We assume that this IGU and other door components will be repaired and/or replaced, if needed, at a cost below the capital threshold of this report.

The doors are in fair condition.

**Photo 5:** Entrance doors

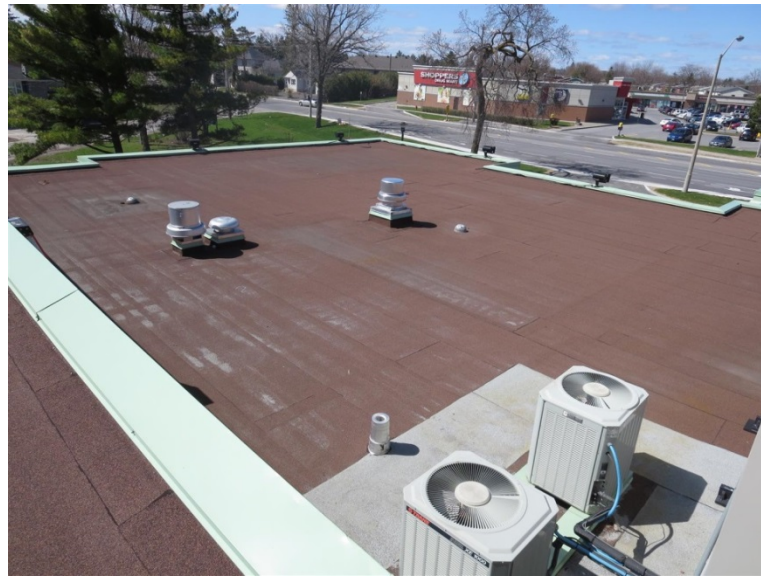
Based on our preliminary review, the roofing membrane appears to be in good condition (but pending further review of the Siporex).

**Photo 6:** Lower roof – main building

4-20yrs: Roof overlays have a reduced life because of the risks related to entrapped moisture and an uneven surface. Based on this, we have included a budget to replace the membrane at all roof sections at the expected service life of overlays. Our budget also includes full replacement of the Siporex roof deck, as this is the strategy that was communicated to us by the City. It is possible that sections of the Siporex may be intact and re-used after the existing roofing membranes are removed; however, we have assumed full replacement.

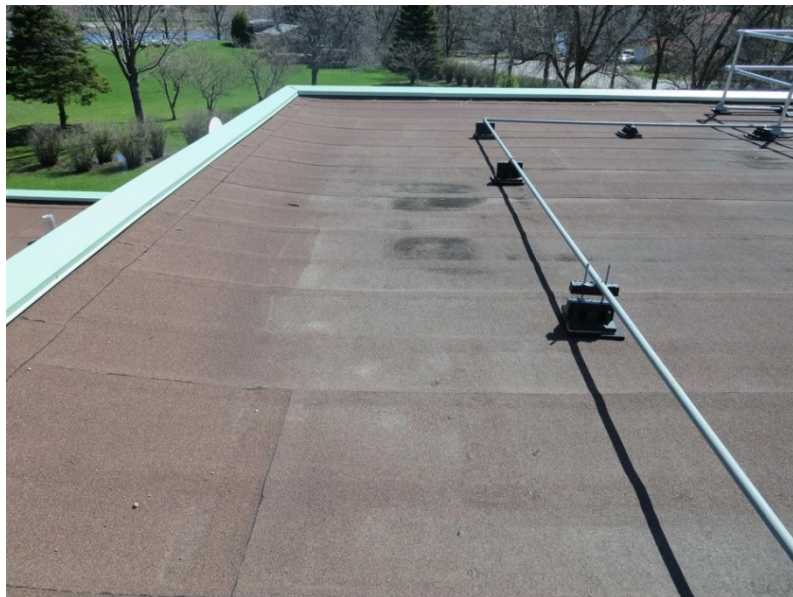
**Photo 7:** Gymnasium roof – low spot

Based on the risks associated with this type of roof deck, we recommend making openings in the plaster ceiling on the north side of the computer room and gymnasium to help determine if water is penetrating through the Siporex deck. These areas correspond with low points in the roof where we noted evidence of ponding water. Pending the results, we may recommend completing roof test cuts to help verify the condition of the topside of the roof deck, and to help determine if the roof membrane is well bonded. We expect that this work can be completed as part of normal operations, at a cost below the capital threshold of this report. Given the presence of the Siporex, an annual inspection and maintenance program needs to be implemented.

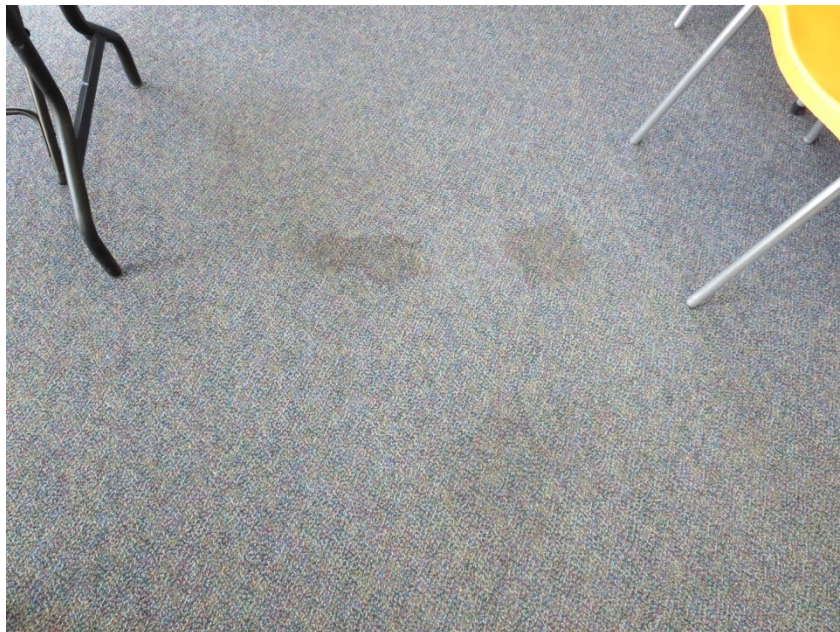
**Photo 13: Stained carpet in 50s' Club**

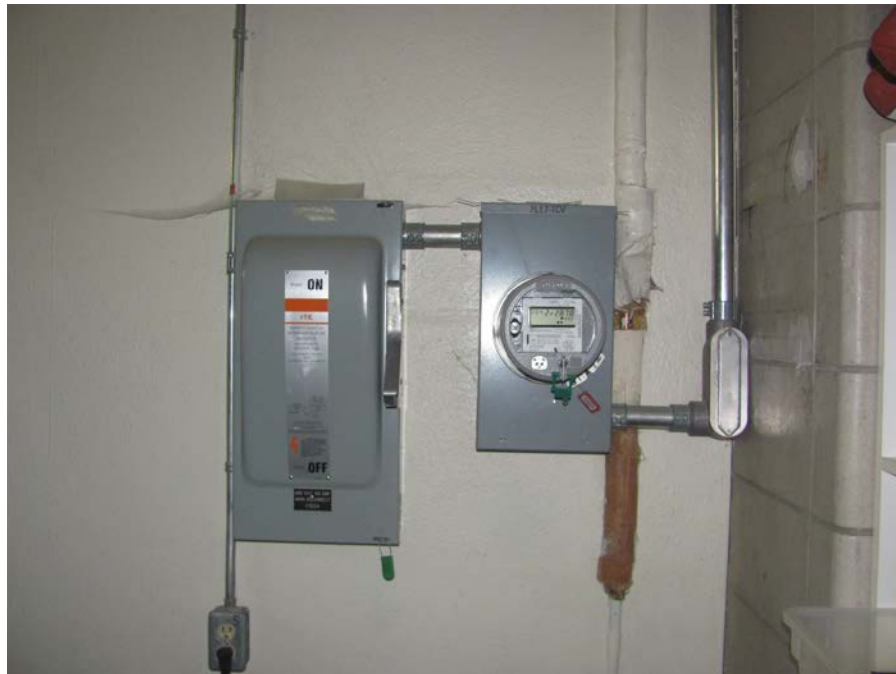
The main disconnect appears to be in good condition.

**Photo 15:** Main electrical switch

Regular infrared scans are recommended to help identify trouble spots and allow proactive repairs before they develop into larger problems. These can be completed as part of normal operations.

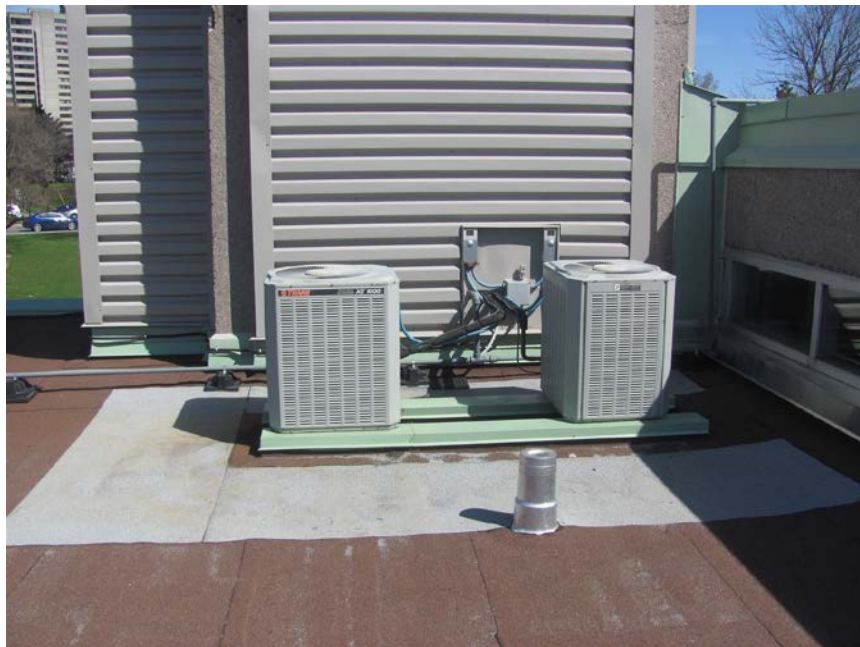
In general, the majority of the AHU components are considered to be in good condition. The rooftop condensers and cooling coil are considered to be in fair condition.

**Photo 17:** Condenser units for AHU

4-20 yrs: Based on age and an average service life of 15 - 20 years, a budget to replace the rooftop condensers and cooling coil is included. A budget to overhaul the remaining AHU components is also included.

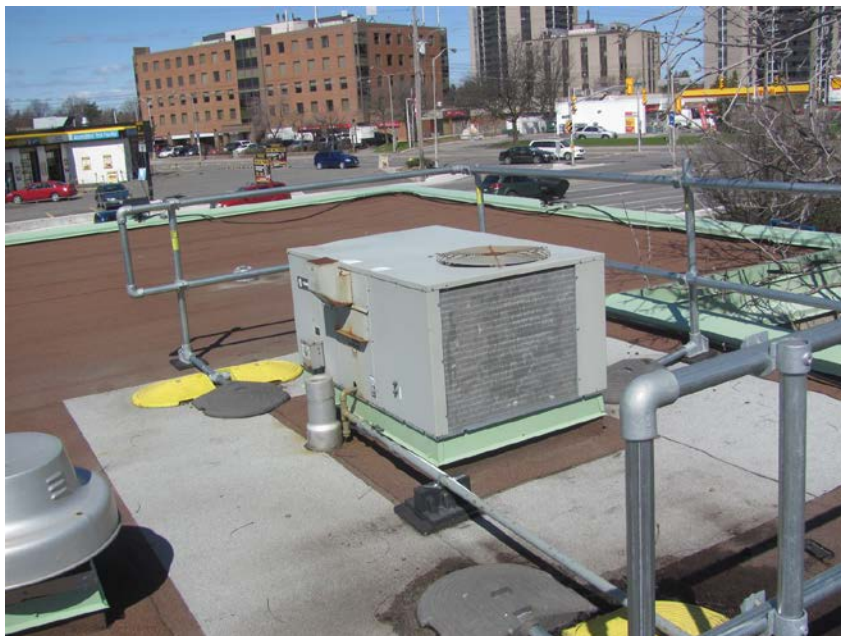
**Photo 19:** Rooftop unit over 50s' Club**7.4 Exhaust Fan Systems**

1-3 yrs: Based on age, the 50's Club RTU is budgeted for replacement during the report term.

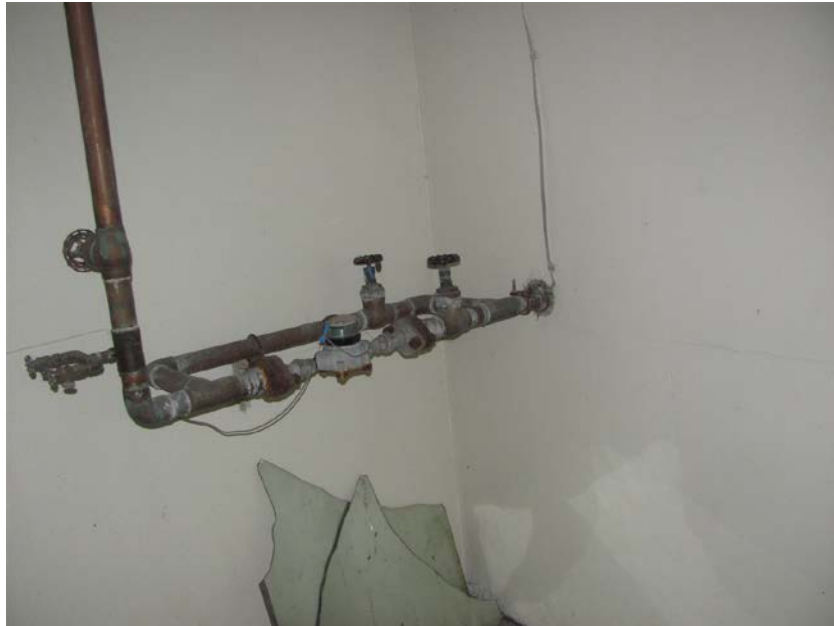
The plumbing system is considered to be in good condition.

**Photo 20:** Main incoming water line

4-20yrs: Based on age, the buried watermain line from the street to the building will likely need to be replaced during the report term. We have included a budget to excavate and replace the incoming line, assuming that it runs from Prince of Wales Dr.

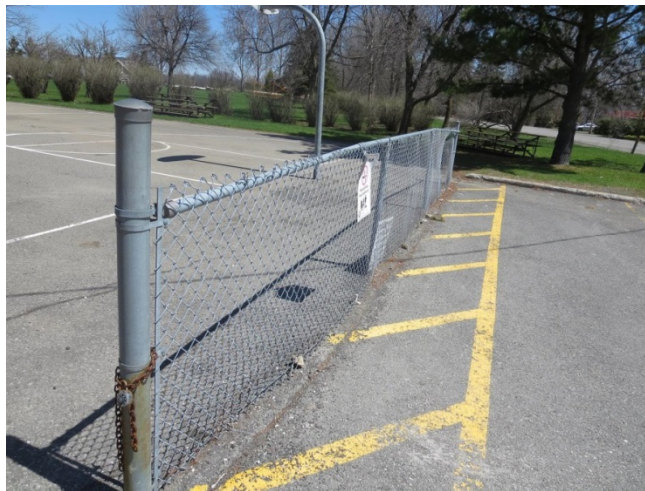
One of the horizontal steel members is not properly secured to a steel post, which has displaced the chain link fencing in this area. Otherwise, the steel posts appear to be well anchored into the ground and the chain link fencing is intact. We assume the fence will be repaired and maintained at a cost below the capital threshold of this report.

The fencing is in fair condition.

**Photo 21:** Chain link fencing.

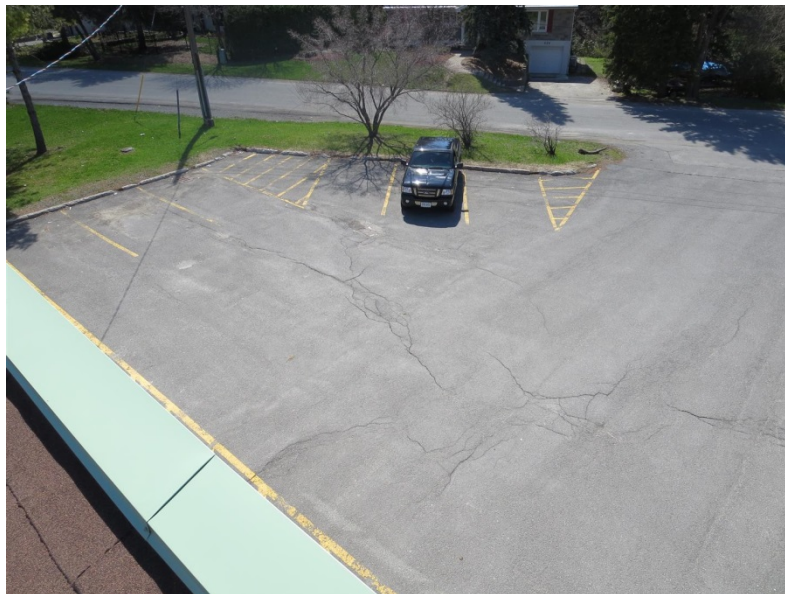
**Photo 22:** South parking lot

1-3yrs: Based on the deterioration seen, we have included budgets to replace the deteriorated sections of the south parking lots, including all curbs. This represents about 3,525ft<sup>2</sup> of asphalt and 200ft of curbs. Please refer to area A in the appended “Site Overview” plan. Our budgets include an allowance for limited sub-base repairs (about 5-10% of the repair area). We assume other areas will be maintained (such as crack sealing and small asphalt patches) at a cost below the capital threshold of this report.

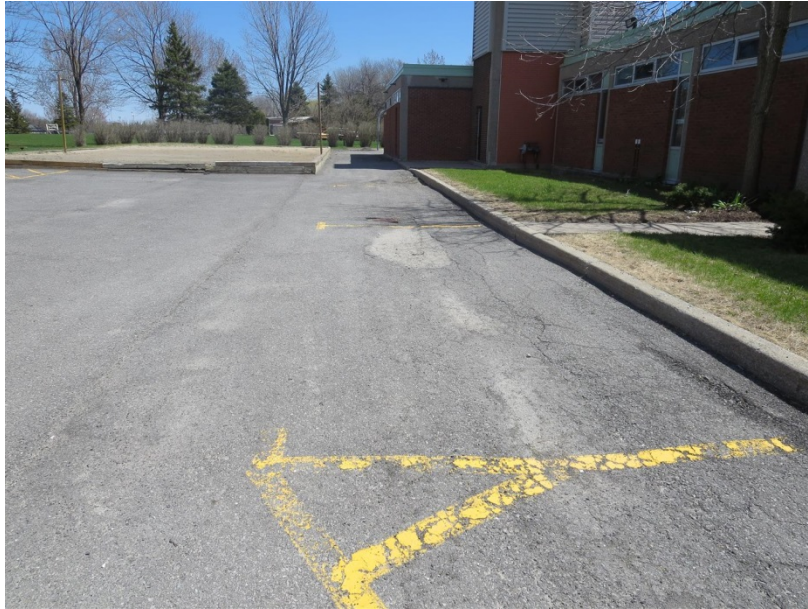
**Photo 23:** Driveway at north side

4-20yrs: We have included a separate budget to replace the north drive lane and re-set the catch basin. This represents about 2,475ft<sup>2</sup> of asphalt.

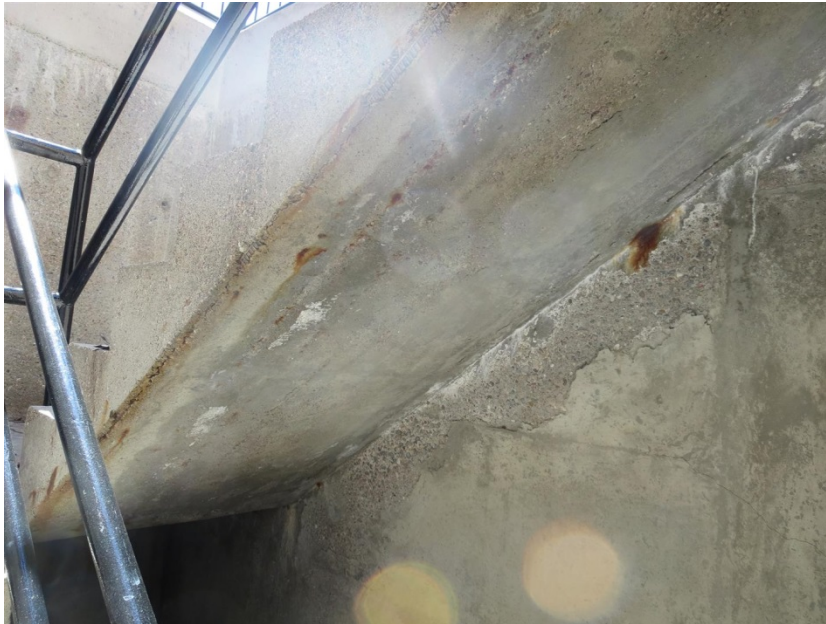
The stairs are in fair condition.

**Photo 25:** Deterioration at stairs

4-20yrs: Based on the deterioration noted, we have included a budget to complete additional concrete repairs.

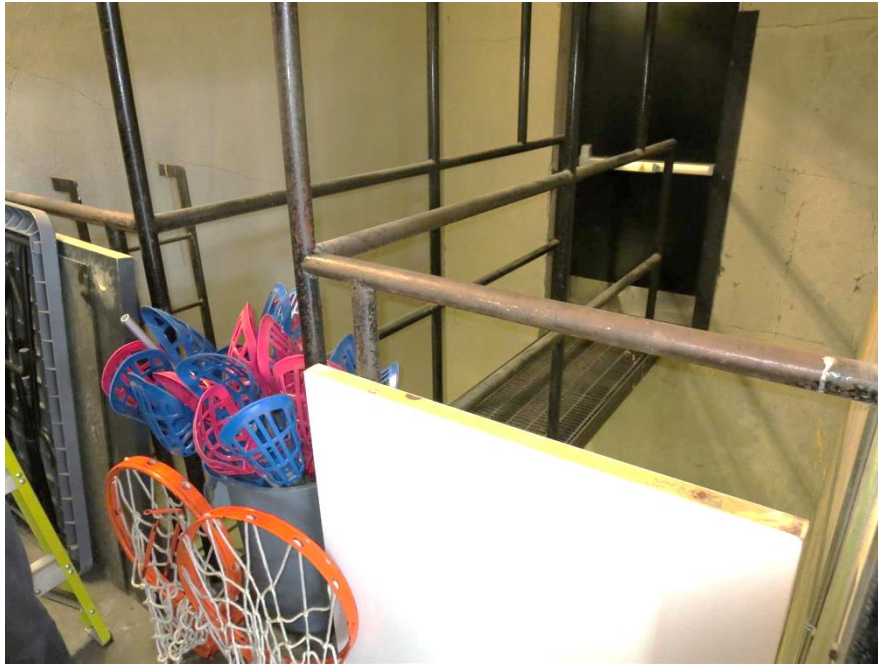
The suspended walkway and stairwell guards do not meet the Ottawa Property Standards By-law as the gaps in the railings are greater than 10cm. We recommend modifying the guards.

**Photo 28:** Suspended walkway

We recommend modifying the guards to comply with the City of Ottawa Property Standards By-law. We have included a preliminary budget to modify the guards in these areas.
