SUPPLEMENTAL INSTRUCTION

PROJ.: **Boys and Girls Club Prince of Wales**
PROJ. No.: **1716**
DATE: **Apr 10, 2018**
S.I. No. **S.I. - 023**

Repair to bearing concrete block wall at Grid 4a-H

Site Review

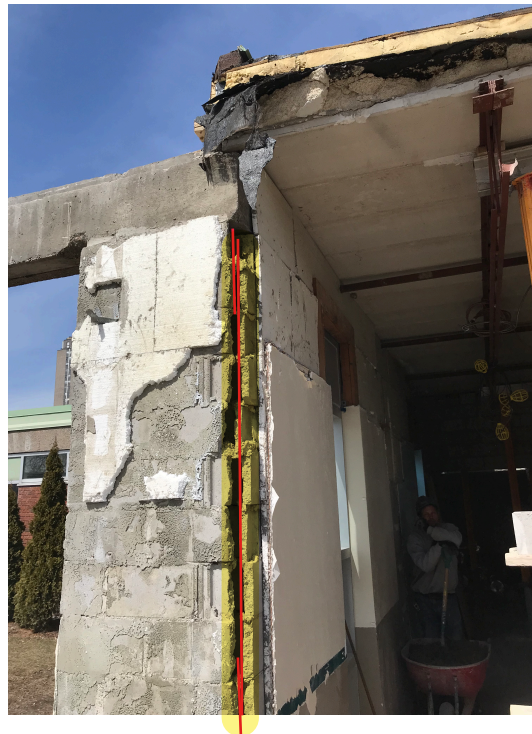
AREA: Existing Masonry Block Wall Under Existing Concrete Beam Grid 4a-H
Structural Masonry Review H,5 8C. F,5 Complete

At time of review, existing load bearing concrete block supporting existing concrete beam was noted as requiring remedial work, please see instruction below.

Dowel 1-20M vert into existing concrete beam.
Dowel 1-20M into Foundation Wall.
Ensure lap of 925mm with vertical reinforcing.
Embed 200mm, fasten with Hilti HY200. Ensure holes are cleaned before applying epoxy.
Ensure to follow Hilti Specifications and application instructions.
Form and pour full height of block to U/S of concrete beam at corner course with non-shrink grout.
