# Pre-Renovation Designated Substances Review

*Maison de la Francophonie d'Ottawa (Former Grant School), 2720 Richmond Road, Ottawa, Ontario*

Project No.: 1791616 (JLR Project No. 27672-000.1)

April 18, 2018

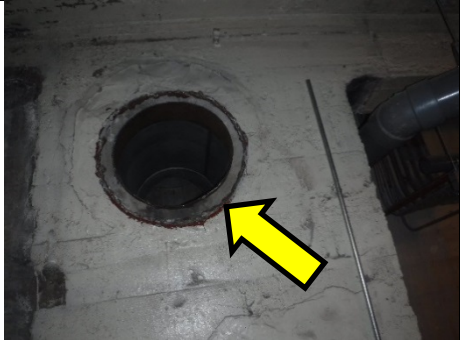
Grey Parging	Present on top of Red Caulking around chimney pipe inside Mechanical Room 002	1.5 linear meters	Poor	Yes	C	2 Parging A – 2 Parging C	65% Chrysotile

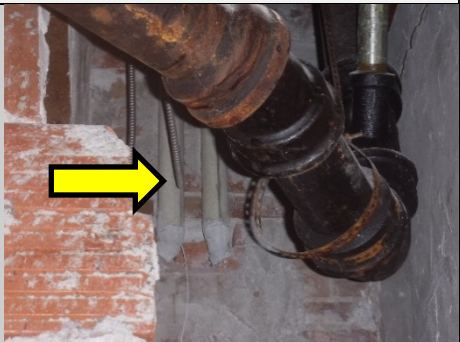
Pipe Straight Insulation	Present inside west air duct wall cavity running between D144C, 215 and 318A	Unknown	Fair to Poor	Yes	D	Historical EHSP Report: 04-0068-12-001  PS-1-A – PS-1-C	90% Chrysotile

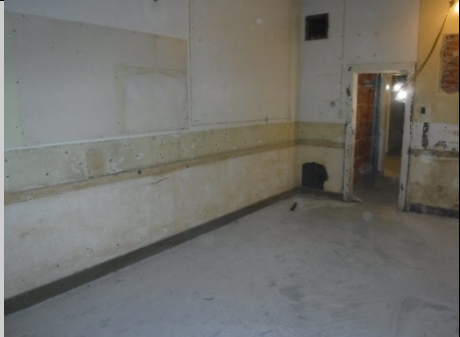
Plaster	Present throughout Ground, Second and Third Floors	2,900 m <sup>2</sup>	Fair to Poor	Yes	A	Historical EHSP Report: 04-0068-12-001 PL-1-A – PL-1-C	2% Chrysotile

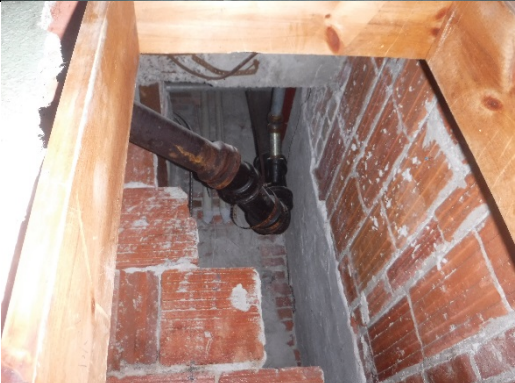
Lead solder / Present bell and spigot joints inside wall cavities for air ducts	Good	No sample collected as sampling would have impacted the integrity of the piping system. Material visually appears to be lead-containing and bell and spigot joints are known to contain lead solder		Assumed

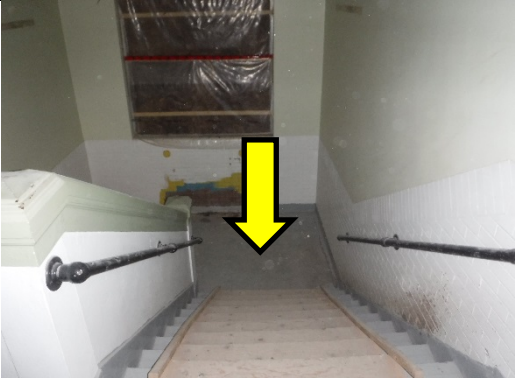
Grey floor paint – Present within the basement and on the east and west stairs	Fair	1955	Historical EHSP Report: 04-0068- 12-001  LBP-G	Yes

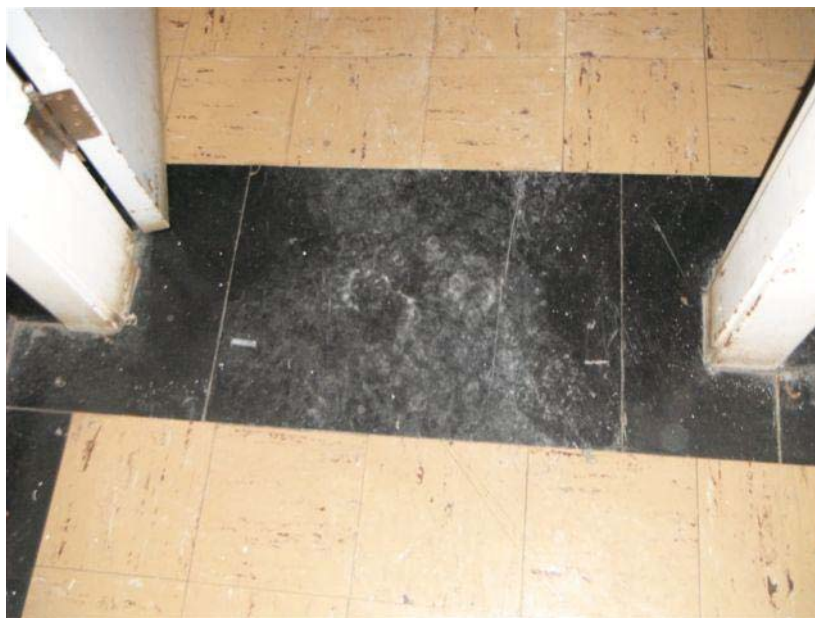
**Photo 8:**

View of Representative Asbestos Containing 9"x 9" Vinyl Floor Tile, Annex Building, Waiting Room, Sample Set: VT-3-X.

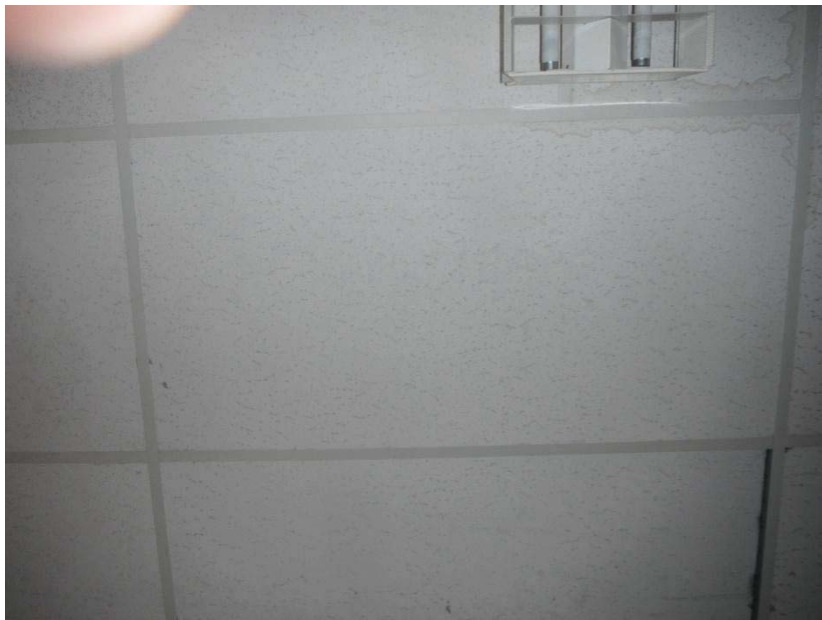
<b>Photo 24:</b>	View of Representative Asbestos Containing Ceiling Tile, 2'x 4'Deep Markings, Main Building, Library, Sample Set: CT-2-X.
------------------	---

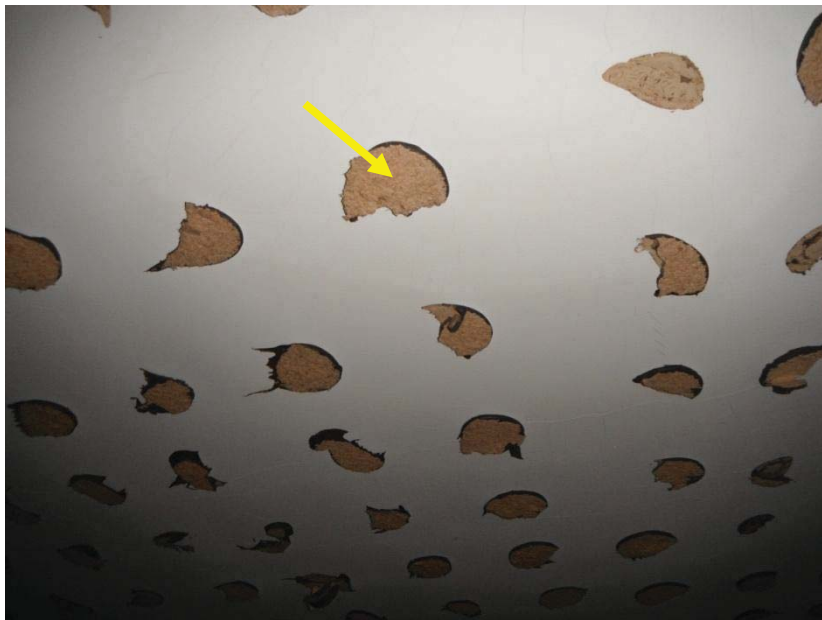
**Photo 25:**

View of Representative Asbestos Containing Ceiling Tile, 2'x 4' Light Markings, Main Building, Library, Sample Set: CT-3-X.

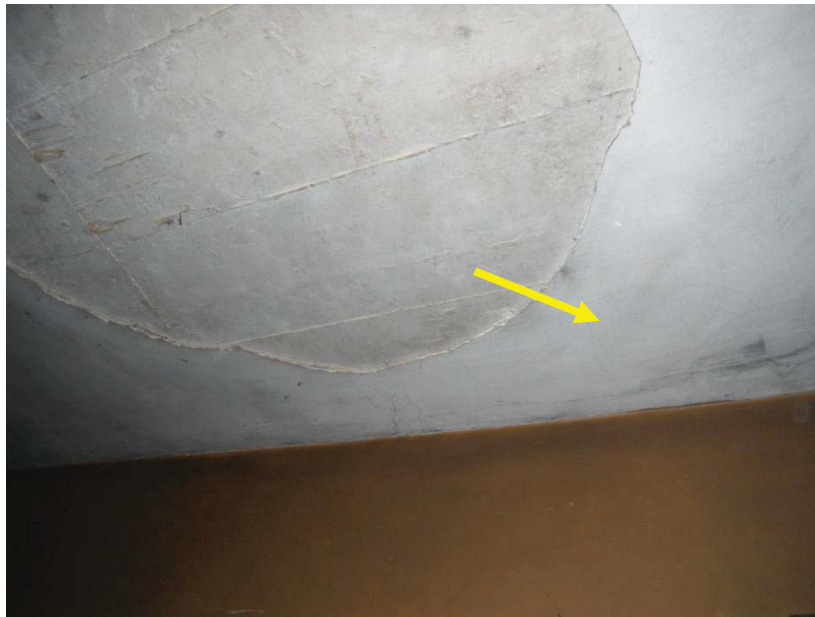
**Photo 26:**

View of Representative Asbestos Containing Ceiling Tile Mastic, Main Building, Library Ceiling Space, Sample Set: MS-1-X.

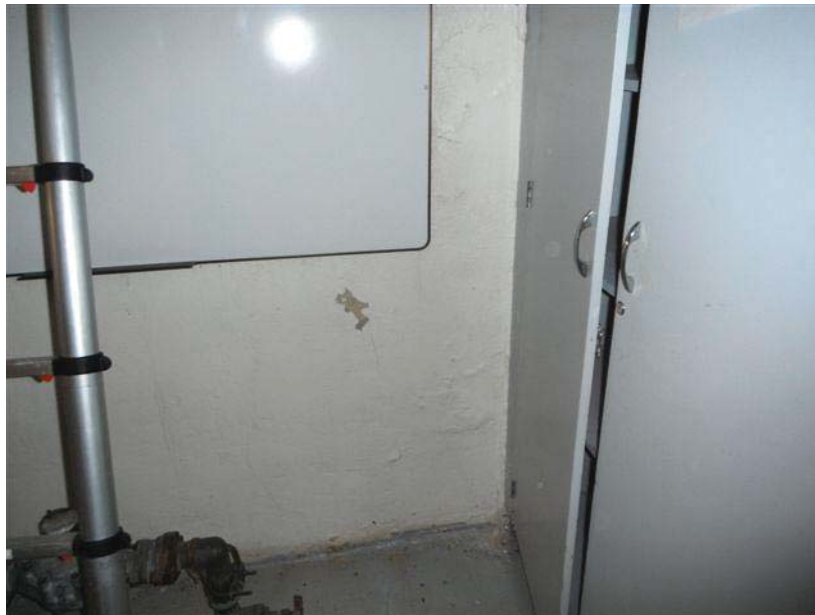
**Photo 46:** View of Representative Lead Containing White Wall Paint, Annex Building, Room 004, Sample: LBP-D.
