## 2016 HAZARDOUS BUILDING MATERIAL ASSESSMENT REPORT

ST. MARY CATHOLIC SCHOOL

4 HAWTHORNE AVENUE IN CARLETON PLACE, ONTARIO

GEC PROJECT No. 29067

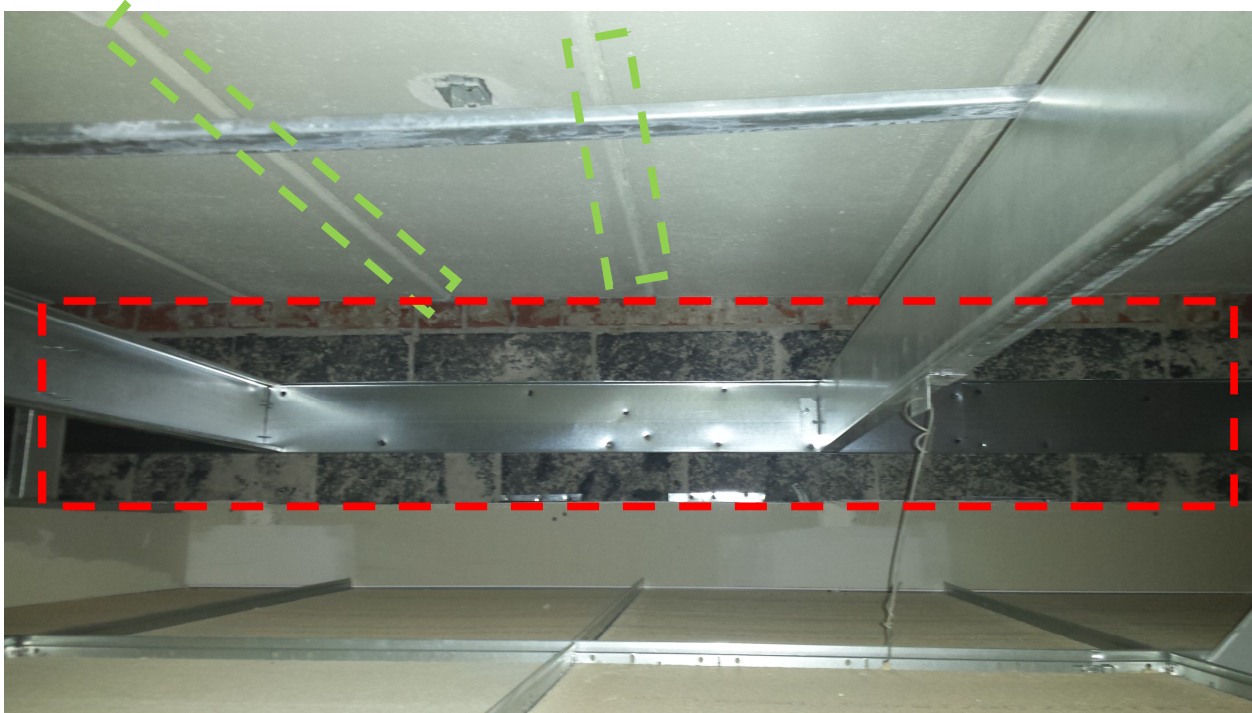
- Plaster is considered a non-friable material, however it is considered friable upon manipulation. Photos of this material can be found in **Appendix 4**.

- Approximately 40m<sup>2</sup> of this material was observed throughout the 1958 phase of the building. All Mortar between Siporex should be treated as ACM. Photos of this material can be found in **Appendix 4**.

Photo 1 – View of remnant plaster on brick above ceiling grid (Red), and Siporex mortar (Green).

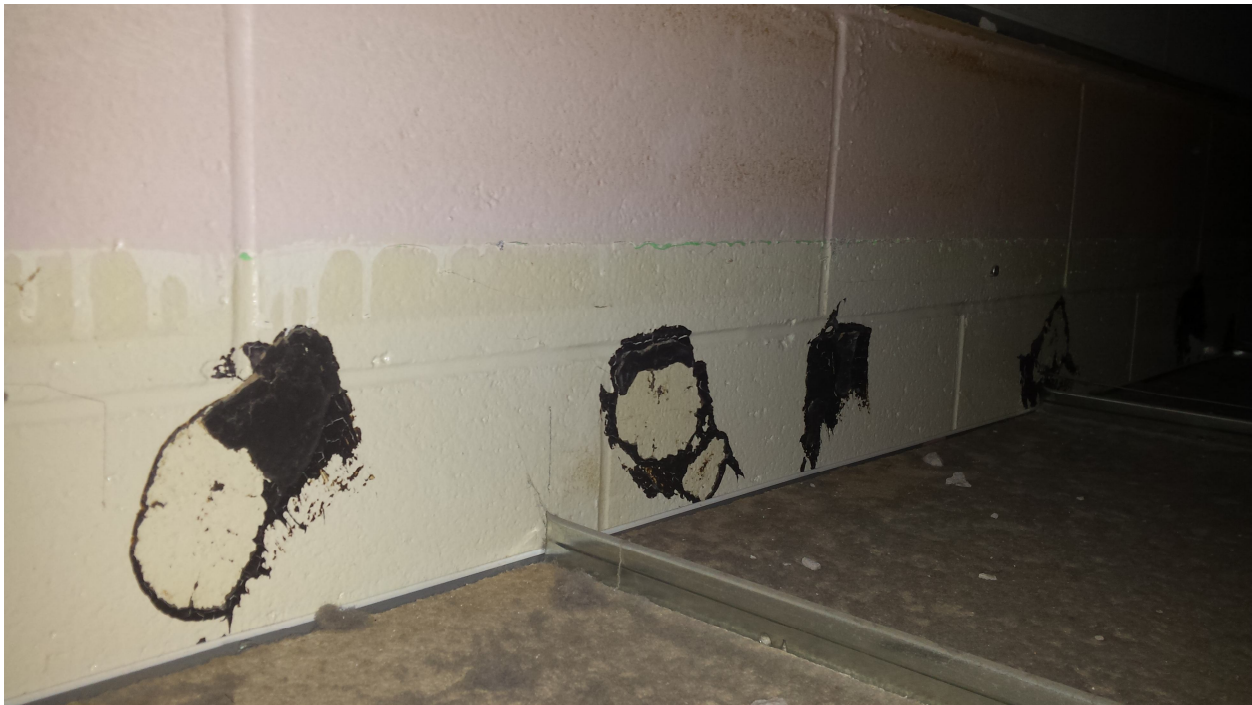
- Black Adhesive Pucks on Concrete Blocks:
  - This material was observed sporadically throughout the school, above ceiling grids, attached to concrete blocks. Due to limited access/obstructions within ceiling space, accurate quantities could not be determined. Any adhesive pucks on concrete blocks within the building should be treated as an ACM. Photos of this material can be found in **Appendix 4**.

Photo 2 – View of Black Adhesive Pucks on Concrete Block above ceiling grid..

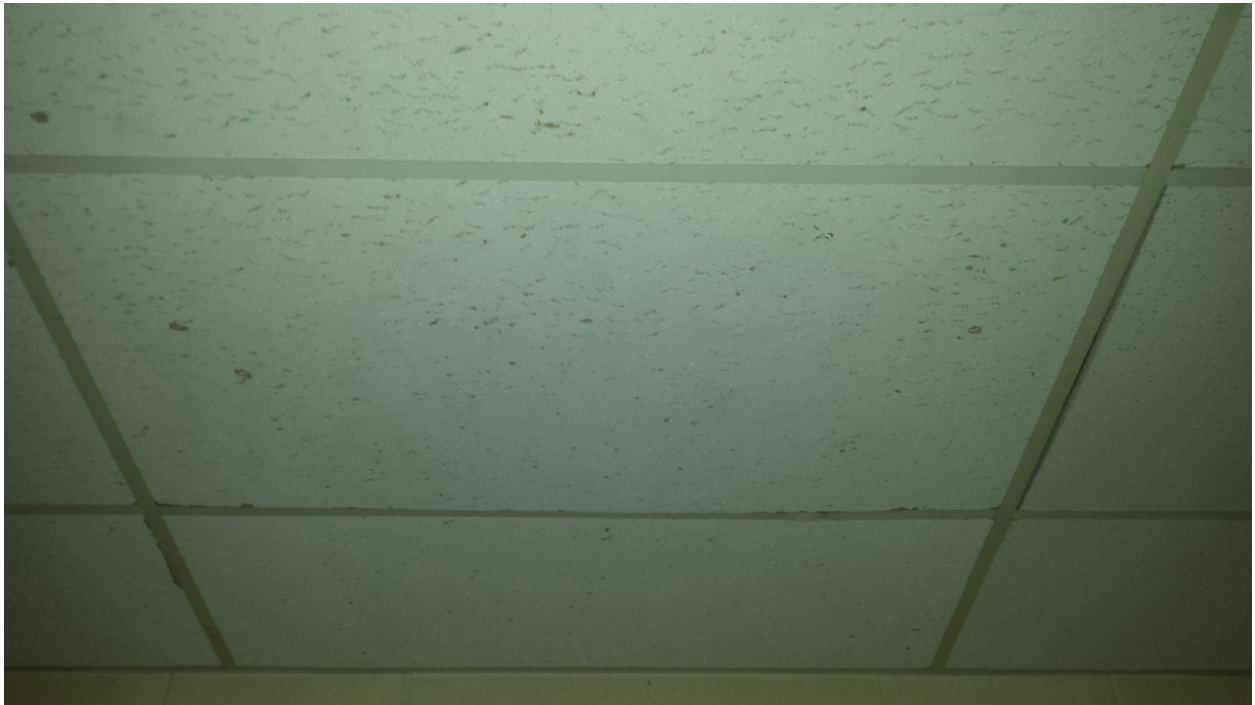
- Acoustic Ceiling Tile – Long Large Lengthwise Fissures and Small Pinholes;
  - Approximately 31 m<sup>2</sup> of this material was observed throughout the building. Photos of this material can be found in **Appendix 4**.

Photo 3 – View of asbestos 60cm x 120cm ACM ceiling tiles.

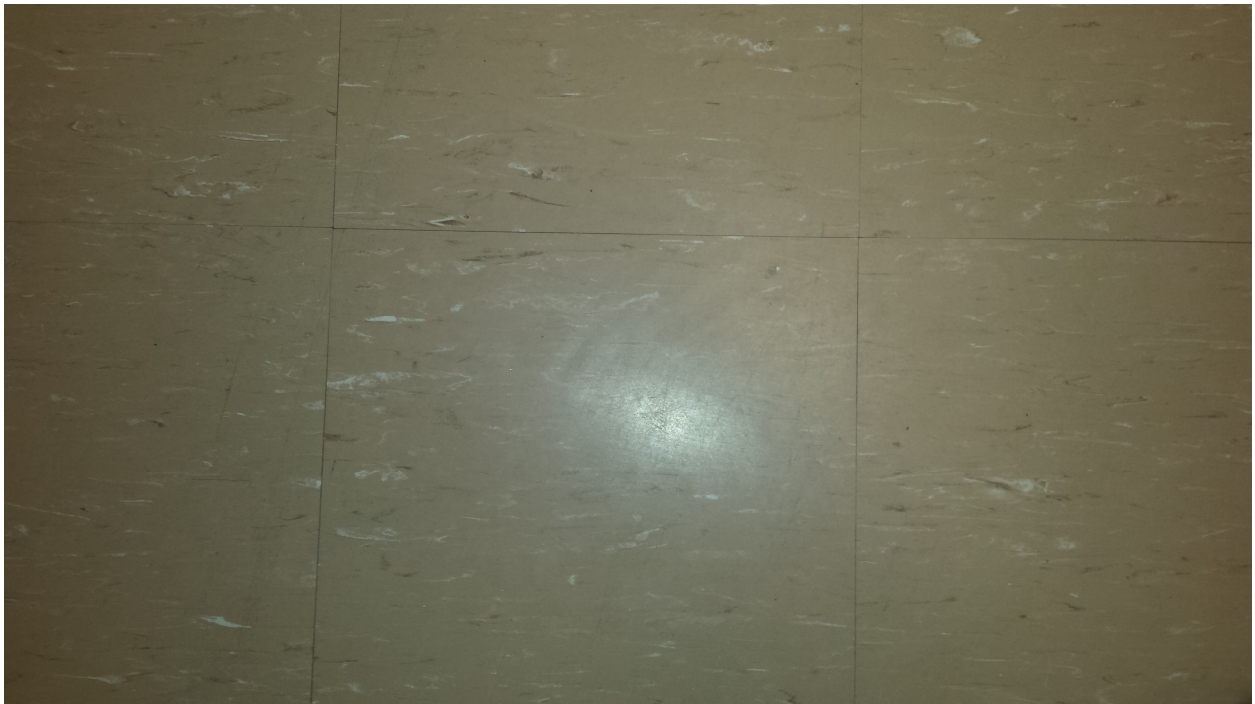
- Vinyl Floor Tile – 30cm x 30cm – Brown with White and Brown Streaks
  - Approximately 130 m<sup>2</sup> of this material was observed throughout the building. Photos of this material can be found in **Appendix 4**.

Photo 4 – View of asbestos 30cm x 30cm vinyl floor tile.

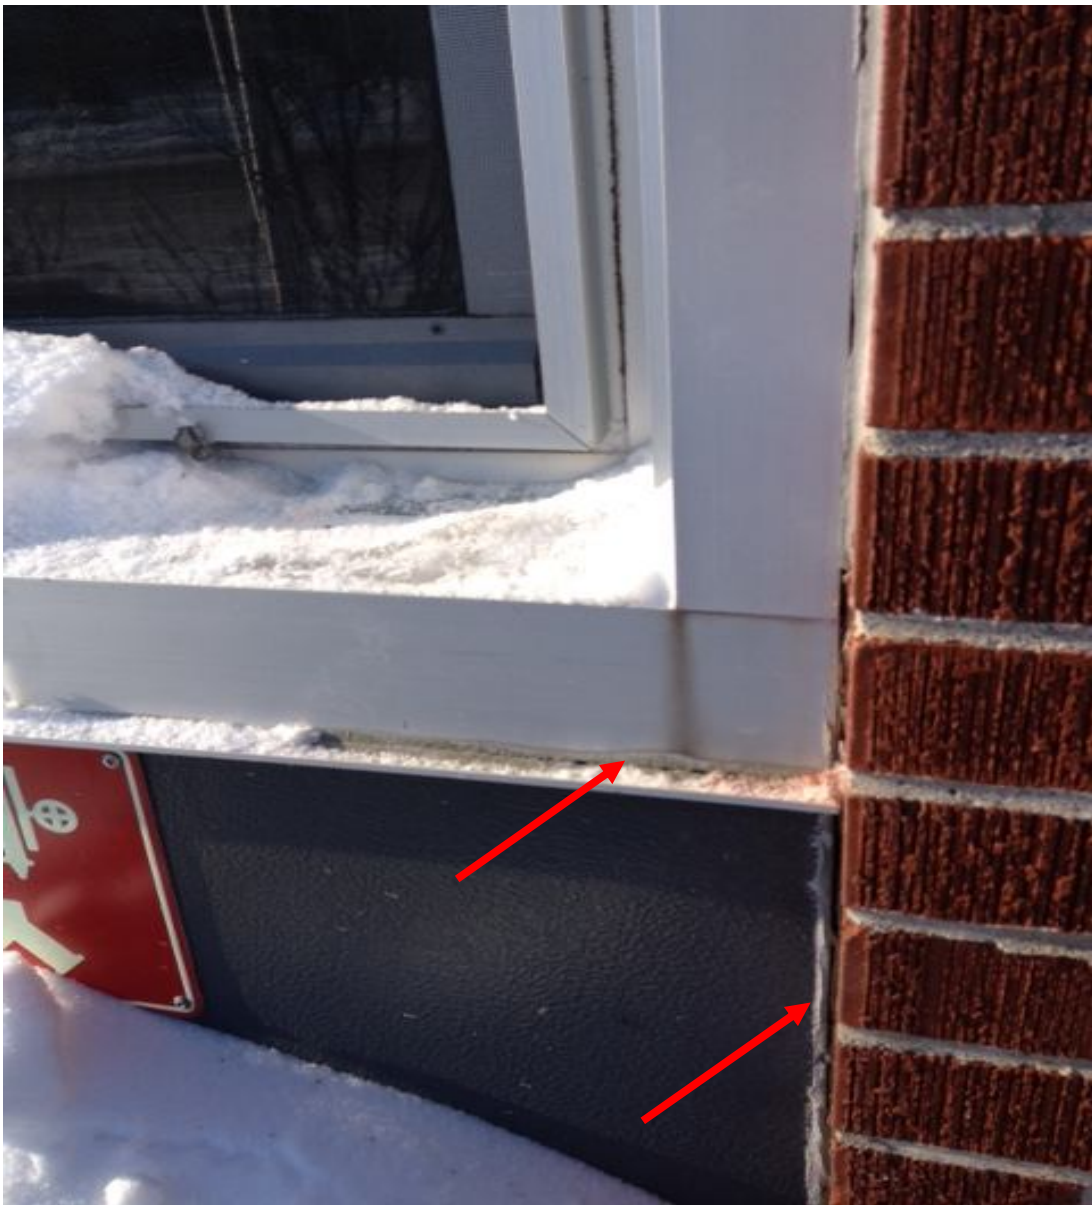
- Grey Exterior Window Caulking;
  - This material was observed on windows and flashing on the exterior of the building (project area). Photos of this material can be found in **Appendix 4**.

Photo 5 – View of asbestos grey exterior caulking on windows and flashing.

- All grey exterior caulking found on windows and flashing should be removed following Type-1 procedures as outlined O.Reg 278/05.
  - Please see attached Type-1 Specification for the upcoming project (**Appendix 5**).
  - Suspect materials identified during renovation and/or demolition activities not discussed in this report herein should be treated as ACMs unless proven otherwise through material specific sampling and analysis in accordance with the requirements of Ontario Regulation 278/05.
