Hazardous Building Materials Assessment

Hello Future Stage 2 Renovation
100 Portsmouth Avenue,
Kingston, Ontario

March 13, 2017

Pinchin File: 202867

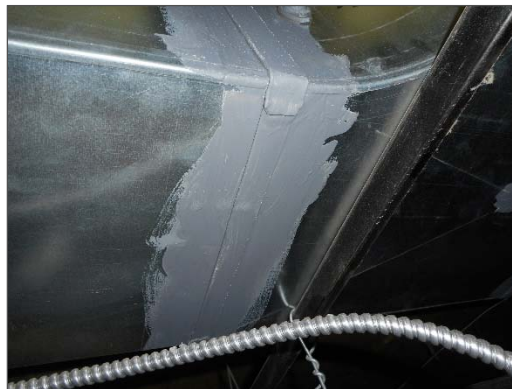
Grey duct mastic present at the seams and joints of ducts throughout the assessed area does not contain asbestos (samples 0004A-C).

Non-asbestos grey duct mastic.

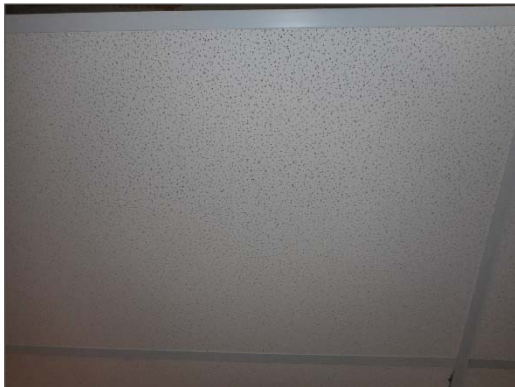
Non-asbestos ceiling tiles present throughout the assessed area.

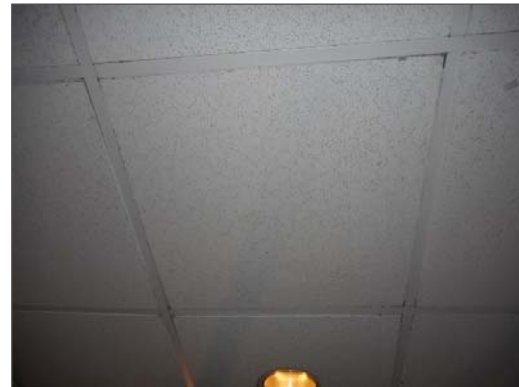
Non-asbestos ceiling tiles present throughout the assessed area.

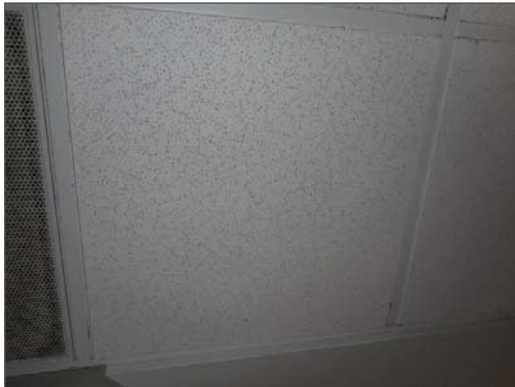
Non-asbestos ceiling tiles present throughout the assessed area.

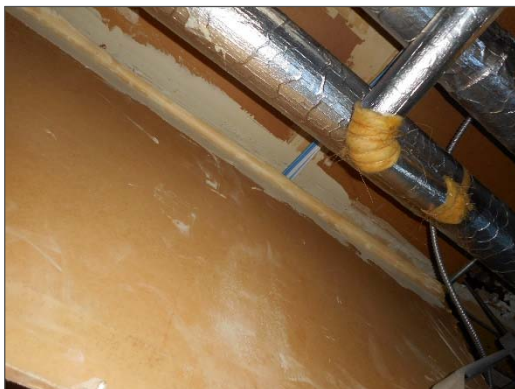
Drywall (gypsum board) and drywall joint compound, containing chrysotile asbestos, is present as a wall and ceiling finish in the ground and second floors within the interior of the building (samples 0003A-C and 0007A-C). Drywall joint compound is a non-friable material and in good condition.

Asbestos-containing drywall joint compound present on drywall wall and ceiling finishes throughout the assessed area (Photo taken above suspended ceiling).

If drywall is to be disturbed/removed, remove minor amounts (less than 1 square metre (10.78 square feet)) of drywall with asbestos-containing drywall joint compound using Type 1 procedures as outlined within Ontario Regulation 278/05. Use Type 2 procedures for larger amounts (greater than 1 square metre).

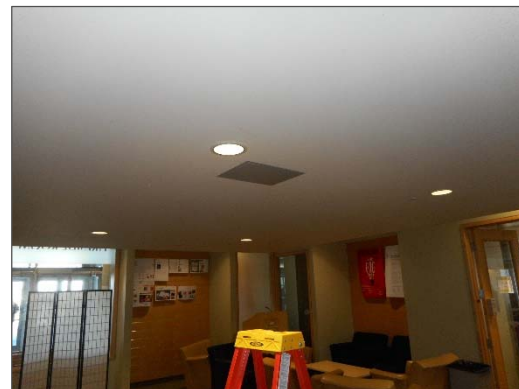
Asbestos-containing drywall joint compound present on drywall wall and ceiling finishes throughout the assessed area.

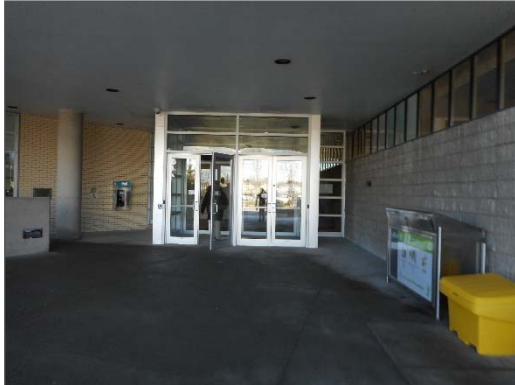
Drywall (gypsum board) and drywall joint compound present on the underside of the exterior main entrance canopy does not contain asbestos (samples 0002A-C).

Non-asbestos drywall joint compound present on the underside of the exterior canopy at the main entrance.

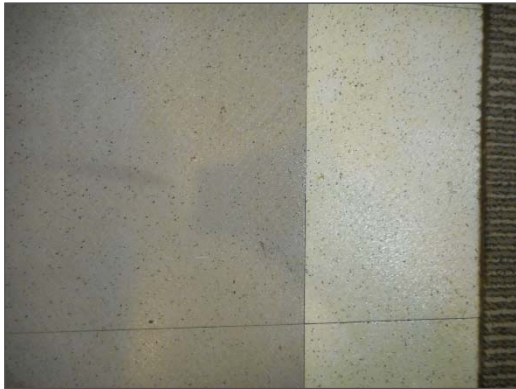
Non-asbestos 12" white and grey vinyl floor tiles with black dots.

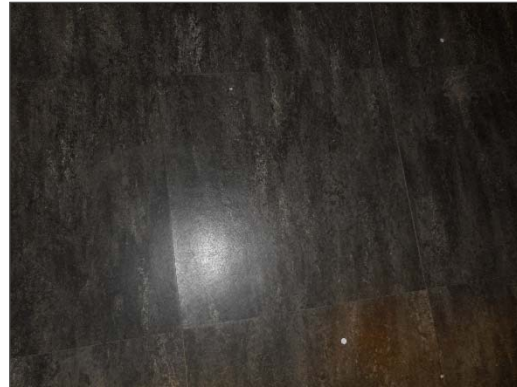
Non-asbestos 12" black vinyl floor tiles with a stone pattern.

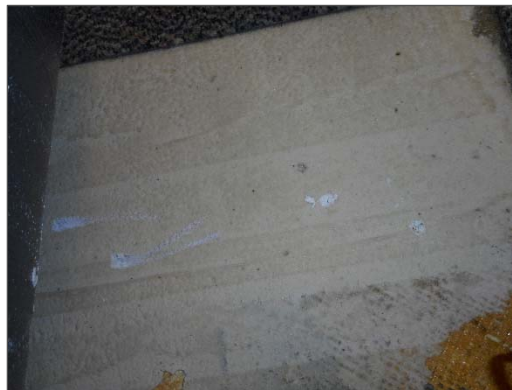
White floor levelling compound present under carpet tiles throughout the assessed area does not contain asbestos (samples 0005A-C).

Non-asbestos white floor levelling compound.

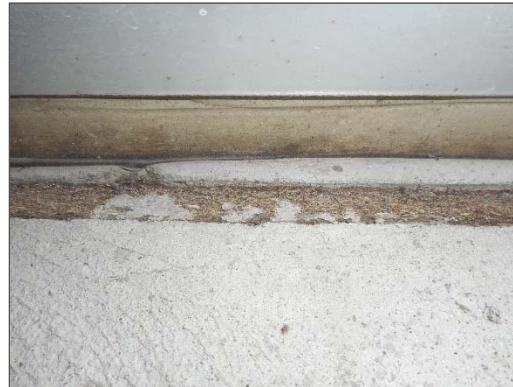
Grey caulking at the front entrance exterior windows and doors does not contain asbestos (samples 0001A-C).

Non-asbestos grey exterior caulking.

Grey caulking is present at exterior windows and doors at the main entrance of the building (sample PCB1) and contains <5.00 ppm PCBs. The material is a non-PCB solid based on the threshold given in SOR/2008-273 (50 ppm).
