Inspection Report

Date: May 11, 2017	Pinchin Representative: Sarah Young, C.Tech., Operations Manager	Report Number: 1 Pinchin File: 202034
Project Name: St. Lawrence College, Hello Future, Stage 2 Renovation	Site Address: 100 Portsmouth Avenue, Kingston, Ontario	
Client: Interprovincial Insulation Inc.	Client File Number: N/A	
Contractor: Interprovincial Insulation Inc.	Arrival on Site: 2:00 PM Number of Workers: 0

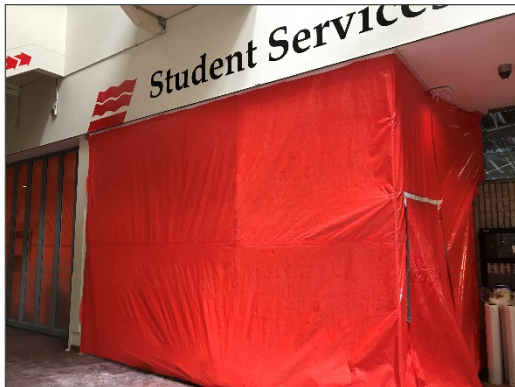
2.1	Although not required, a partial decontamination facility, consisting of a clean change room/waste storage room, was installed immediately outside the Welcome centre, providing access into the Asbestos Work Area. The floors were covered with orange rip proof polyethylene sheeting and the walls were constructed with orange rip proof polyethylene sheeting. Zip poles were used to support the walls. All seams, joints and edges were taped with duct tape

Site isolation outside the entrance to the Welcome Centre; acceptable.

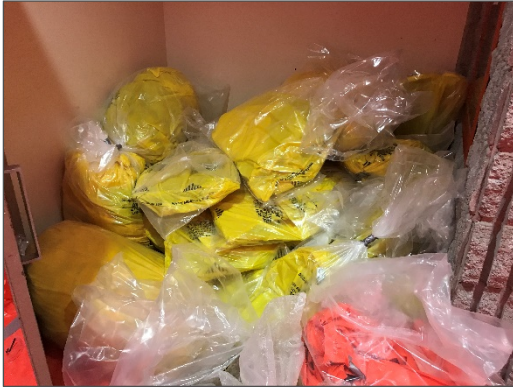
Waste stored inside the clean room; awaiting transport to bin; acceptable.

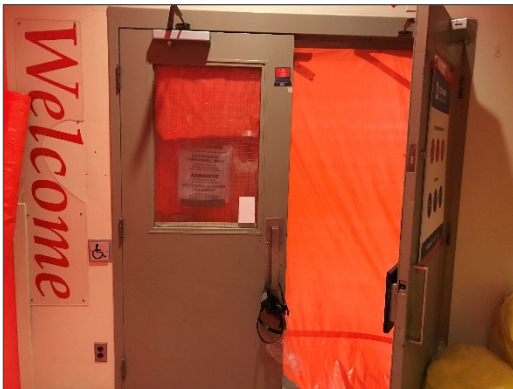
2.2	The entrances to the work area are provided by overlapping flapped doors.	
2.3	Asbestos hazard signage is posted at the entrance to the work area. A portion of the sign was covered with polyethylene sheeting at the time of the inspection. Ensure signage remains visible at all times.	III

Entrance to work area; asbestos hazard signage posted but partially covered.

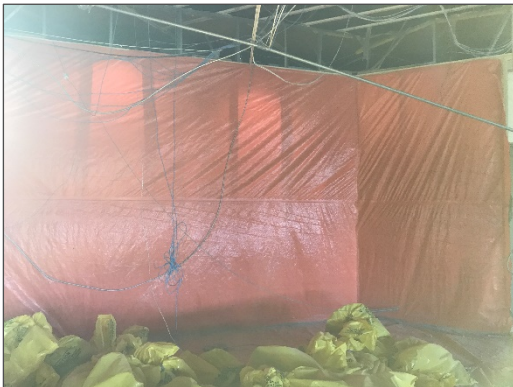
Item	Comments	Action
2.0	The Type 2 enclosure was constructed of orange rip proof polyethylene sheeting. All seams, joints and edges were taped with duct tape. Glass Walls, and doors to the work area were covered with orange rip proof polyethylene sheeting and sealed with duct tape.

Glass wall inside work area covered with polyethylene sheeting and sealed with duct tape.

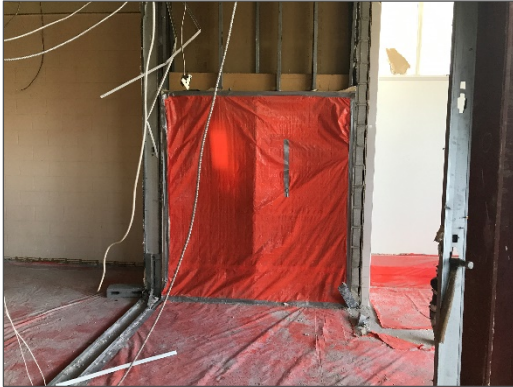
Doors inside work area covered with polyethylene sheeting and sealed with duct tape.

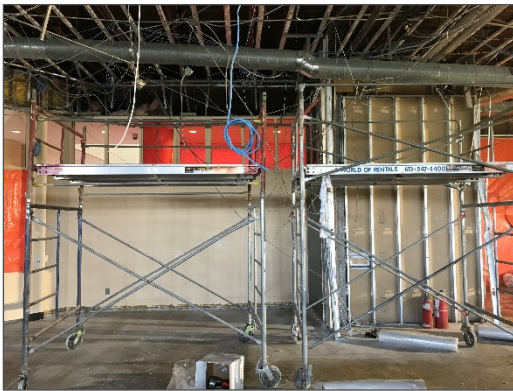
Item	Comments	Action
	of this project.	
3.0	All facilities and equipment were present on site and operational. Two movable scaffolds, ladders, temporary lights, hose, pump sprayers, HEPA vacuums and waste bags were observed.

Movable scaffold equipment present on site.

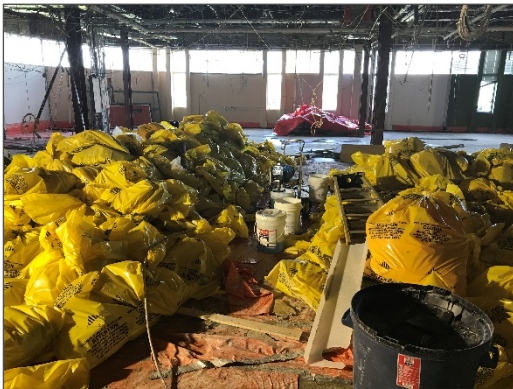
6.0	A hose and pump sprayers were observed on site and used for both cleaning and dust suppression measures.	
7.0	The drywall bulk removal has been completed and waste packaging is well underway. Waste is bagged in yellow asbestos labeled 6 mil polyethylene bags. The outside of the yellow bag is then reportedly cleaned and placed into a second clear 6 mil polyethylene bag and temporarily stored within the enclosure and clean change room. Asbestos waste transfer is reportedly completed after hours; bagged waste is removed from the enclosure and placed in a lined and covered waste bin located outside the main entrance within the fenced construction area. Asbestos hazard signage is posted on the bin.

Waste packaging underway.

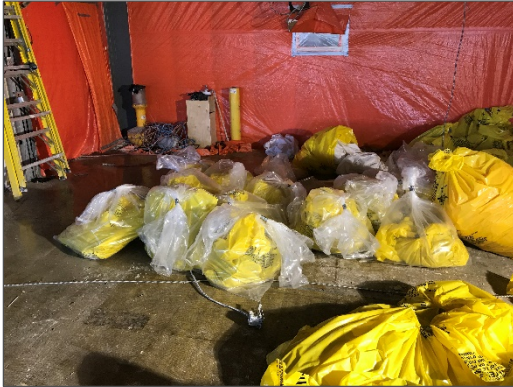
Bag cleaning and double bagging area.

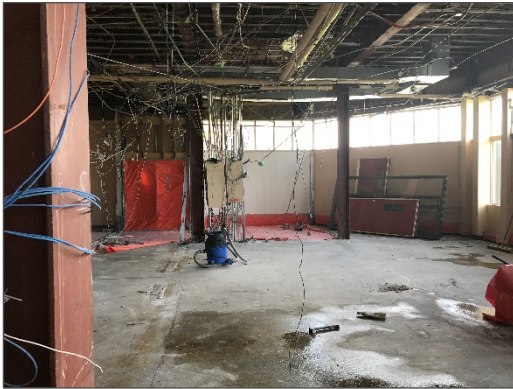
8.0	Cleaning is reportedly underway commencing at the exterior walls and working towards the work area entrance as the waste removal progresses. HEPA vacuums and wet wiping methods are reportedly used.

Portion of work area with final cleaning underway.
