Hazardous Building Materials Assessment

Cafeteria Renovation
St Lawrence College
100 Portsmouth Avenue,
Kingston, Ontario

April 26, 2019

Pinchin File: 240088

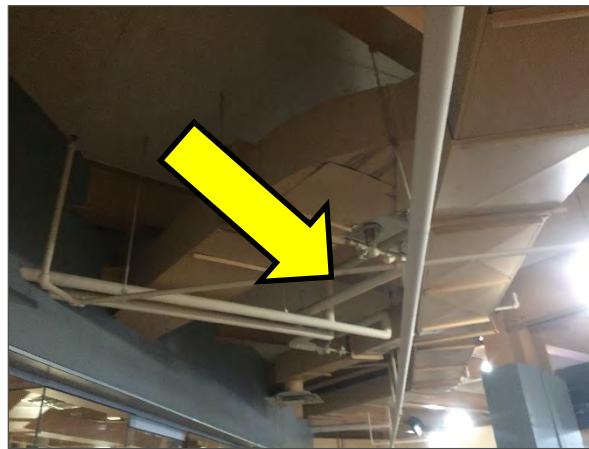
Pipes are either uninsulated or insulated with non-asbestos fibreglass, or other non-asbestos insulation such as mineral fibre or elastomeric foam insulation.

Uninsulated pipes.

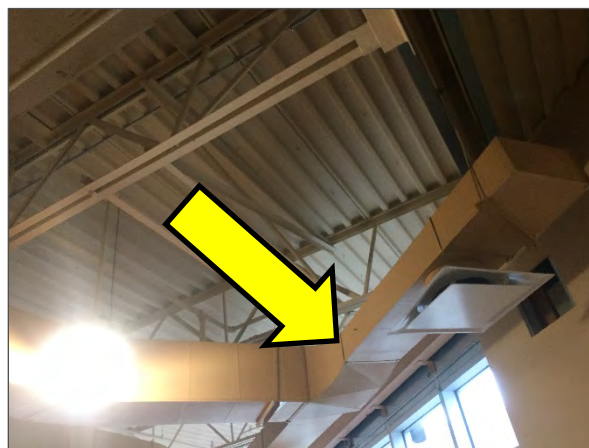
Ducts are either uninsulated or insulated with non-asbestos fibreglass (foil-faced).

Uninsulated ducts.

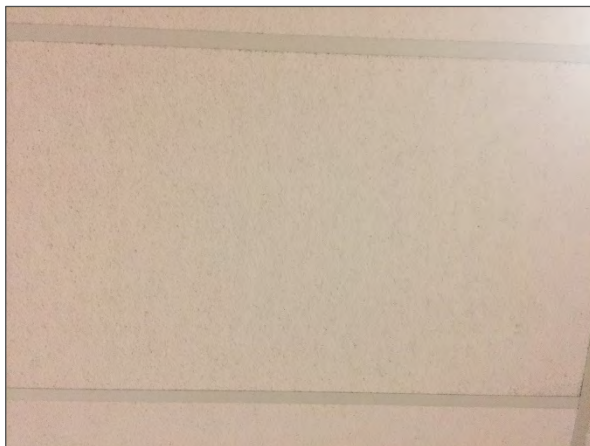
Non-asbestos 2'x4' lay-in, rough textured acoustic ceiling tile.

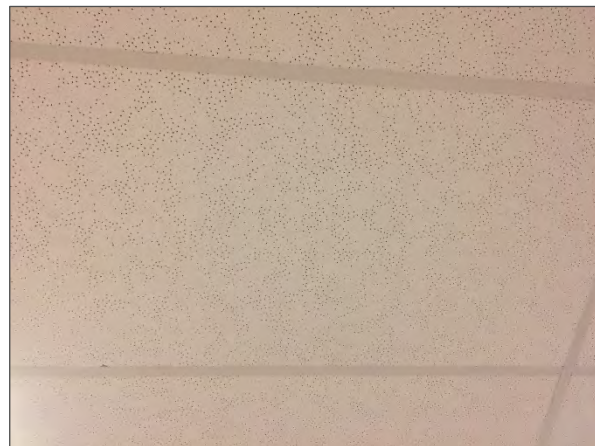
Non-asbestos, 2'x4' lay-in, random pinhole acoustic ceiling tile.

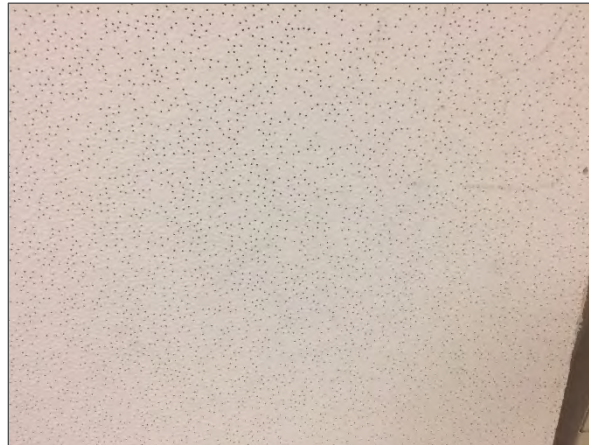
All ceiling tiles are presumed to be non-asbestos based on the date of manufacture determined from the date stamp applied to the top of the tiles. The tiles were manufactured after asbestos was stopped being used in acoustic ceiling tiles.

Non-asbestos, 2'x4' lay-in, small pinhole acoustic ceiling tile.

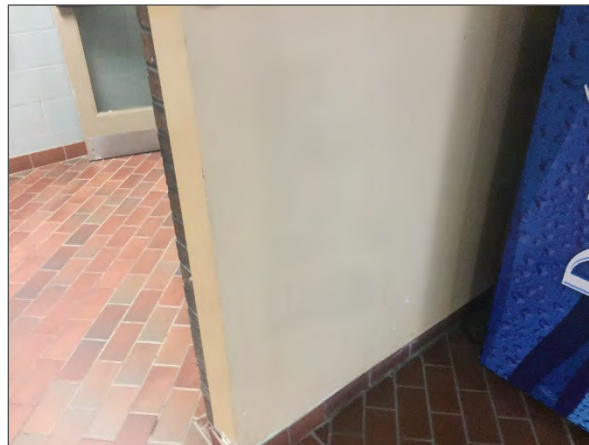
Drywall joint compound present on wall finishes throughout the assessed area does not contain asbestos (samples A0002A-C).

Non-asbestos drywall joint compound on wall.

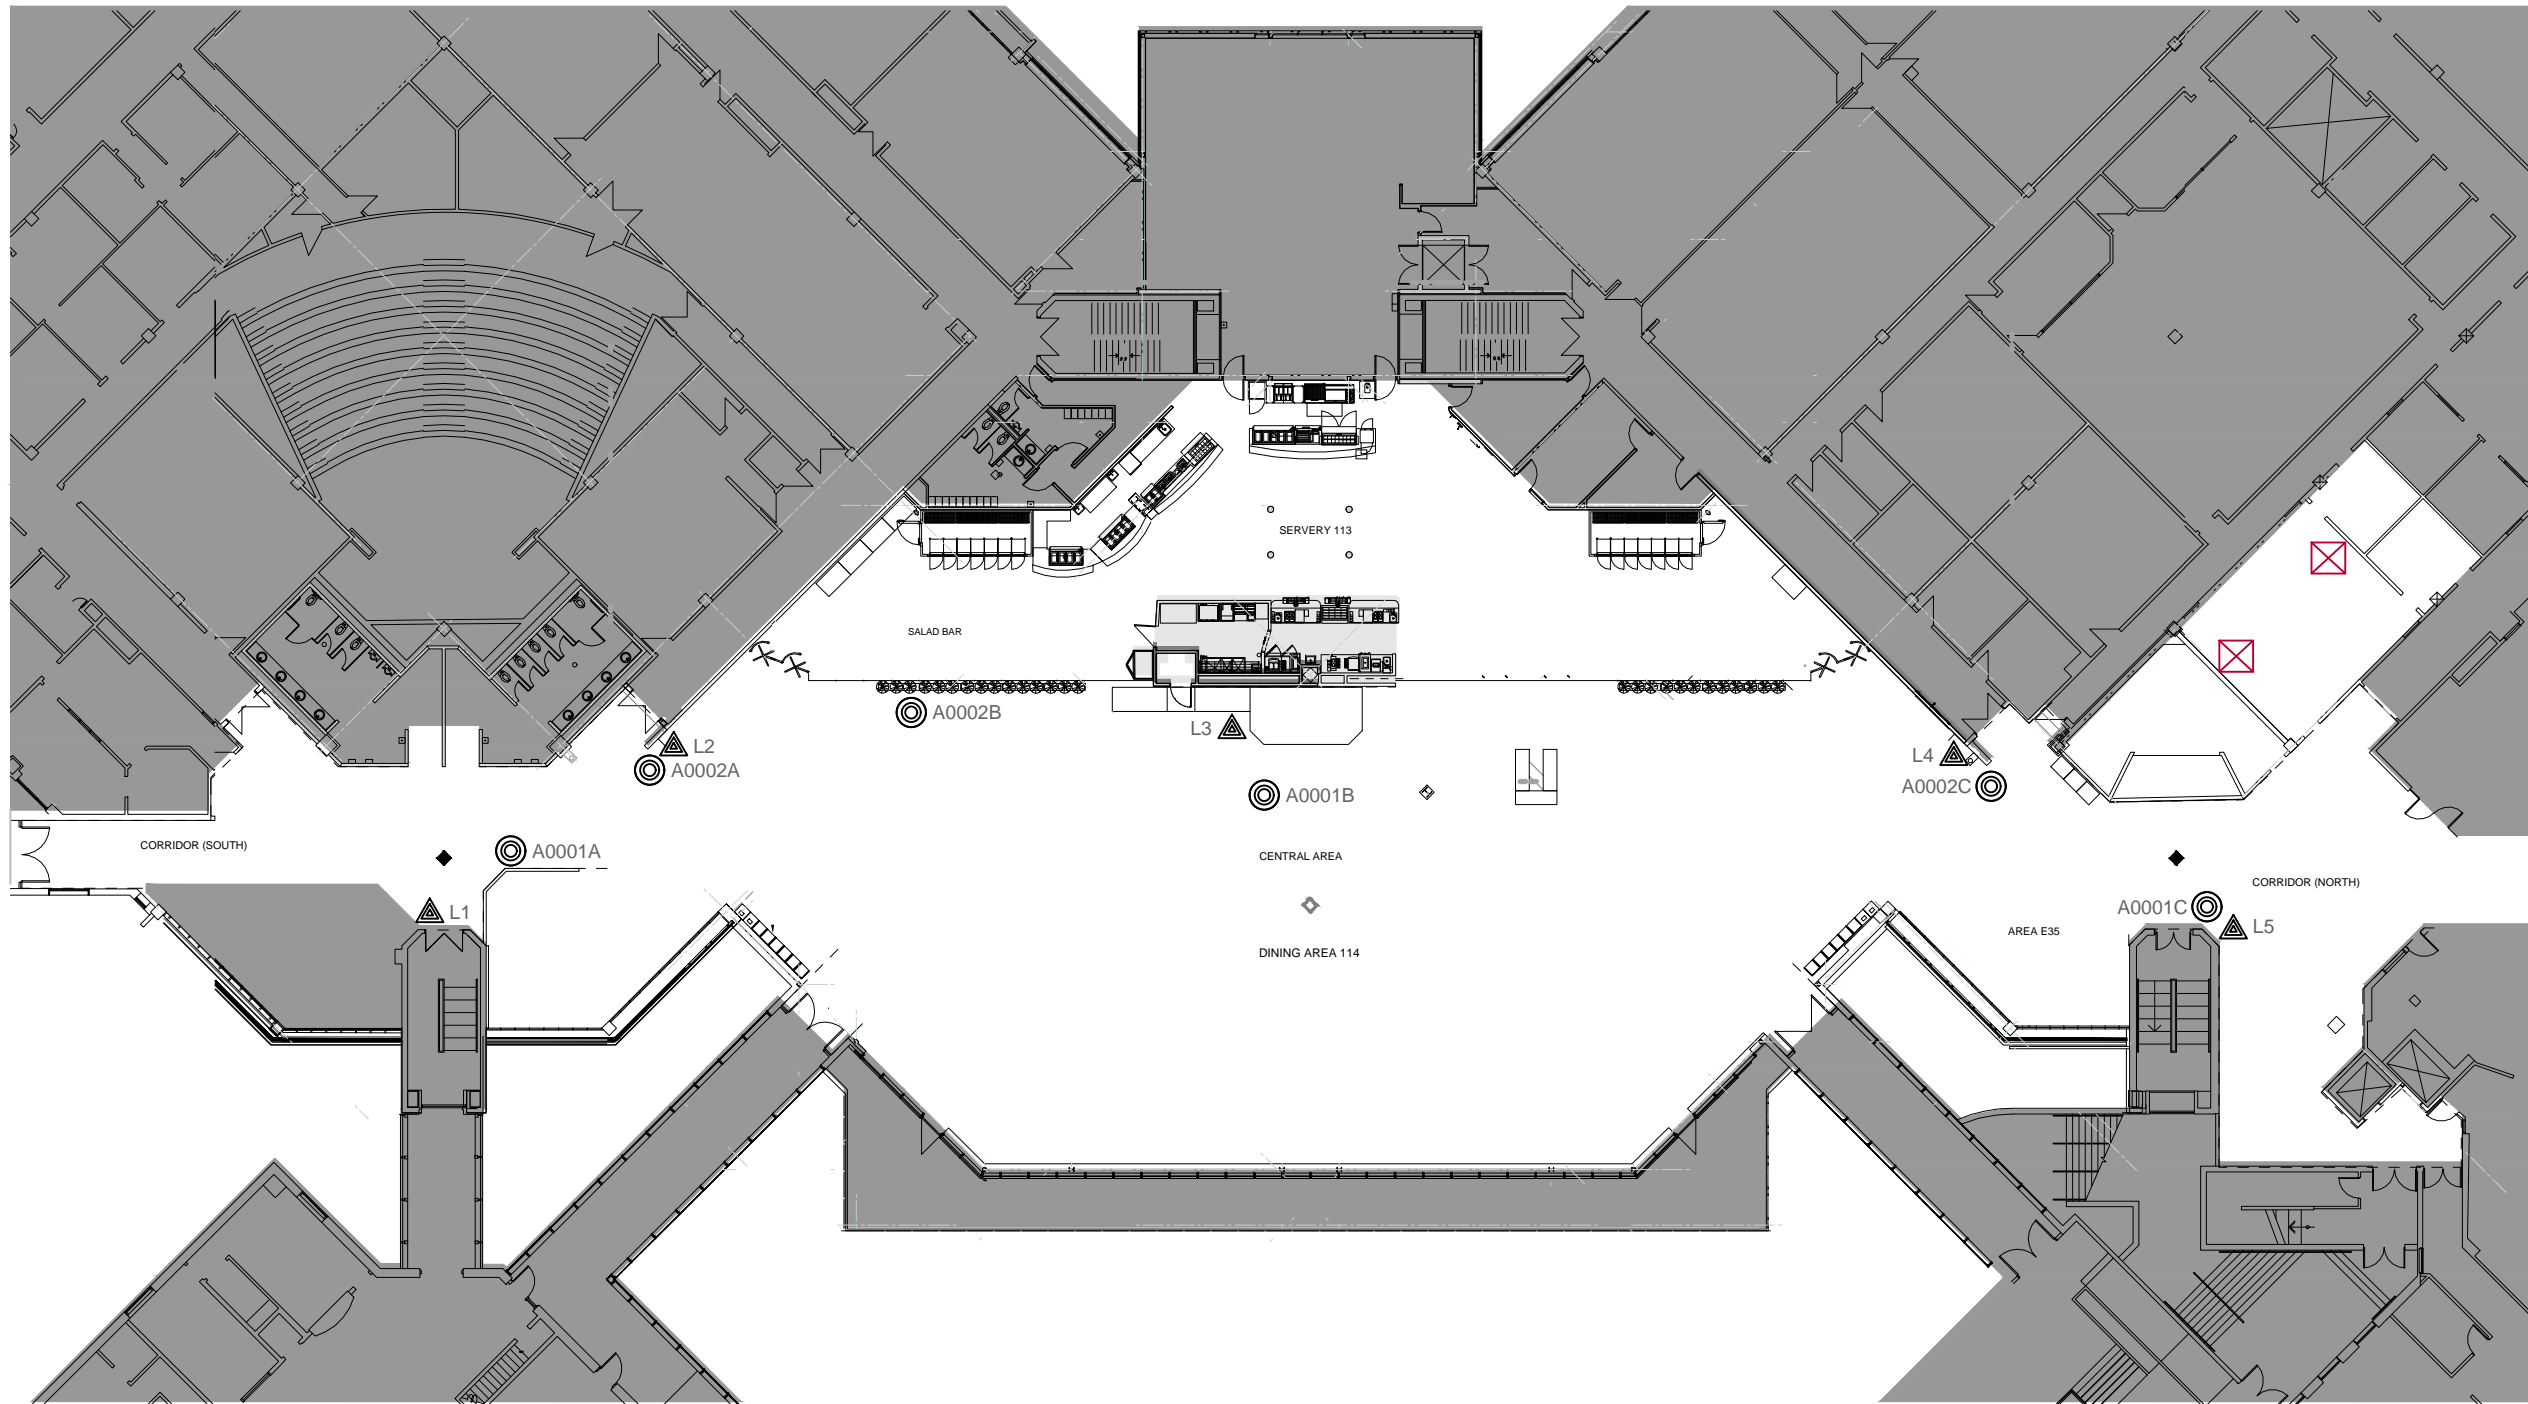
TITLE:
 HAZARDOUS BUILDING MATERIALS ASSESSMENT
 GROUND FLOOR

Destructive testing was conducted of masonry block walls. The masonry block walls were penetrated in two locations anticipated to be affected by planned renovations, loose fill vermiculite was not observed within the cavities. The locations of destructive testing have been indicated on the drawings in Appendix I.

NOTE:
 PRESUMED ASBESTOS-CONTAINING ROOFING MATERIAL IS PRESENT IN ASSESSED AREA.
