CONTEMPLATED CHANGE ORDER

PROJ.: Meridian Community
Building Rebuild
PROJ. No.: 1841
DATE: June 27, 2019
C.C.O. No. 004

4.1 TITLE
Outstanding Items from Owner Deficiency List

Meridian Deficiency List

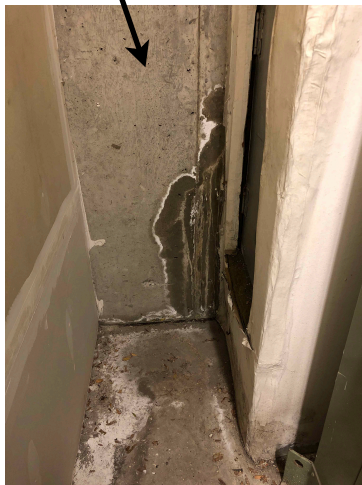
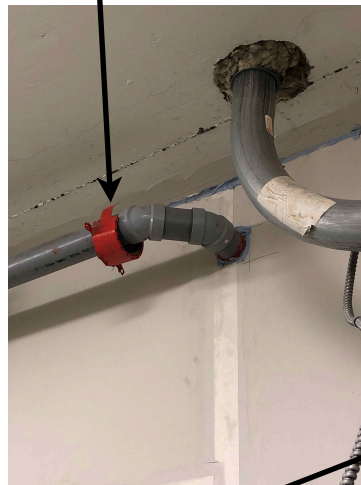
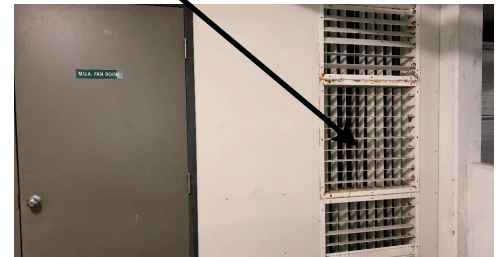
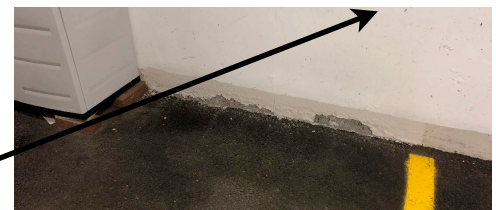
5. ~~Garage area under insulation to be swept and pressure washed.~~ DONE
6. ~~MUA unit in garage: Switch plate cover missing.~~ DONE
7. ~~MUA unit in garage: Cleaning inside and on top of unit.~~ DONE
8. MUA unit in garage: Leaking inside room - on drywall and floor - insulation wet. PART OF REBUILD
9. ~~MUA unit in garage: Firestop not attached to drywall.~~ DONE
10. MUA unit in garage: Insulate small room behind vents. PART OF REBUILD.

- .1 Item No. 4 is included in the current scope of work.
- .2 Item No. 9: Review existing firestop donut on horizontal section of pipe with Authority Having Jurisdiction – the wall that the pipe penetrates was not noted as a fire-rated separation on the original drawings and if it is rated the mechanical consultant has indicated that it may not require a firestop donut if the pipe is 50mm or less in diameter.
- .3 Item No. 10: Replace damaged/missing insulation in vent space.
