CONTEMPLATED CHANGE ORDER

PROJ.: Meridian Community
Building Rebuild
PROJ. No.: 1841
DATE: Oct. 31, 2019
C.C.O. No. 032

SITE VISIT REPORT

PROJECT:
Meridian Community Building Rebuild

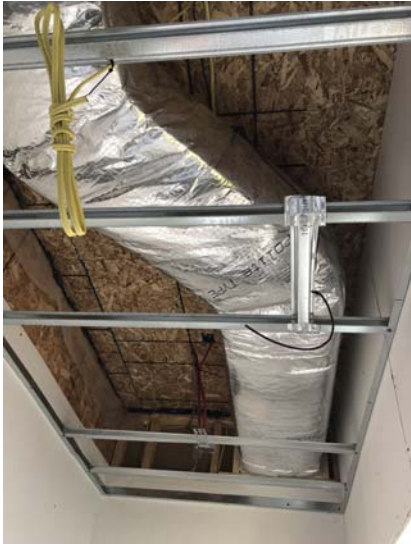
01 Duct in Stor-3

- 6.2.1 Ductwork in Store-3 (Room 108) has been insulated and there does not appear to be a take-off for the supply grille shown on Drawing M5. Please confirm that the supply grille will be added as this is intended to be a conditioned space (photo 01).

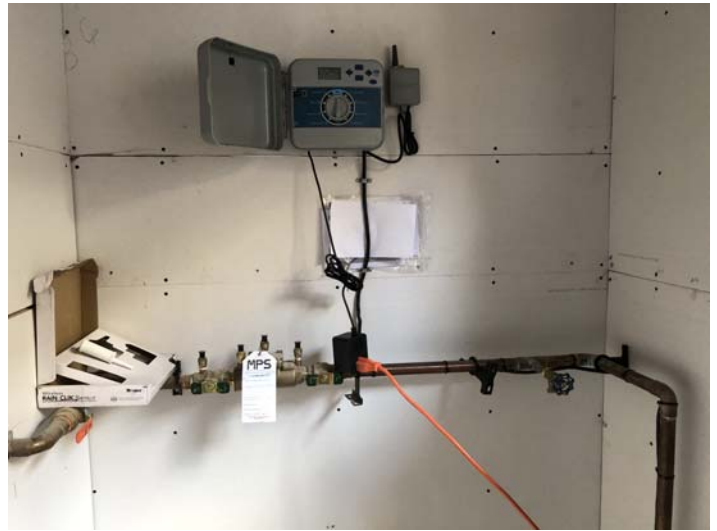
02 Irrigation Controls

- Irrigation system is installed and operation was demonstrated during site review. Power was being supplied through an extension cord as permanent power was not yet available (photo 02). Outside rain sensor to be installed once exterior fascia and soffit installed. Refer also to Landscape Field Review 04.
- Installation of plant material on podium mostly complete (photo 04). Sod is on site but installation not yet started.
- Hollow metal doors installed at links (without glass). Exit signs at doors installed (photo 05).
- Supports for accordion partitions installed. Drywall bulkheads installed.
- Drywall installation progressing towards completion. Link bump outs not yet started.
- Installation of services continuing in Janitor/Storage Room (photo 10).
- EIFS has been installed at the garage entry (photos 07 & 11).
- Wood "beam" and brackets installed at front bay (photo 12).

SVR-06: Drywall has been installed on walls (photo 02).

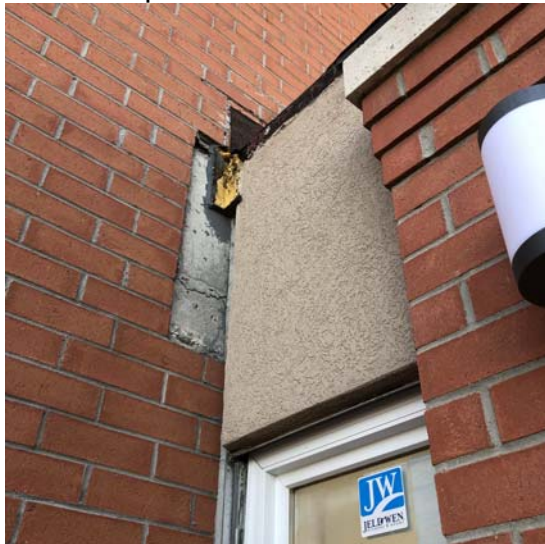
03 Exposed Concrete at Links

- 6.2.2 Exposed concrete areas at junction of links and residential wings were reviewed (photo 03). HAI to review original condition and advise on any further action required.

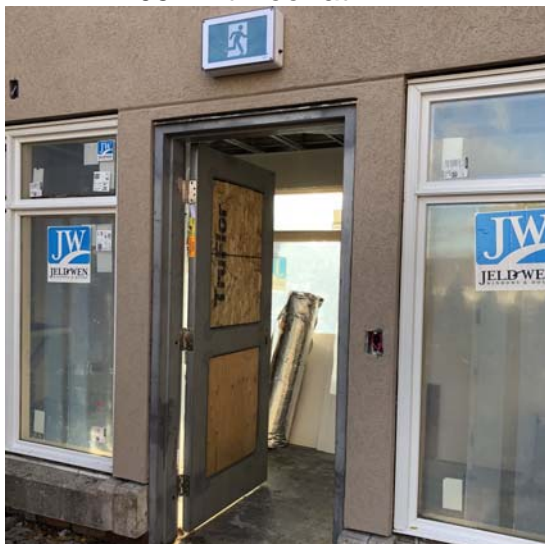
05 Exit Door at Link

5.2.2 Contractor requested additional detail for the tie in of the Links to the residential wings. There is an existing expansion joint material in this location (photo 05) and it appears that this may have butted directly against the window frame. HAI to review.

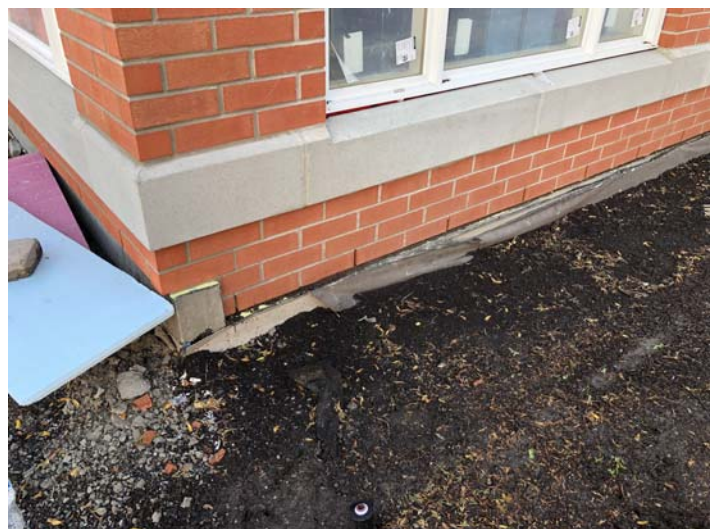
06 Base of North Wall

3.2.3 *The existing slab is not square along the north side of the Community Building – the brick as installed leaves part of the top of the slab exposed and the existing roof membrane was not carried under the thru-wall flashing before the masonry was started. Contractor has proposed removing 25mm of mortar under the base row of brick, adhering the existing membrane over the thru-wall flashing and repointing the mortar. This should be reviewed with the roofing contractor to confirm that the materials are all compatible. As the existing metal flashing at the face of the slab upstand will not cover the exposed horizontal section of the exposed membrane, an additional flashing will be required to cover the exposed membrane.*

SVR-06: Flashing not yet installed (photo 06).

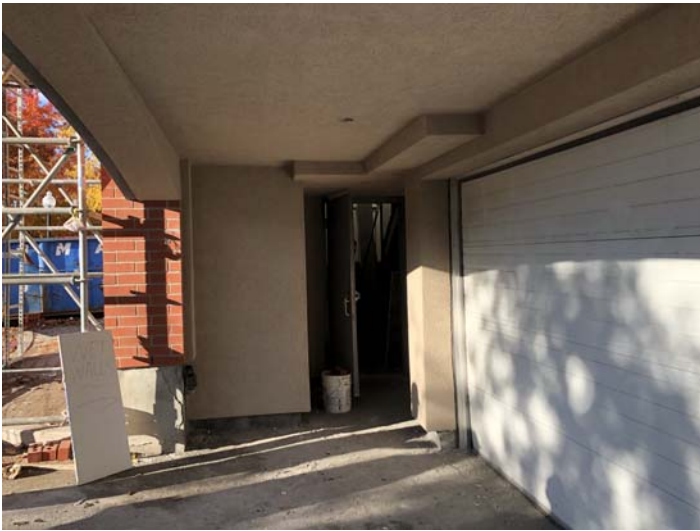
07 Soffit at Garage Entry

SVR-06: Ceiling has been installed (photo 07).

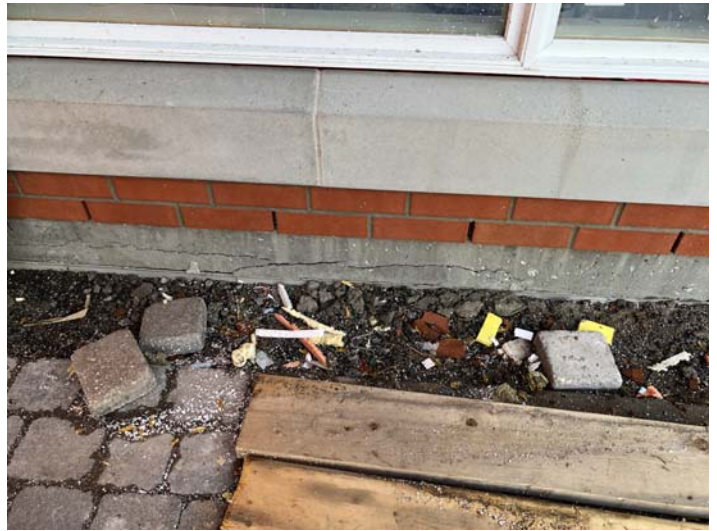
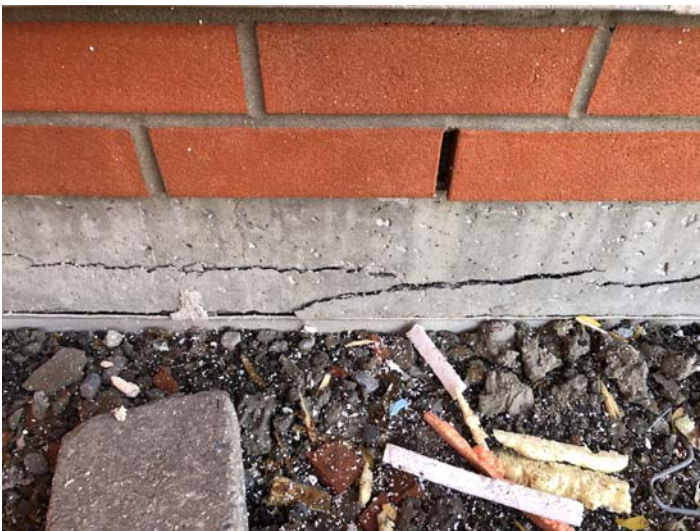
- 6.2.3 Cracking was noted in the curb at the north end of the east wall (photos 8 & 9). This is to be reviewed with the structural engineer.
- 6.2.4 Damaged paving at the base of the walls at the entry to the garage requires remedial work (photos 13 & 14) – HAI to issue CCO.

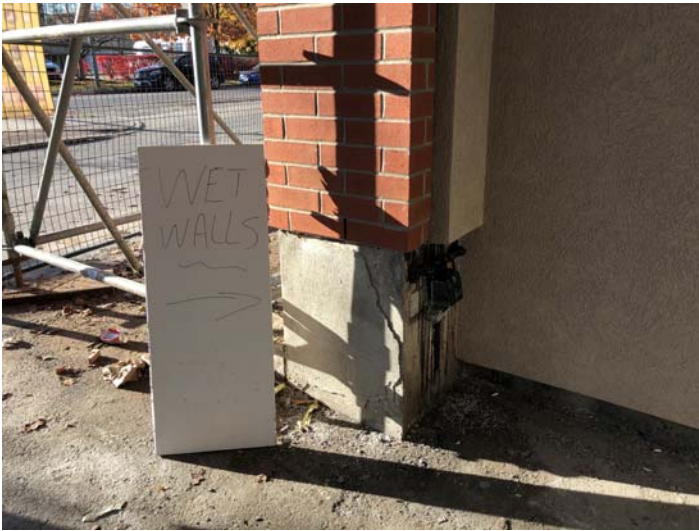
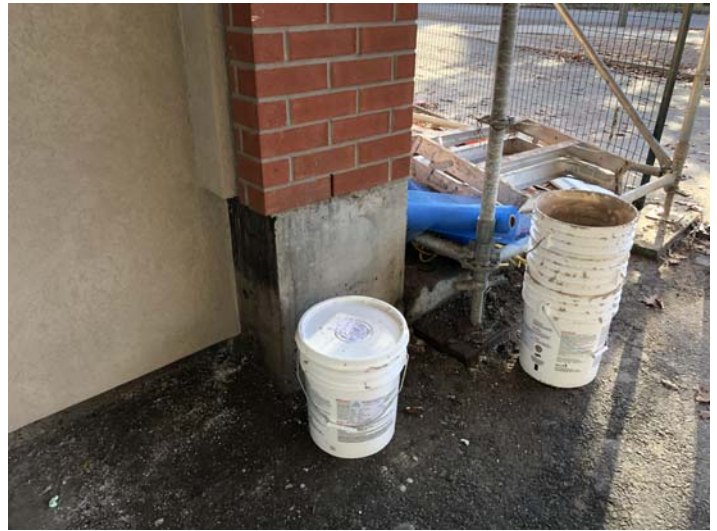
13 Damaged Parging at North Pier

14 Damaged Parging at South Pier

.1 Clean and reparge the damaged areas at the base of the masonry piers at the garage entry as noted in Site Visit Report No. 06.
