DESIGNATED SUBSTANCE REVIEW

Carleton Place Arena
75 Neelin Street
Carleton Place, Ontario

Date: May 6, 2020

Final Report

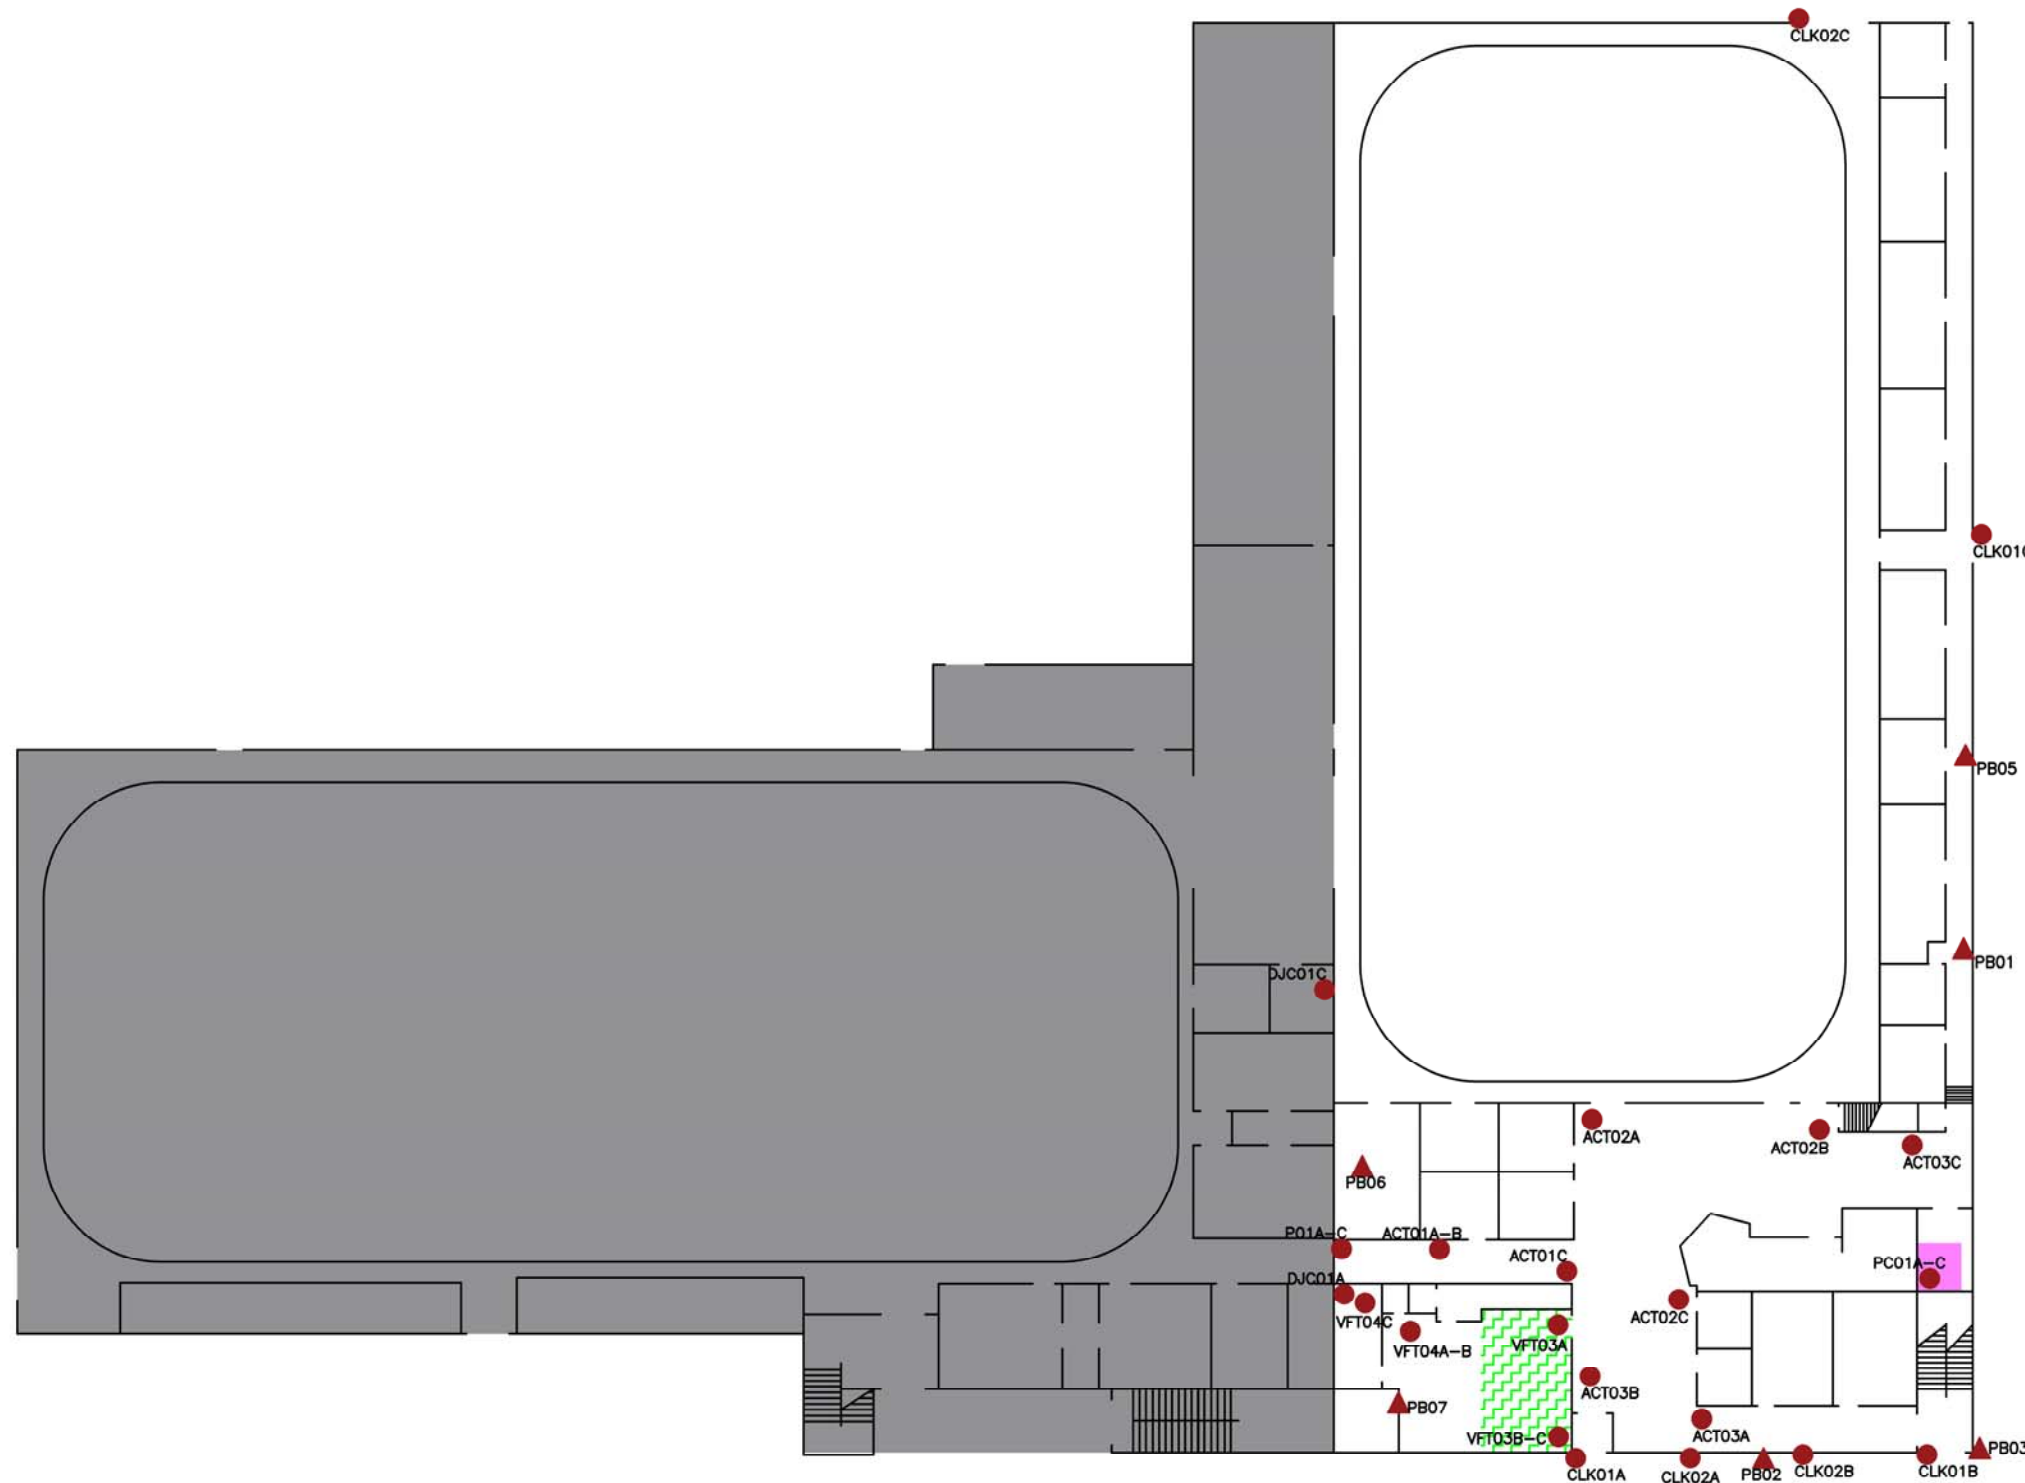
DATE: MAY 2020	DWG. No.
	SCALE: AS NOTED	1
	DRAWN: A.N	
	APPROVED: R.P

SCHEMATIC LAYOUTS TO SHOW LOCATIONS AND TYPES OF ASBESTOS.

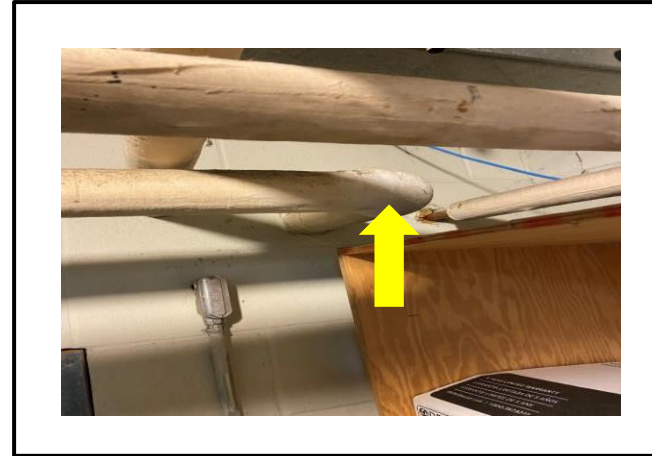
Pipes insulated with non-asbestos fiberglass insulation are present throughout the building on domestic water systems. Parging cement insulation was observed on elbows in the mechanical room. Three (3) sample of parging cement (IPC01A-C) was collected from a pipe elbow and submitted for asbestos content analysis. Sample PC01A was found to contain 10% chrysotile asbestos by laboratory analysis. The parging cement insulation is a friable ACM. Two (2) pipe fittings are present and insulated with asbestos-containing parging cement and was in good condition at time of assessment.

Photograph 2: Parging Cement Elbow – Mechanical Room

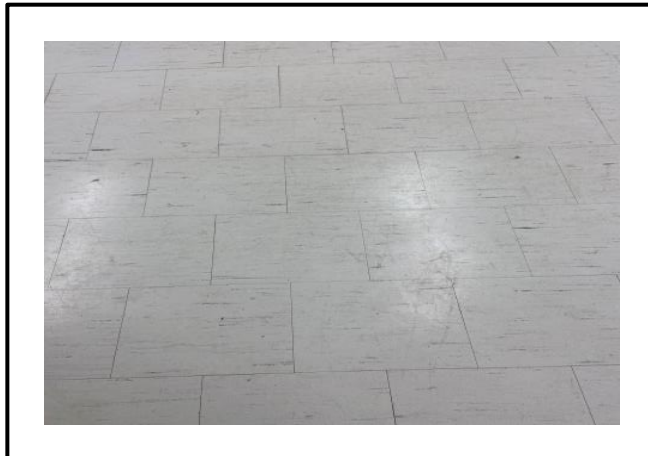
Three (3) samples the vinyl floor tiles (VFT03A-C) described as 12" x 12" white with black streaks were collected from the room next to the main entrance and submitted for asbestos content analysis. Sample VFT03A was found to contain 1% chrysotile asbestos by laboratory analysis. The vinyl floor tile is considered a non-friable material and was in good condition at time of assessment.

Photograph 3: 12" x 12" White w/Black Streaks Vinyl Floor Ties – Room Next to Main Entrance.

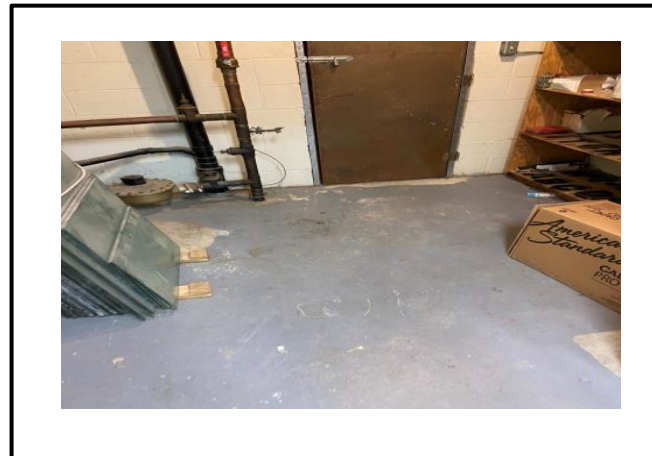
For the purposes of our assessment, any paint containing lead at a concentration of 0.5% by weight (i.e. 5,000ug/g, or 5,000ppm) or greater is lead-based paint (LBP). These paints represent the greatest potential exposure if disturbed. Paints confirmed to contain lead at a concentration of at least 0.009% by weight (i.e. 90ug/g, or 90ppm) but less than 0.5% by weight are considered to be lead-containing paints (LCP). These paints may present an exposure hazard depending on the type of work activities (i.e. degree of disturbance) and length of exposure. Paint with lead concentrations below 0.009% by weight are not considered to be lead-containing and represent little to no lead exposure hazard. In summary, samples PB-02, PB-03 and PB-07 were found to be LCP and sample PB-06 was found to be LBP

Photograph 4: Lead-Based Grey Floor in Mechanical Room.

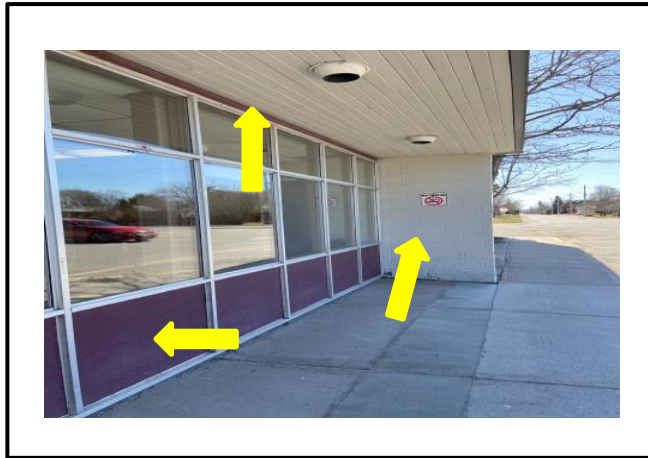
Photograph 5: Exterior Lead-Containing Red and White Paint.

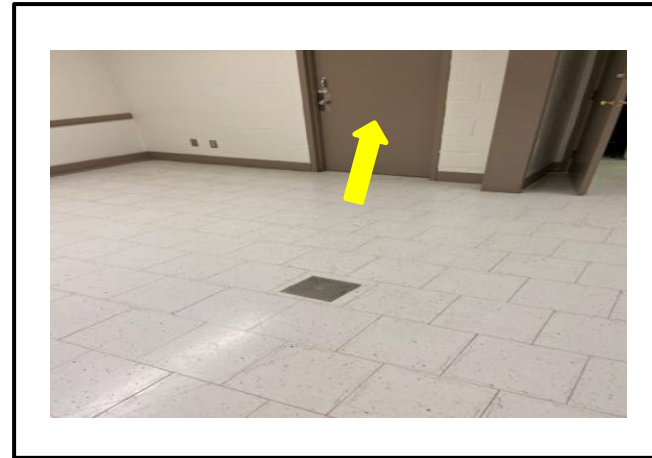
Photograph 6: Lead-Containing Doors and Frames
