TAL-CO Building Innovations Limited
4728 Bank Street, Suite A
Gloucester, Ontario K1T 3W7
Tel: 613-821-3959
Fax: 613-821-2938

CIR #12 Detailed Summary

Please see attached CIR #12 for your review and response, for the Carleton Place Arena.

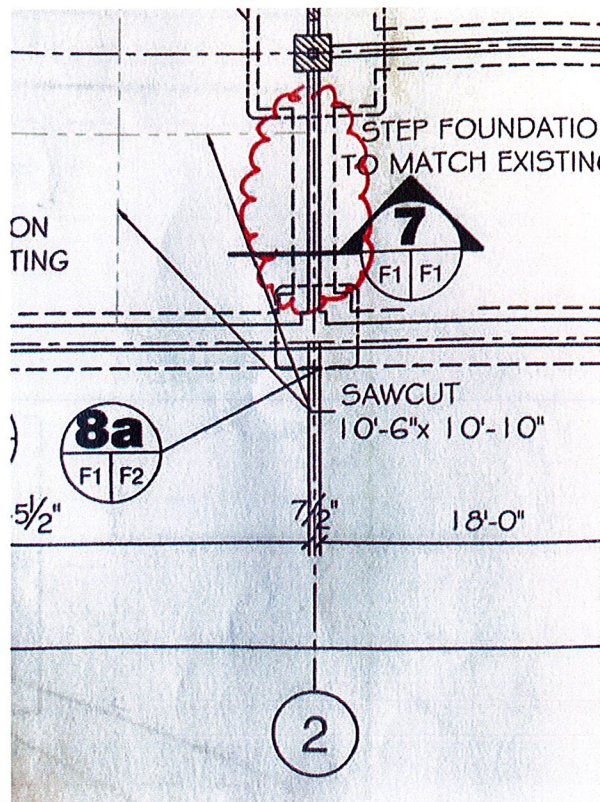
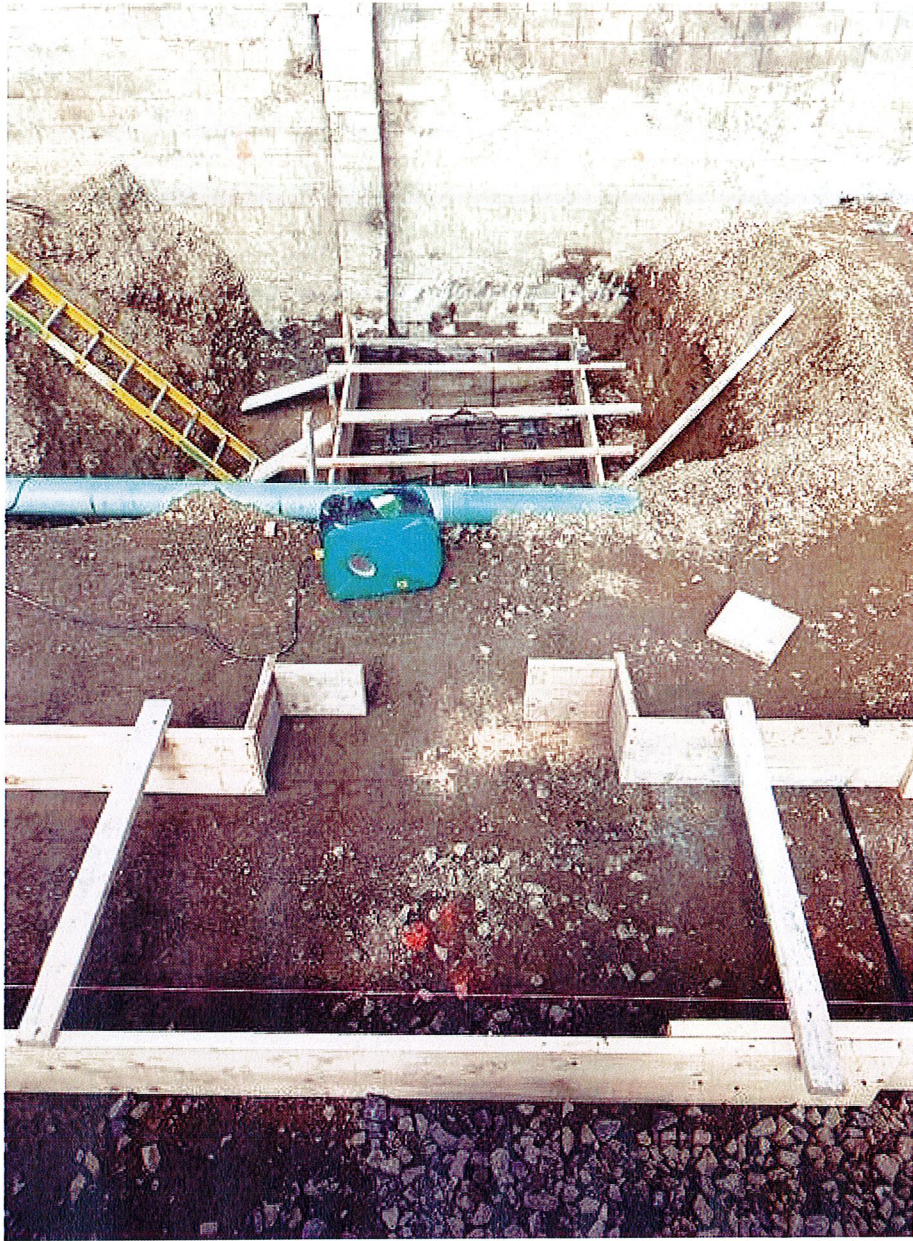
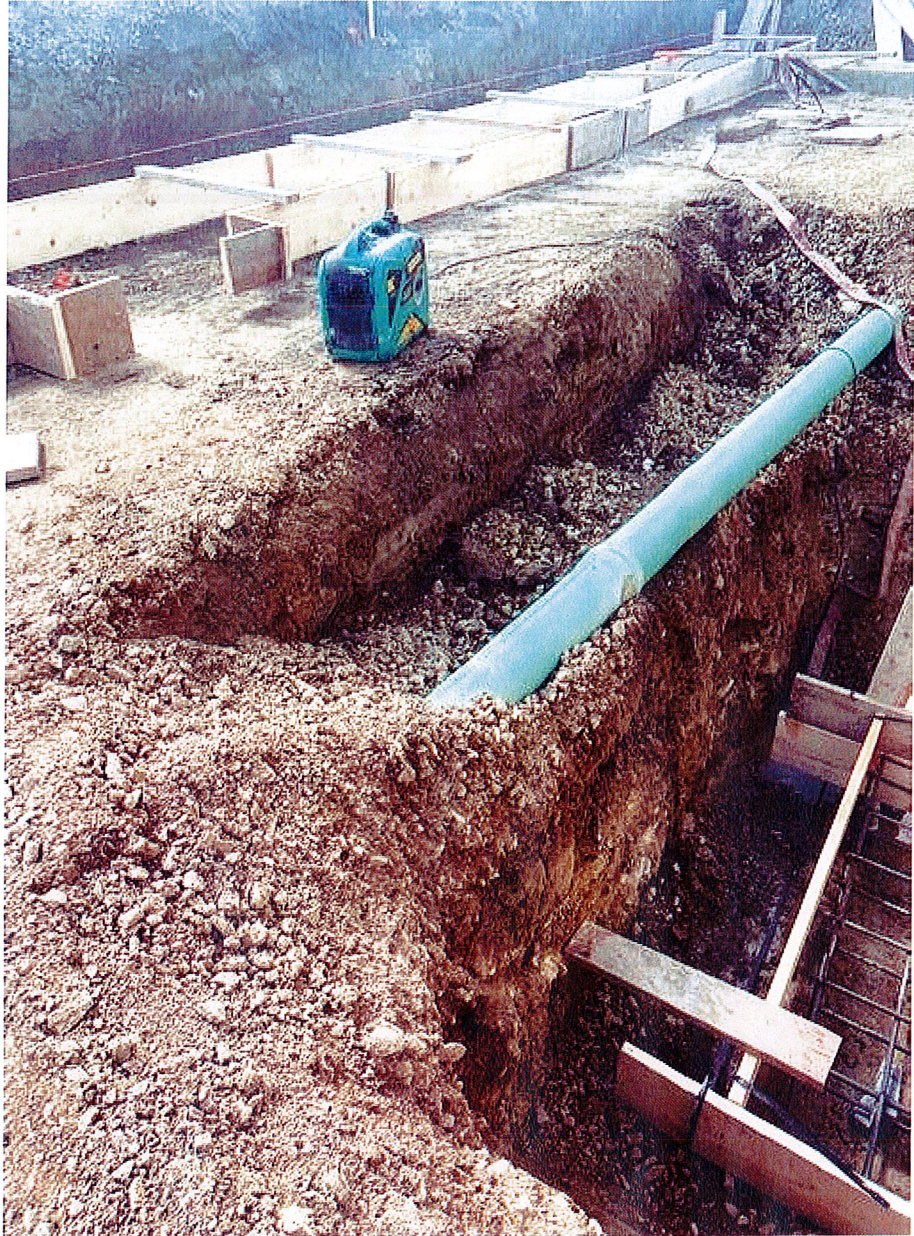
1. The required step footing on GL 2 connecting to the pier footing and required to be on undisturbed soil or bedrock, the distance of 10' between them does not allow to connect with the new storm sewer interfering. Attached marked up picture and pictures of site conditions for your reference below. Please provide instruction.

I have reviewed the photos and believe that the pipe can be sleeved through the wall. It is difficult to tell at this time if there will be a bar interference, however this can be addressed if that is the case using 4 diagonal bars (diamond shape) around the penetration. I would like to see how the bar layout goes and we can issue a sketch if that is the case. We need to maintain the required 2" clear cover from the pipe when doing this layout. Also you may want to consider sleeving the pipe if ever in the future you need to remove or replace this pipe.

The second consideration is that the backfill under this pipe will be very difficult to getting the necessary under slab compaction for. It has been my experience that to alleviate this issue the use of 0.4MPa flowable fill works very well. Should that product not be available a lean concrete mix of 4MPa can be used -though is not as economical as the flowable fill.

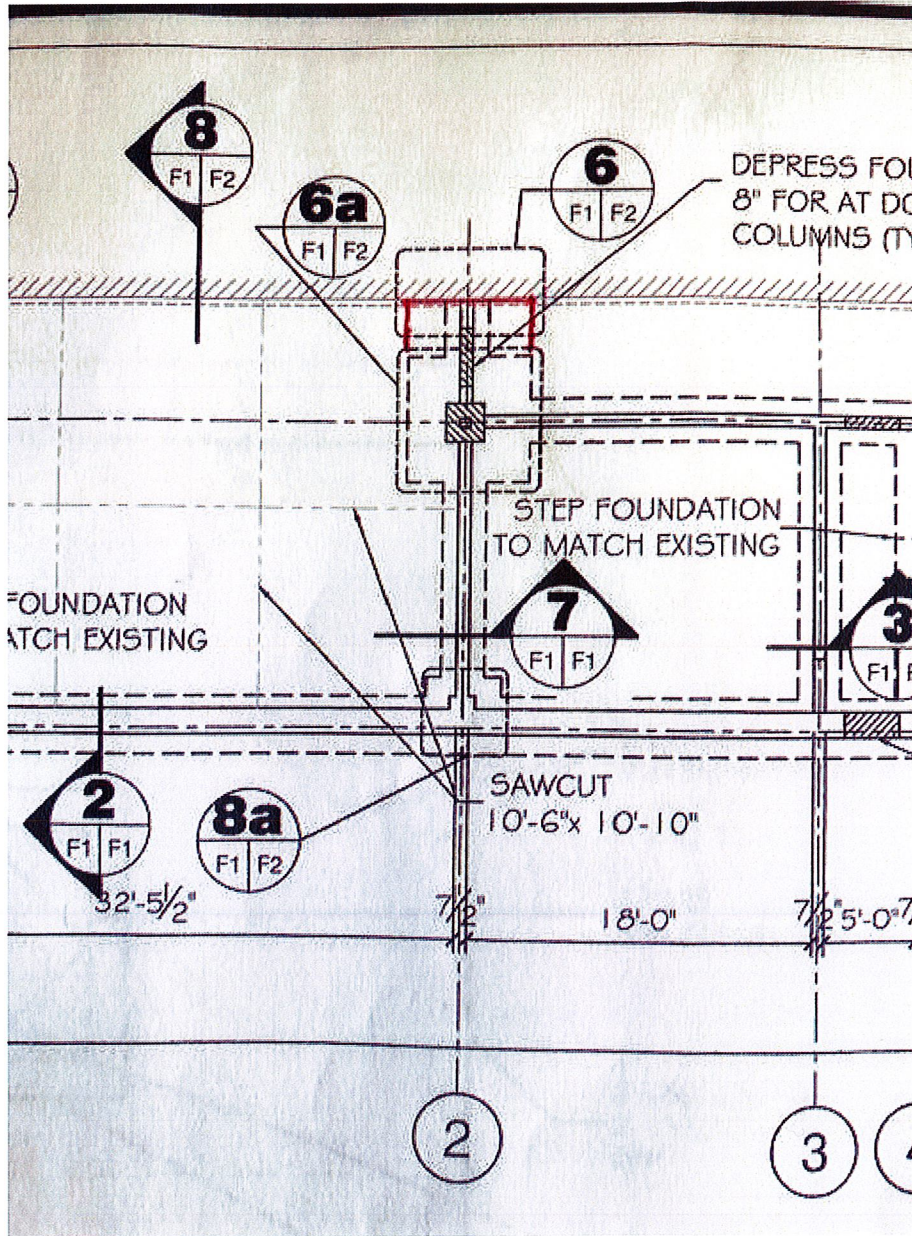
2. Please acknowledge the agreed upon plan with Eastern Engineering to proceed by attaching the full width of the footing 6'6" to existing footing and as the pier would be higher, the footing shall not be redesigned to carry the load; to maintain the 6'6" to one direction as is. Marked up picture in red below.
