RE: Project-Specific Designated Substances Survey  
Boys and Girls Club of Ottawa  
1463 Prince of Wales Drive, Ottawa, Ontario

DST File No.: TSSO029633

DST Consulting Engineers Inc. (DST) was retained by the Boys and Girls Club Ottawa to conduct a Project-Specific Designated Substances Survey (DSS) for the Police Youth Centre facility, located at 1463 Prince of Wales Drive, in Ottawa, ON.

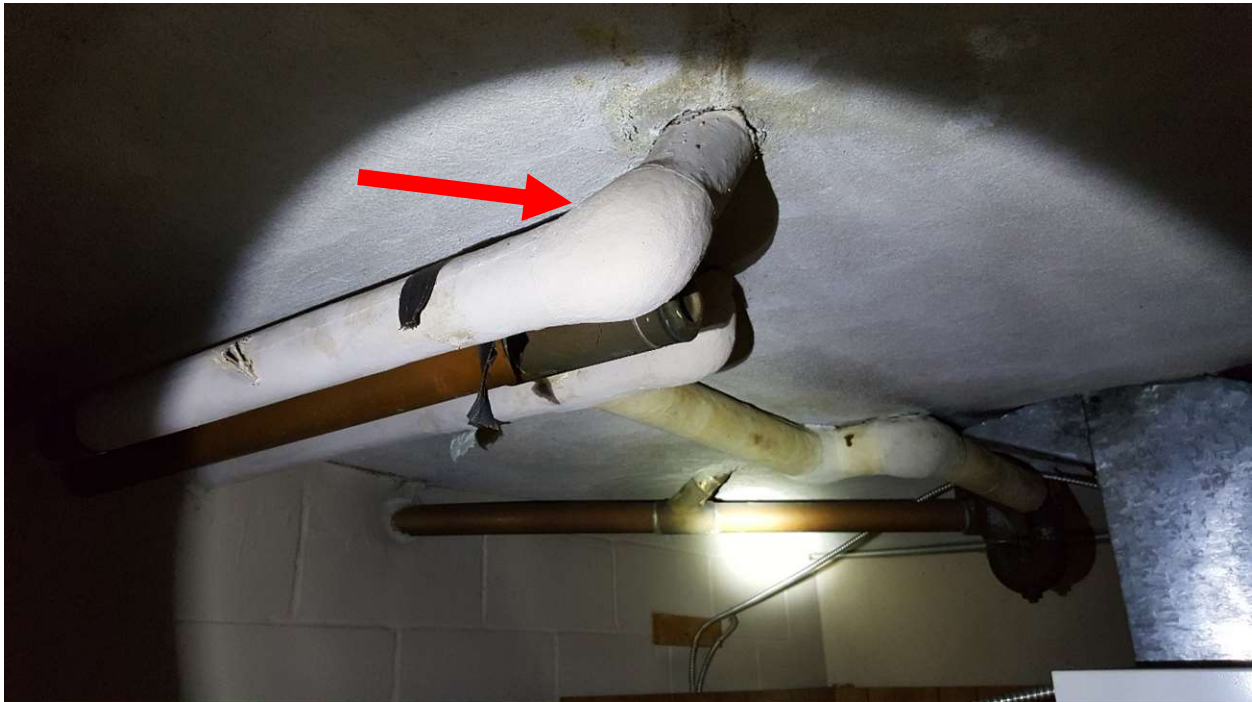
- Five (5) friable mechanical pipe insulation fittings, which contain 90% Chrysotile asbestos, observed in the basement south east storage room above the lay in ceiling tiles. The material was in good condition; (Seacor Sample SA-9);

**Photograph 4:** Friable mechanical pipe insulation fittings which contain 90% Chrysotile asbestos (Seacor Sample SA-9) were observed in the basement south-east storage room above the ceiling tiles.

Identified asbestos-containing friable pipe fitting insulation and cardboard wrap insulation require a minimum of Type 2 abatement procedures under Ontario Regulation 278/05, as amended, when disturbing/removing/repairing one (1) square metre or less of this material. Should renovation or disturbance be required of more than one (1) square metre of friable ACM, Type 3 abatement procedures are required. It should also be noted that pipe insulation and/or pipe fitting insulation in good condition can be removed using Type 2 glove-bag procedures, provided the glove-bag seal can be maintained throughout the removal and cleaning process. If these conditions cannot be met, then more stringent procedures will be required.

1. In general, materials must be maintained in good condition;
2. The condition of material(s) identified in this report must be inspected at least annually, and this record must be updated accordingly;

3. Appropriate work procedures and precautionary measures must be used, as outlined in O. Reg. 278/05, as amended, when performing work that may disturb ACMs or suspected ACMs, including prior to building demolition;

4. If ACMs or suspected ACMs become damaged and worker exposure to the material is likely to occur, the damaged material must be repaired or removed following work procedures outlined in O. Reg. 278/05, as amended; and

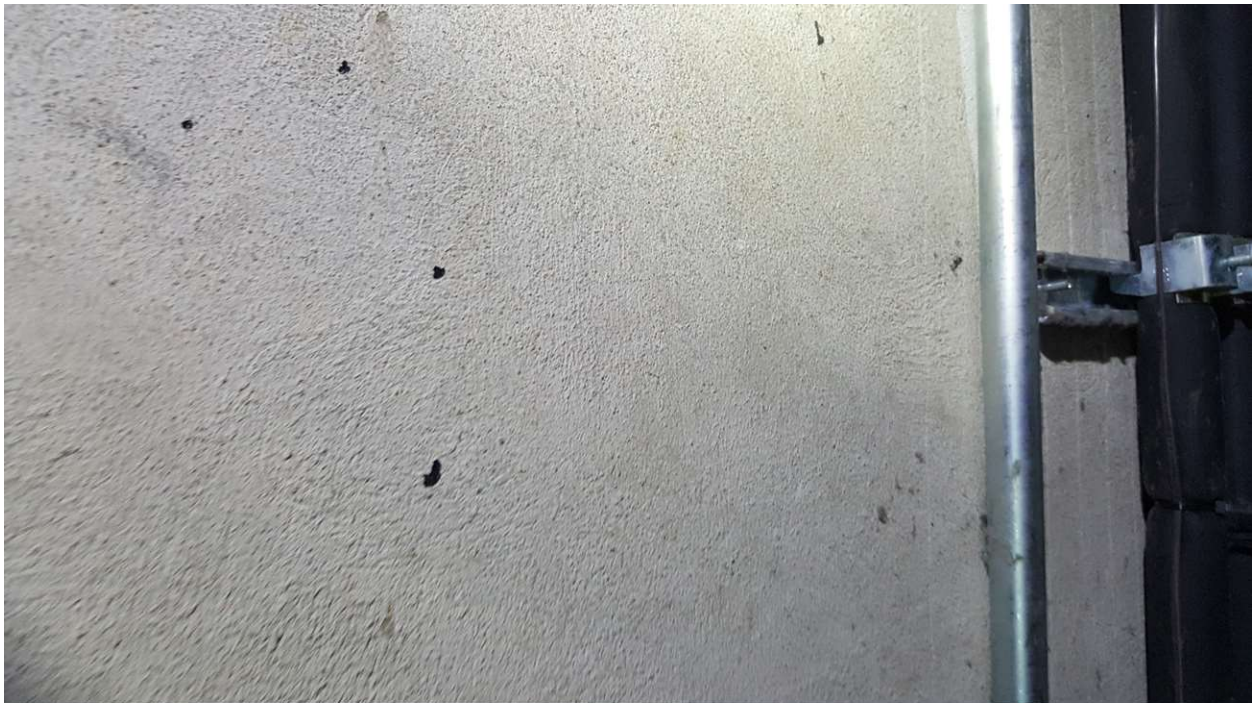
- Non-friable light and dark grey rough textured plaster, which contains 0.5% Chrysotile asbestos, observed on the walls of the former bell tower and two (2) rooms immediately north of the gymnasium. The material was in good condition; (DST Sample 29633-03C);

**Photograph 5:** Non-friable rough textured plaster, which contains 0.5% Chrysotile asbestos, observed on the walls of the former bell tower.

The removal or disturbance of non-friable ACMs (textured plaster) can be completed using Type 1 asbestos precautionary measures, provided the material is wetted and only non-powered hand-held tools are used. If these conditions cannot be met, than more stringent (Type 2 or Type 3) procedures are required.

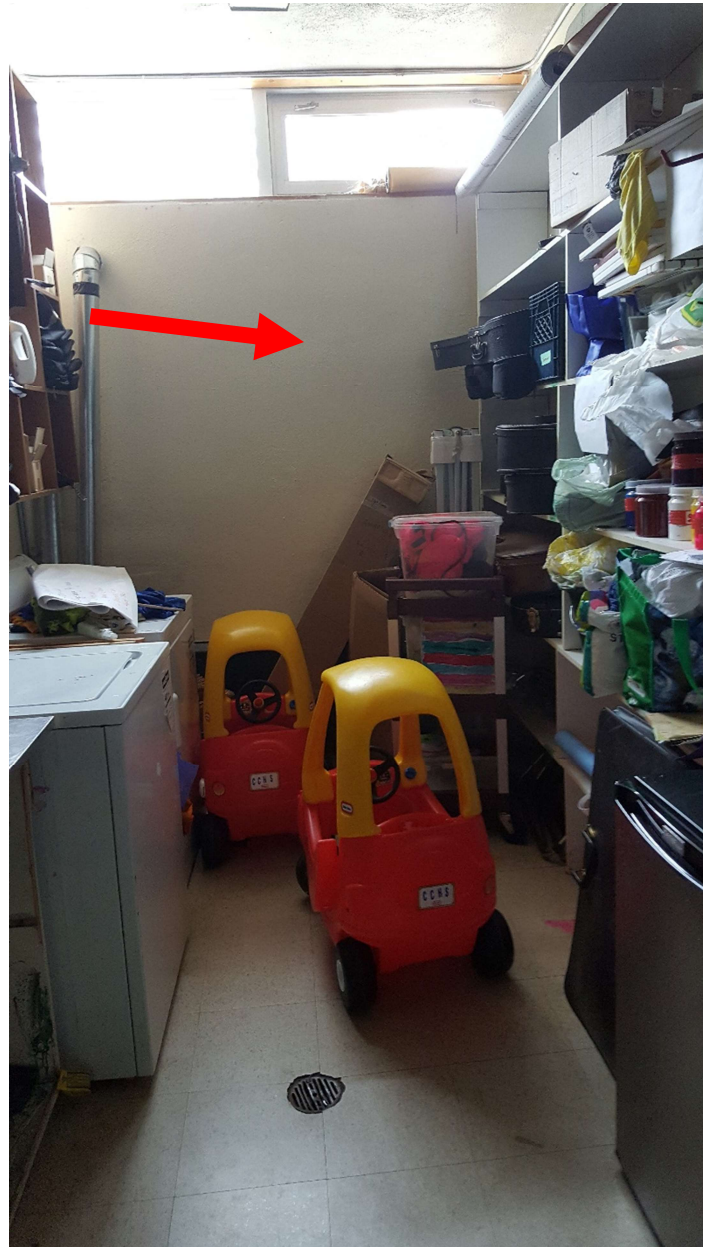
**Photograph 6:** Non-friable rough textured plaster, which contains 0.5% Chrysotile asbestos, observed on the walls of the rooms north of the gymnasium.

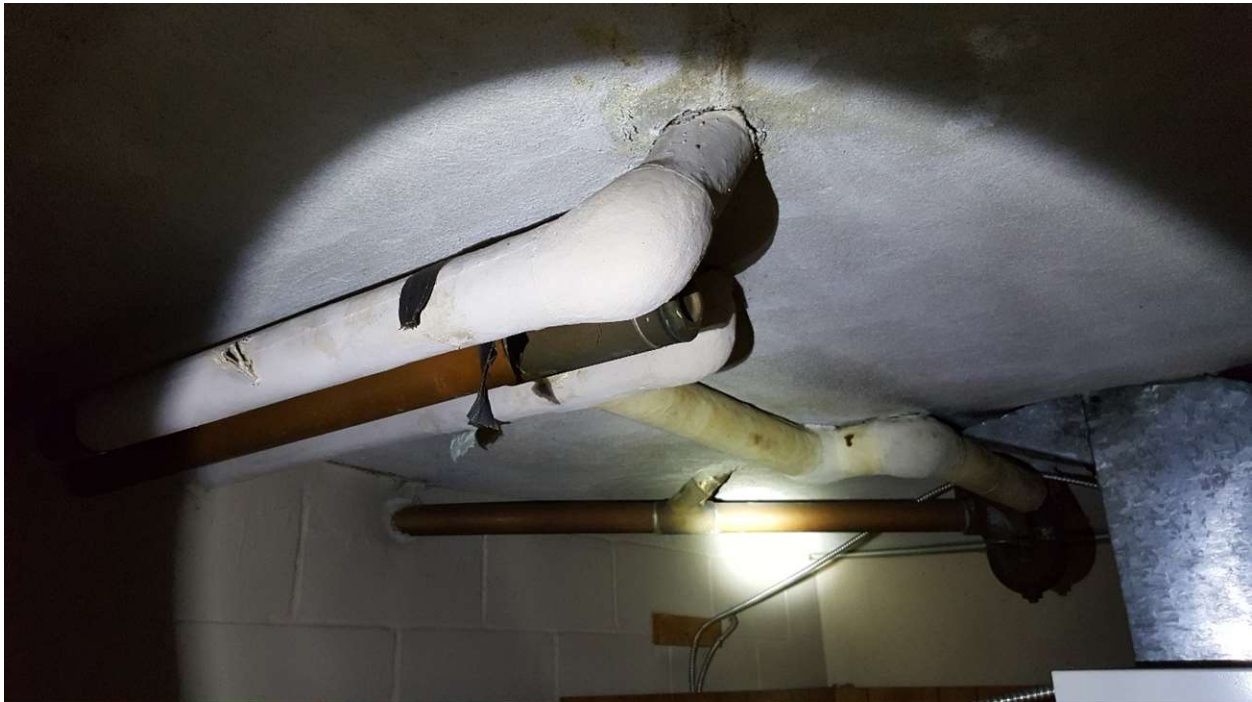
- Non-friable light and dark grey rough textured plaster, which contains 1% Chrysotile asbestos, observed on the ceilings of the basement electrical room, three (3) basement storage rooms and two (2) rooms immediately north of the gymnasium. The material was in good condition; (DST Sample 29633-11A);

**Photograph 7:** Non-friable rough textured plaster, which contains 1% Chrysotile asbestos, observed on the ceilings of all basement storage rooms.

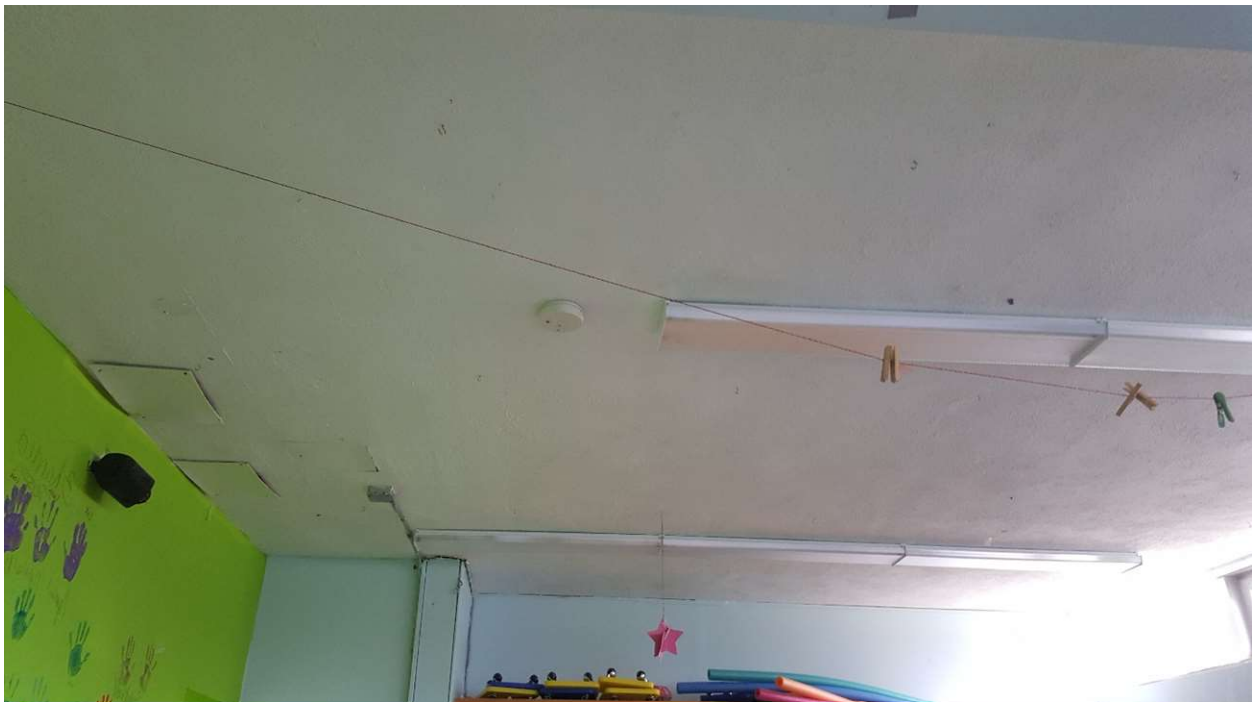
**Photograph 8:** Non-friable rough textured plaster, which contains 1% Chrysotile asbestos, observed on the ceilings on the main level in the two rooms north of the gymnasium.

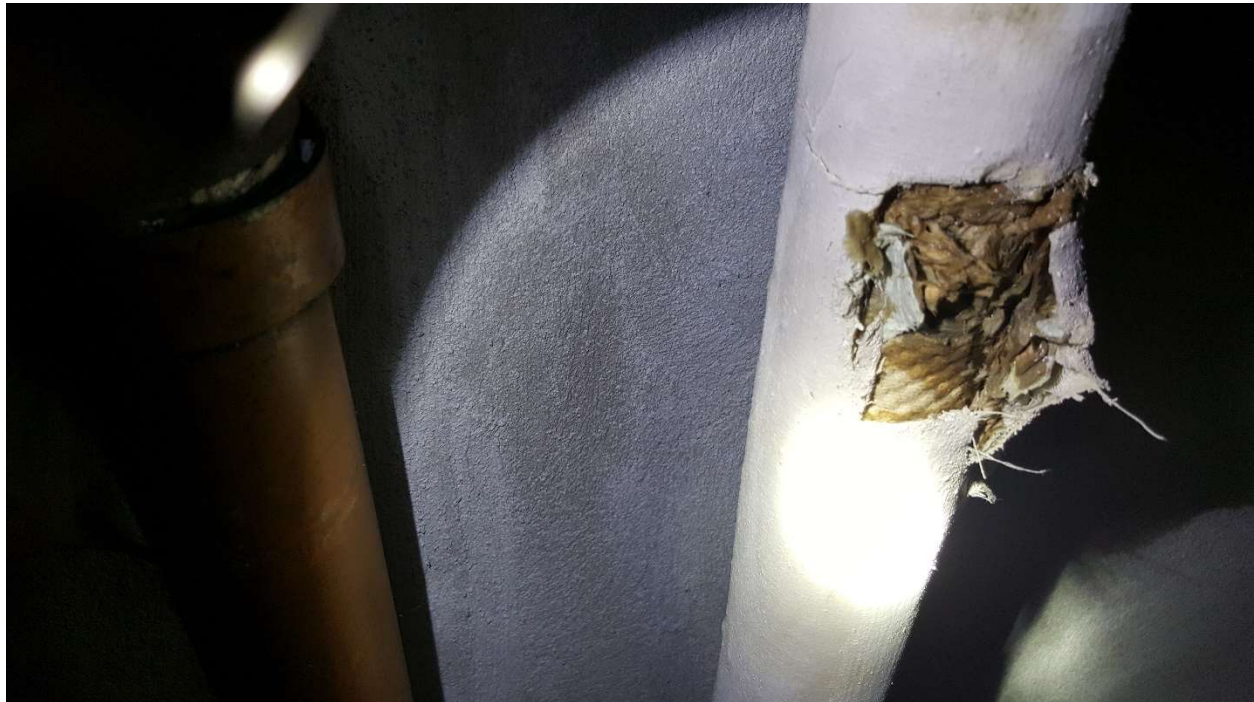
- Approximately fourteen (14) linear metres of cardboard wrap insulation, which contain 5% Chrysotile asbestos, observed in the basement level southeast storage room above lay-in ceiling tiles and in the basement south/middle storage room. This material was in good condition; (DST Sample 29633-12B).

**Photograph 9:** Friable cardboard wrap pipe straight run insulation which contains 5% Chrysotile asbestos (DST Sample 12A-C) were observed in the basement south-east and south/middle storage rooms.

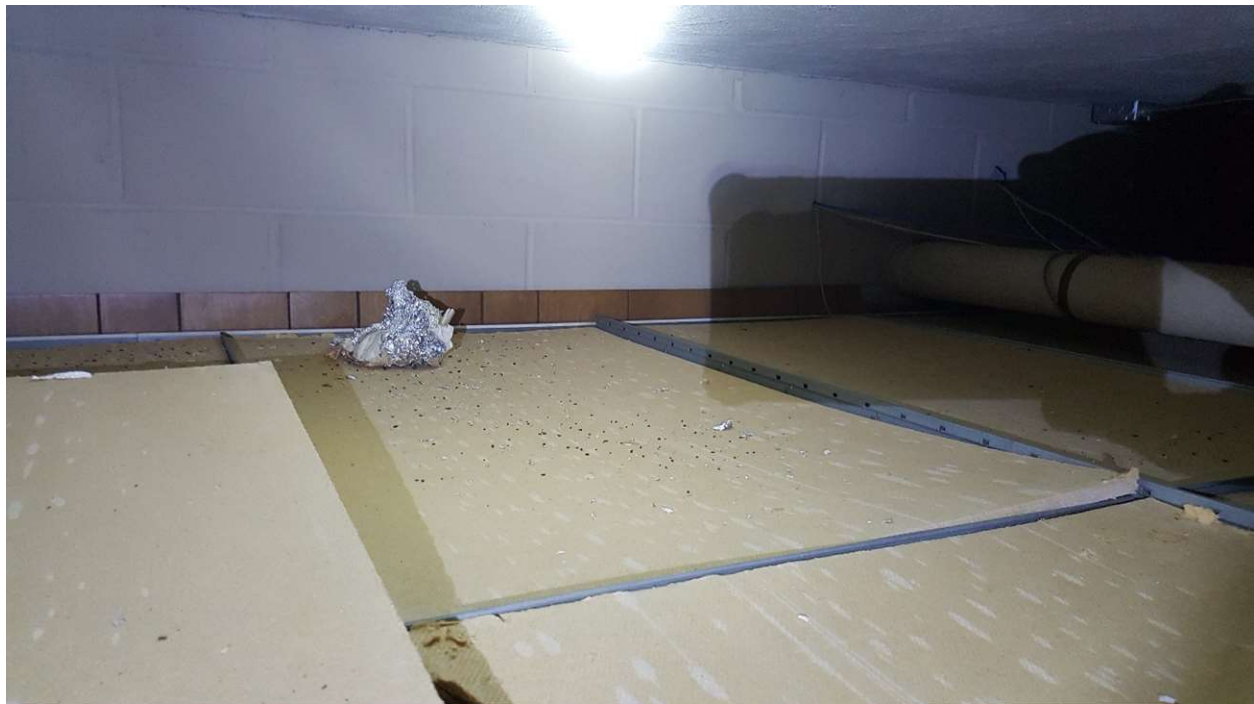
Approximately one (1) square metre of suspected rodent droppings were observed above the ceiling tiles of the basement south-east storage room.

**Photograph 10:** Rodent feces and signs of rodents feeding were observed in the basement south-east storage room above the ceiling tiles.

Fecal matter from animals has been associated with a variety of human health and safety concerns. Feces may contain moulds that may cause disease in humans. If the feces are disturbed, the toxic moulds may become airborne and pose a respiratory health risk.

It is recommended that animal droppings be removed using a combination of High Efficiency Particulate Aerosol (HEPA) filtered vacuum and wet cleaning (disinfecting) methods. Workers should consider the use of appropriate respiratory protection and protective clothing in order to reduce exposure to mould when disturbing animal fecal matter or building materials contaminated with animal fecal matter.
