February 7, 2018

RE: Project-Specific Designated Substances Survey
Boys and Girls Club of Ottawa
1463 Prince of Wales Drive, Ottawa, Ontario

DST File No.: TSSO029633

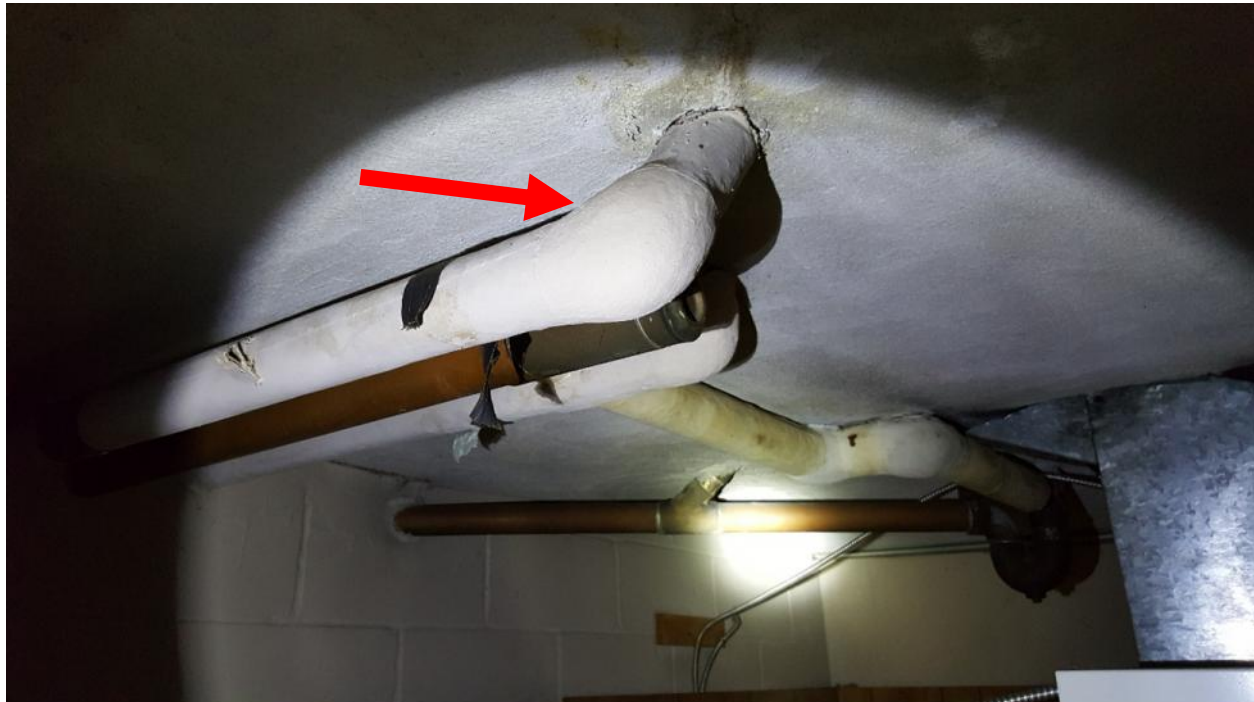
- chases. The material was in inaccessible but had an exposed end indicating fair to poor condition; (Seacor Sample SA-9);
- J Five (5) friable mechanical pipe insulation fittings, which contain 90% Chrysotile asbestos, observed in the basement south east storage room above the lay in ceiling tiles. The material was in good condition; (Seacor Sample SA-9);

Photograph 4: Friable mechanical pipe insulation fittings which contain 90% Chrysotile asbestos (Seacor Sample SA-9) were observed in the basement south-east storage room above the ceiling tiles.

Identified asbestos-containing friable pipe fitting insulation and cardboard wrap insulation require a minimum of Type 2 abatement procedures under Ontario Regulation 278/05, as amended, when disturbing/removing/repairing one (1) square metre or less of this material. Should renovation or disturbance be required of more than one (1) square metre of friable ACM, Type 3 abatement procedures are required. It should also be noted that pipe insulation and/or pipe fitting insulation in good condition can be removed using Type 2 glove-bag procedures, provided the glove-bag seal can be maintained throughout the removal and cleaning process. If these conditions cannot be met, then more stringent procedures will be required.

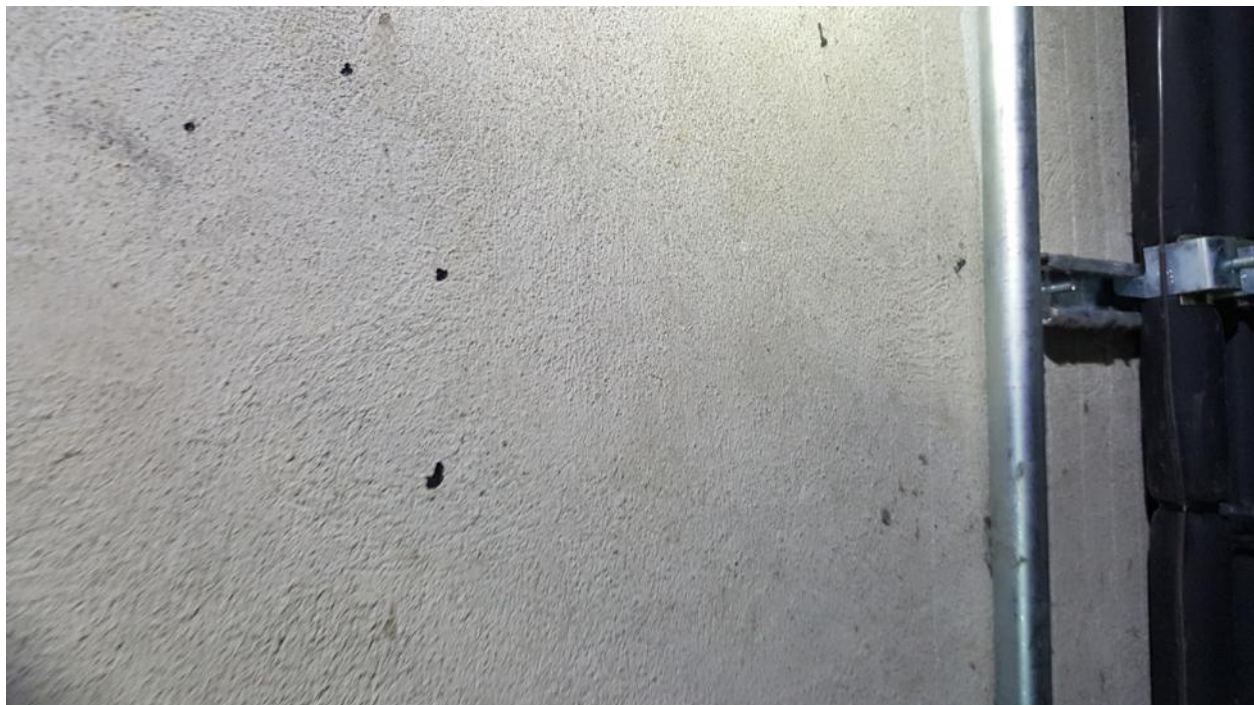
- J Non-friable light and dark grey rough textured plaster, which contains 0.5% Chrysotile asbestos, observed on the walls of the former bell tower and two (2) rooms immediately north of the gymnasium. The material was in good condition; (DST Sample 29633-03C);

Photograph 5: Non-friable rough textured plaster, which contains 0.5% Chrysotile asbestos, observed on the walls of the former bell tower.

The removal or disturbance of non-friable ACMs (textured plaster) can be completed using Type 1 asbestos precautionary measures, provided the material is wetted and only non-powered hand-held tools are used. If these conditions cannot be met, than more stringent (Type 2 or Type 3) procedures are required.

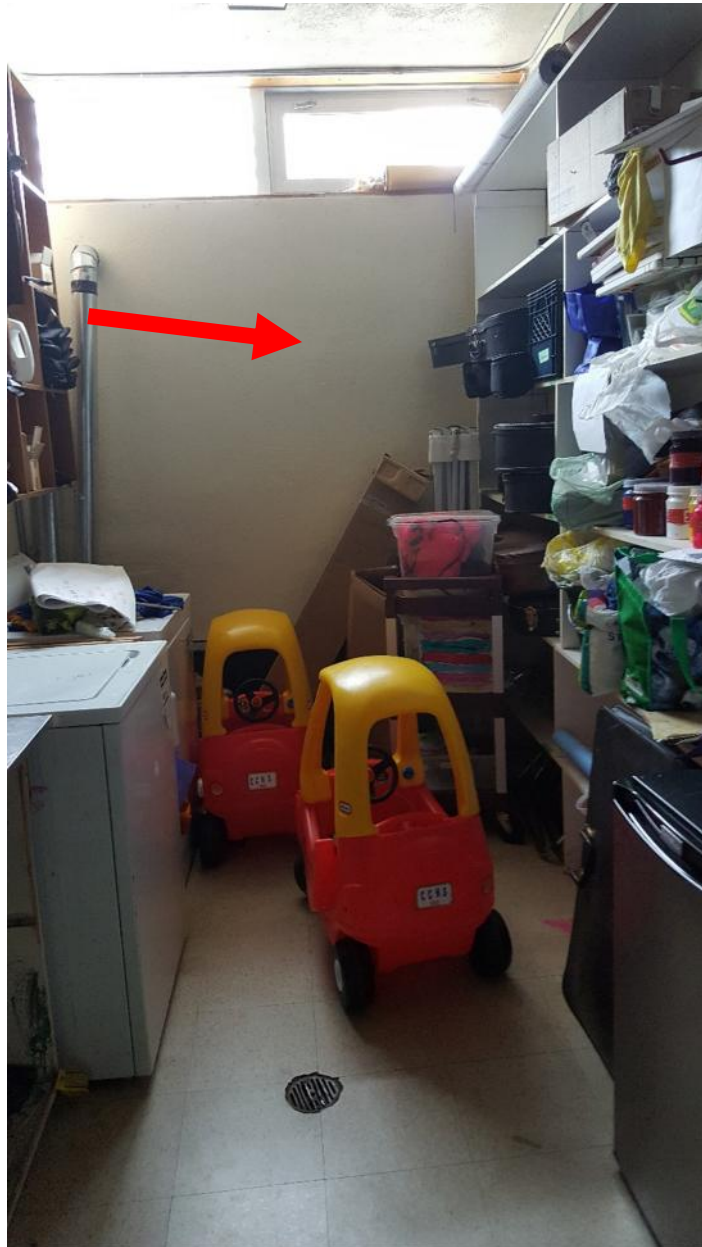
Photograph 6: Non-friable rough textured plaster, which contains 0.5% Chrysotile asbestos, observed on the walls of the rooms north of the gymnasium.

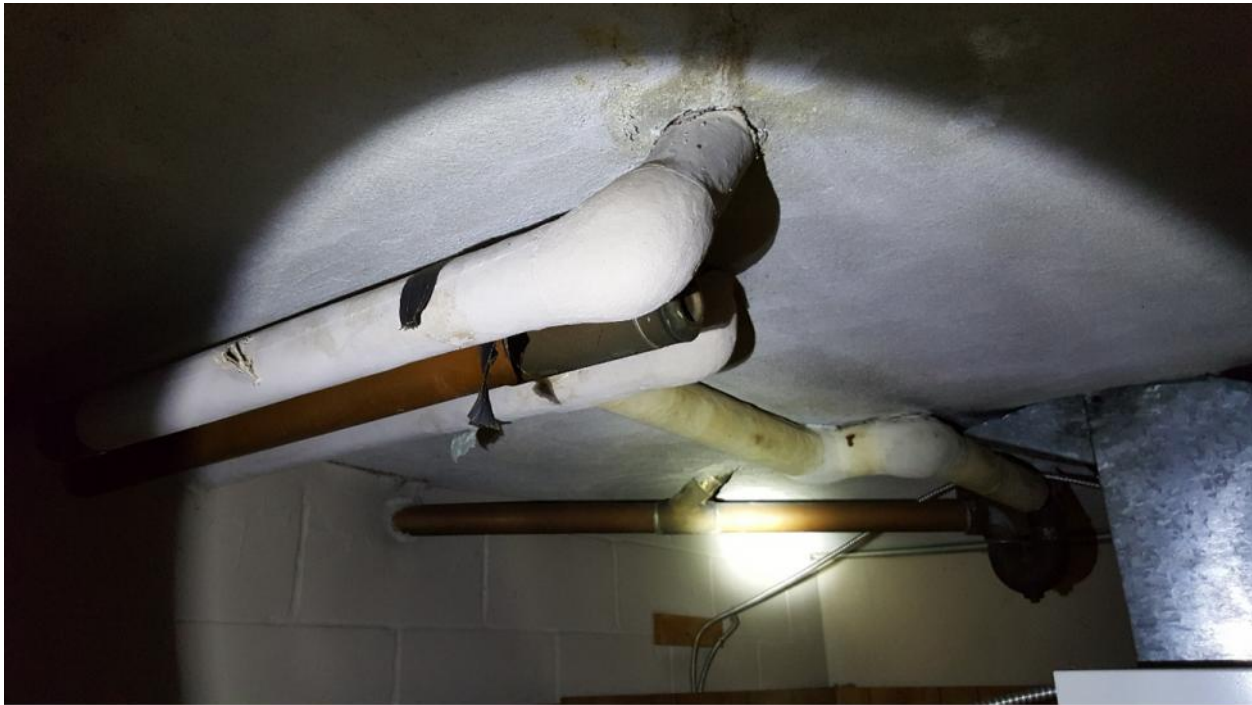
- J Non-friable light and dark grey rough textured plaster, which contains 1% Chrysotile asbestos, observed on the ceilings of the basement electrical room, three (3) basement storage rooms, basement corridor and two (2) rooms immediately north of the gymnasium. The material was in good condition; (DST Sample 29633-11A);

Photograph 7: Non-friable rough textured plaster, which contains 1% Chrysotile asbestos, observed on the ceilings of all basement storage rooms and the basement corridor.

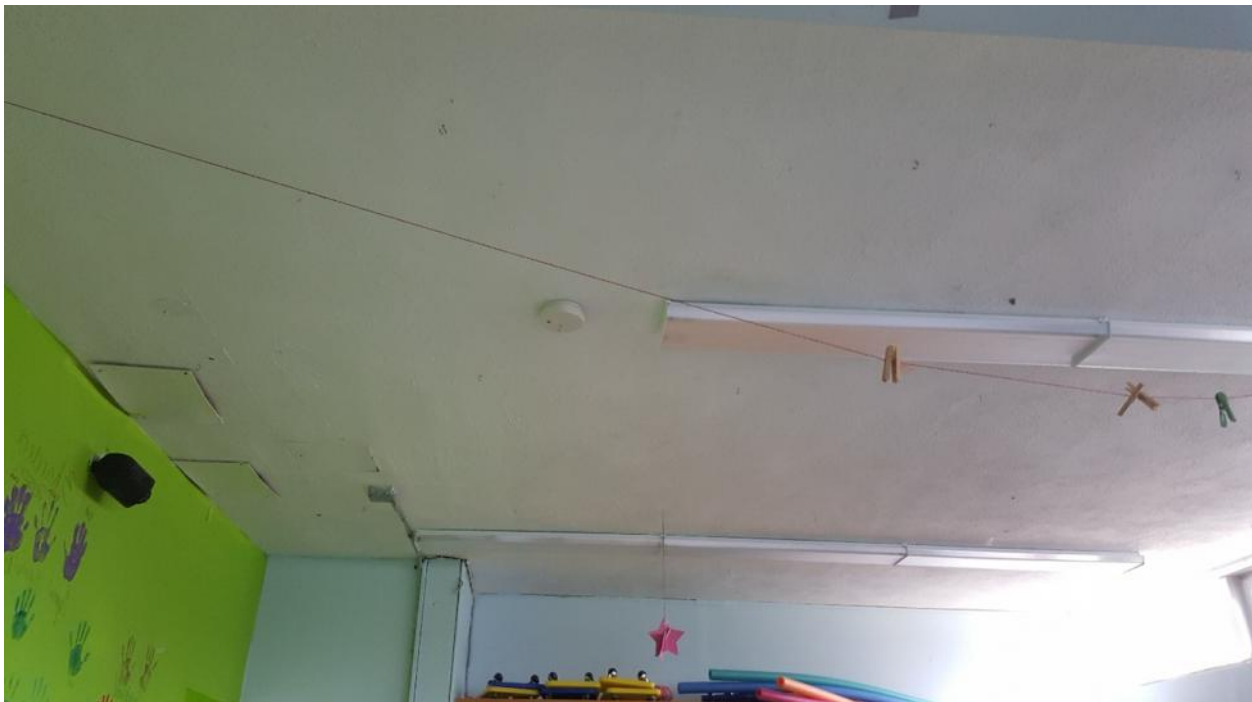
Photograph 8: Non-friable rough textured plaster, which contains 1% Chrysotile asbestos, observed on the ceilings on the main level in the two rooms north of the gymnasium.

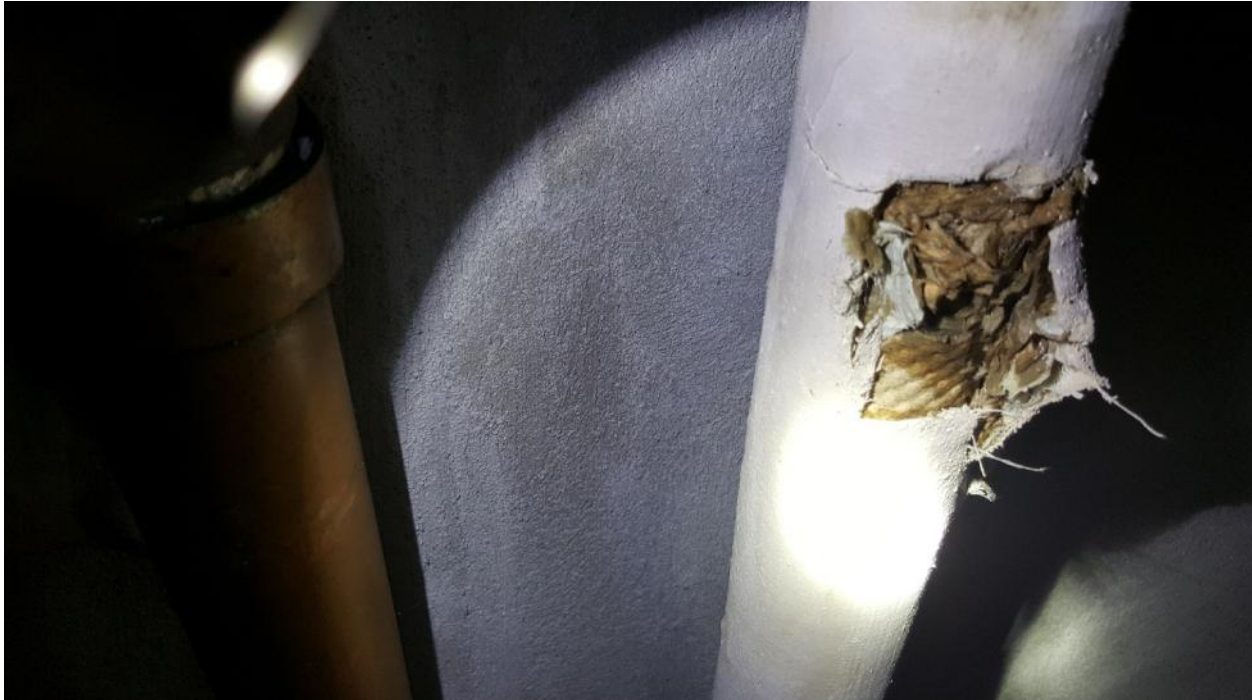
- J Approximately fourteen (14) linear metres of cardboard wrap insulation, which contain 5% Chrysotile asbestos, observed in the basement level southeast storage room above lay-in ceiling tiles and in the basement south/middle storage room. This material was in good condition; (DST Sample 29633-12B).

Photograph 9: Friable cardboard wrap pipe straight run insulation which contains 5% Chrysotile asbestos (DST Sample 12A-C) were observed in the basement south-east and south/middle storage rooms.

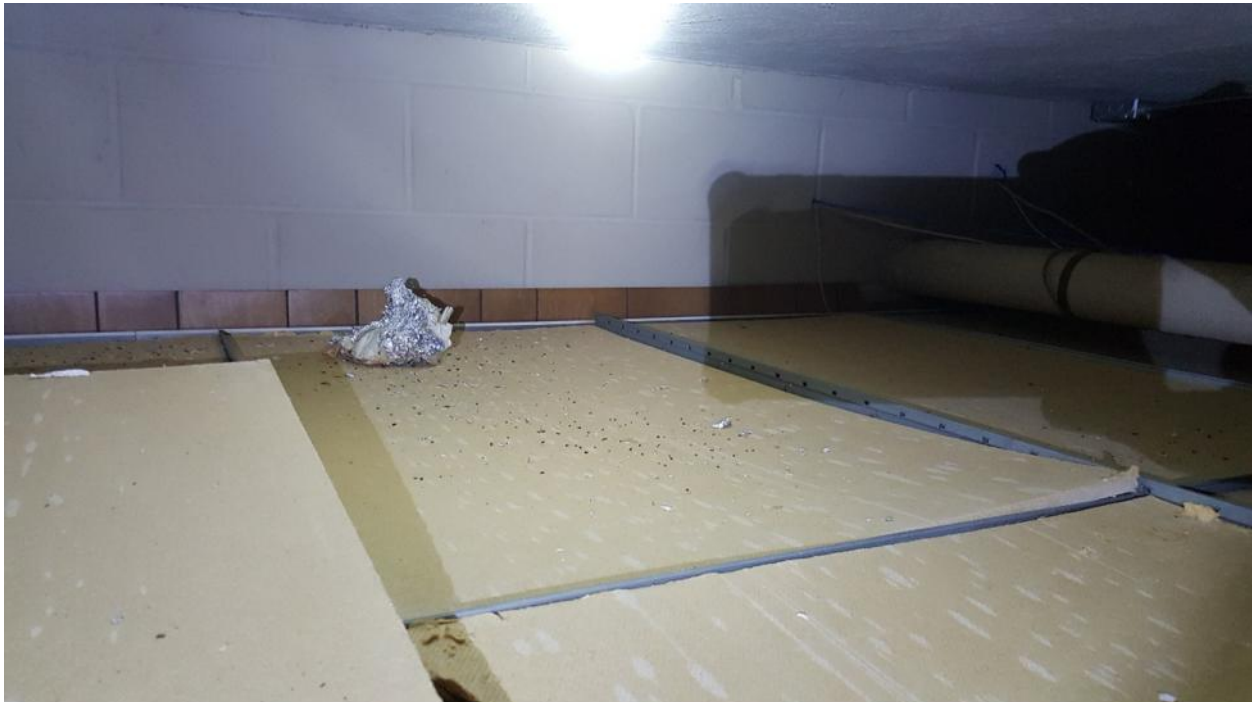
Approximately one (1) square metre of suspected rodent droppings were observed above the ceiling tiles of the basement south-east storage room.

Fecal matter from animals has been associated with a variety of human health and safety concerns. Feces may contain moulds that may cause disease in humans. If the feces are disturbed, the toxic moulds may become airborne and pose a respiratory health risk.

Photograph 10: Rodent feces and signs of rodents feeding were observed in the basement south-east storage room above the ceiling tiles.

It is recommended that animal droppings be removed using a combination of High Efficiency Particulate Aerosol (HEPA) filtered vacuum and wet cleaning (disinfecting) methods. Workers should consider the use of appropriate respiratory protection and protective clothing in order to reduce exposure to mould when disturbing animal fecal matter or building materials contaminated with animal fecal matter.
