# Pre-Renovation Designated Substances Review

*Maison de la Francophonie d'Ottawa (Former Grant School), 2720 Richmond Road, Ottawa, Ontario*

Project No.: 1791616 (JLR Project No. 27672-000.1)

April 18, 2018

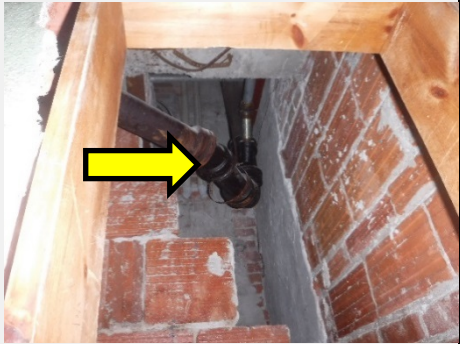
Bell and spigot joint packing materials	Present within wall cavities where existing air ducts are present and in the proposed Community Centre 140	Unknown	Good	Yes	D	No sample collected as sampling would have impacted the integrity of the piping system	Assumed as bell and spigot joints are known to contain ACMs

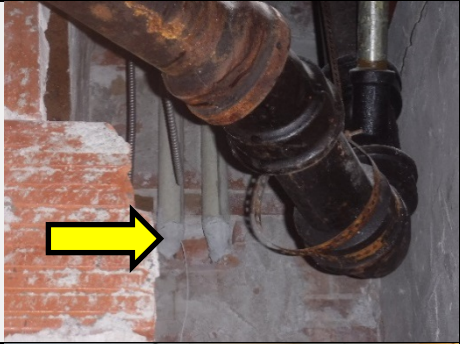
Material Description	Material Location <sup>(1)</sup>	Observed Estimated Quantity	Condition	Friable (Yes / No)	Accessibility <sup>(3)</sup>	Sample Number	Asbestos Concentration (%) and Type	Photograph
Elbow Parging	Present inside west air duct wall cavity running between D144C, 215 and 318A	Unknown	Fair to Poor	Yes	D	Historical EHSP Report: 04-0068-12-001 PR-1-A – PR-1-C	65% Chrysotile

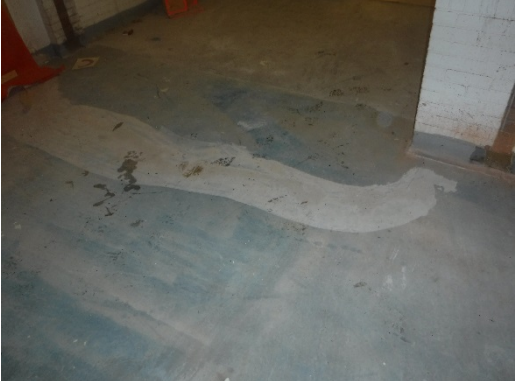
Description / Location of Material	Condition	Lead Concentration (ppm)	Sample Number	Lead-Containing (Yes/No)	Photograph
Blue paint – Present on floors throughout second floor and third floor	N/A <sup>(1)</sup>	<88	Lp-01	No

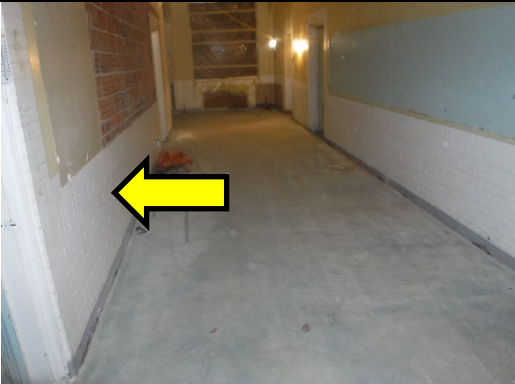
Description / Location of Material	Condition	Lead Concentration (ppm)	Sample Number	Lead-Containing (Yes/No)	Photograph
White wall paint – Present on walls from the basement to the fourth floor	Fair	154	Historical EHSP Report: 04-0068- 12-001  LBP-D	Yes

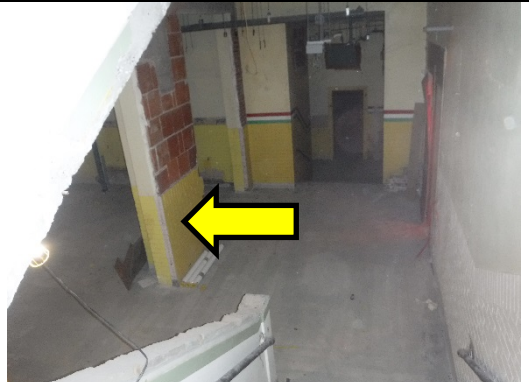
Description / Location of Material	Condition	Lead Concentration (ppm)	Sample Number	Lead-Containing (Yes/No)	Photograph
Yellow paint – Present on brick in various areas from the basement to the third floor	Fair	1243	Historical EHSP Report: 04-0068-12-001  LBP-J	Yes

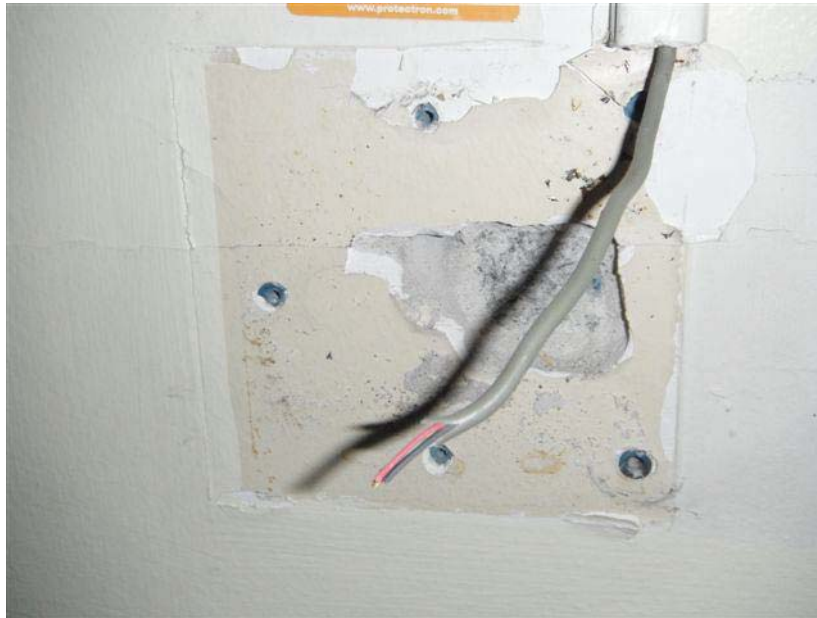
**Photo 1:**

1. **Plaster** – Non-friable asbestos containing plaster is located throughout walls and ceilings at the Site. See Photo 1.
2. **Drywall Joint Compound** – Non-Friable asbestos containing drywall joint compound is located throughout drywall at the Site. Drywall was observed on interior pillars. See Photo 4.

Representative view of asbestos containing plaster, Annex Building, Room 004, Sample Set PL-1-X

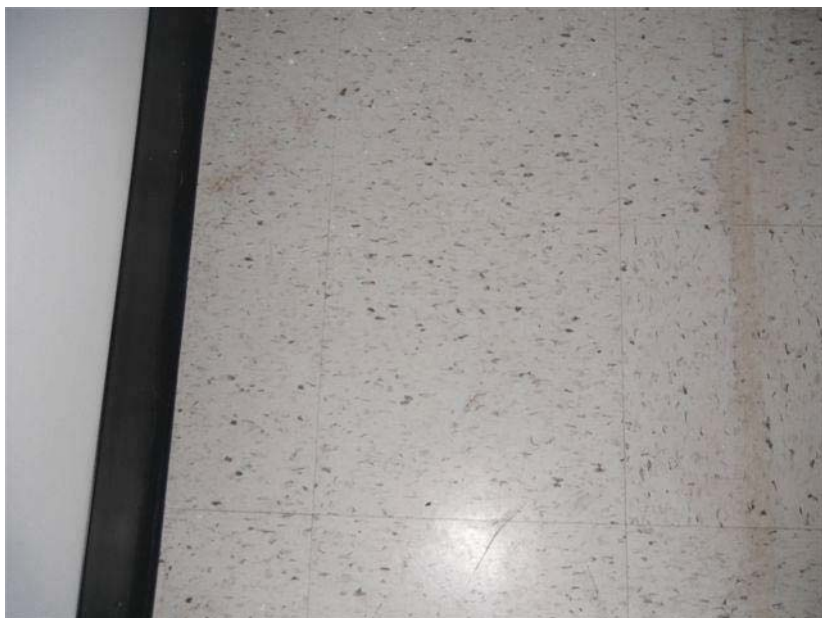
**Photo 3:** View of Representative Vinyl Floor Tile, 1'x 1' White, Annex Building, Room 001, Sample Set: VT-1-X.

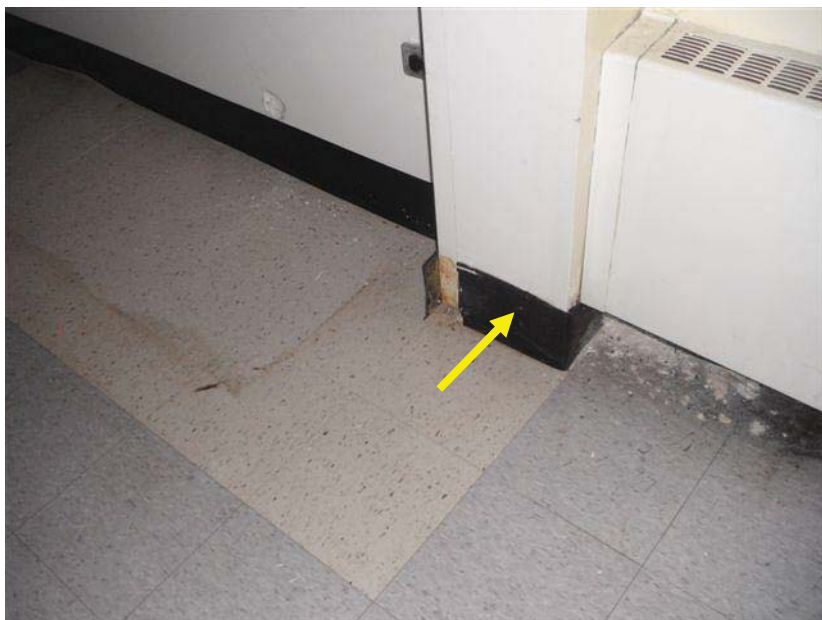
**Photo 4:** View of Representative Cove Base, Annex Building, Room 001, Sample Set: CB-1-X.

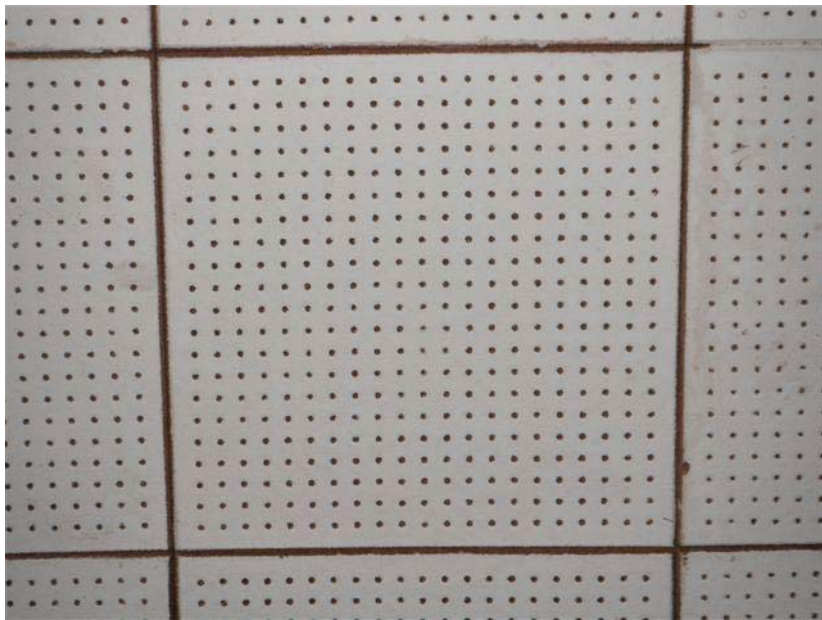
**Photo 5:**

View of Representative 1'X 1' Ceiling Tile, Annex Building, Room 001, Sample Set: CT-1-X.

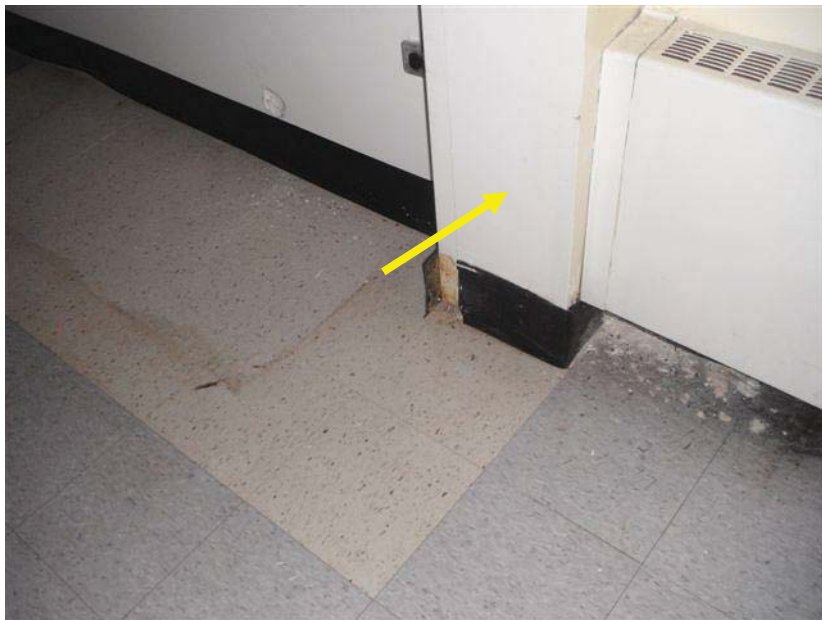
**Photo 6:**

View of Representative Drywall with Asbestos Containing Drywall Joint Compound, Annex Building, Room 001, Sample Set: DC-1-X. Pillars within the Annex Building are constructed with drywall.

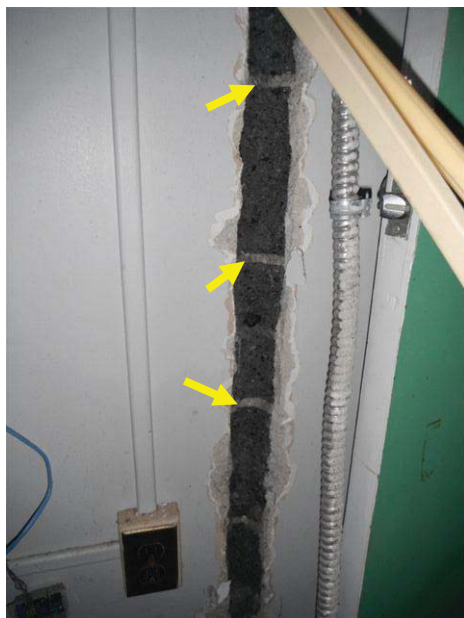
**Photo 7:**

View of Representative Concrete Block Mortar, Annex Building, Teachers Lounge, Sample Set: MT-1-X.

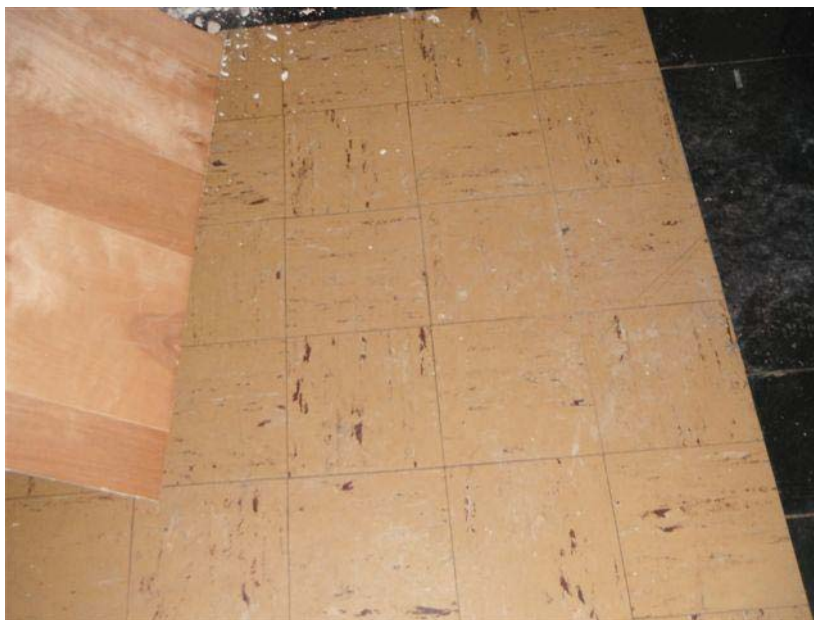
**Photo 8:**

3. **9"x 9" Vinyl Floor Tile** – Approximately 1,220 square feet were observed throughout the Site in the waiting room, storage room, and room 002. See Photo 8.

View of Representative Asbestos Containing 9"x 9" Vinyl Floor Tile, Annex Building, Waiting Room, Sample Set: VT-3-X.

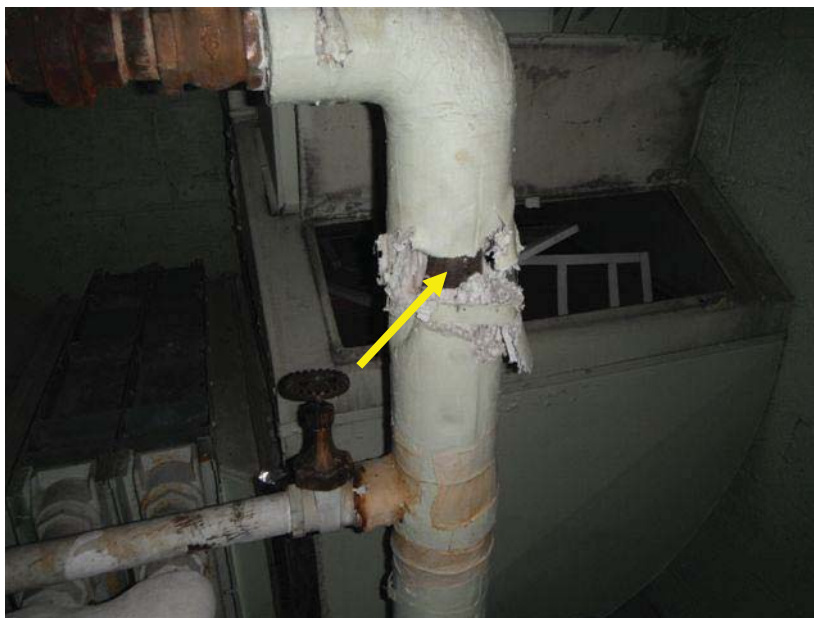
**Photo 11:**

6. **Pipe Straight Insulation, Corrugated Cardboard (Aircell)** – Approximately 10 linear feet of asbestos containing aircell insulation was observed in the mechanical room. See Photo 11.

View of Representative Asbestos Containing Pipe Straight Corrugated Cardboard Insulation, Annex Building, Mechanical Room, Sample Set: PS-1-X.

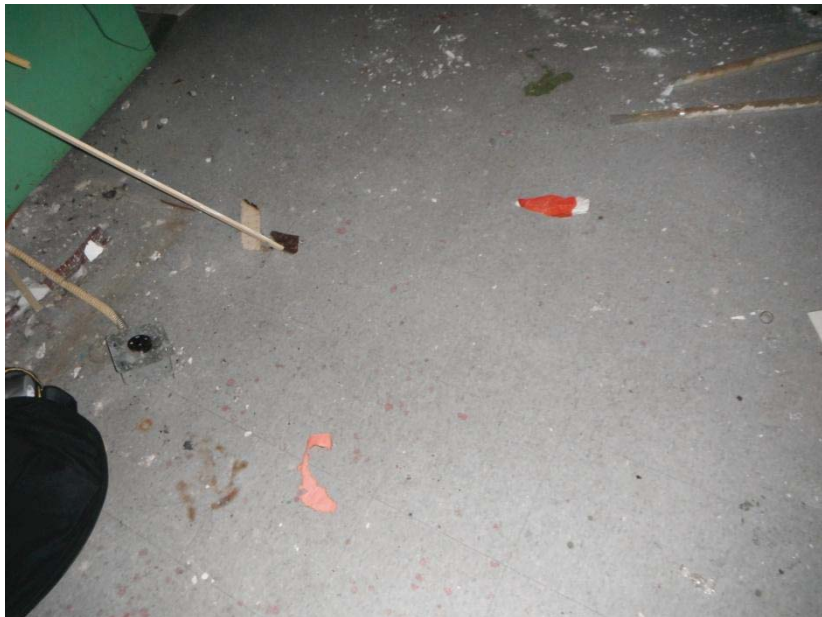
**Photo 13:**

View of Representative Vinyl Floor Tile, Annex Building, Room 002, Sample Set: VT-5-X.

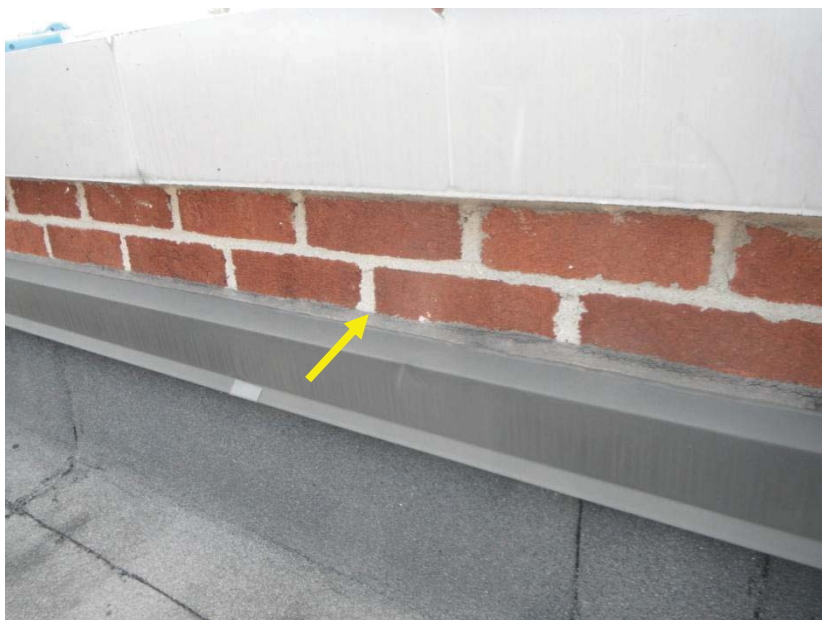
**Photo 14:**

View of Representative Black Caulking, Annex Building, Exterior, Sample Set: CA-1-X.

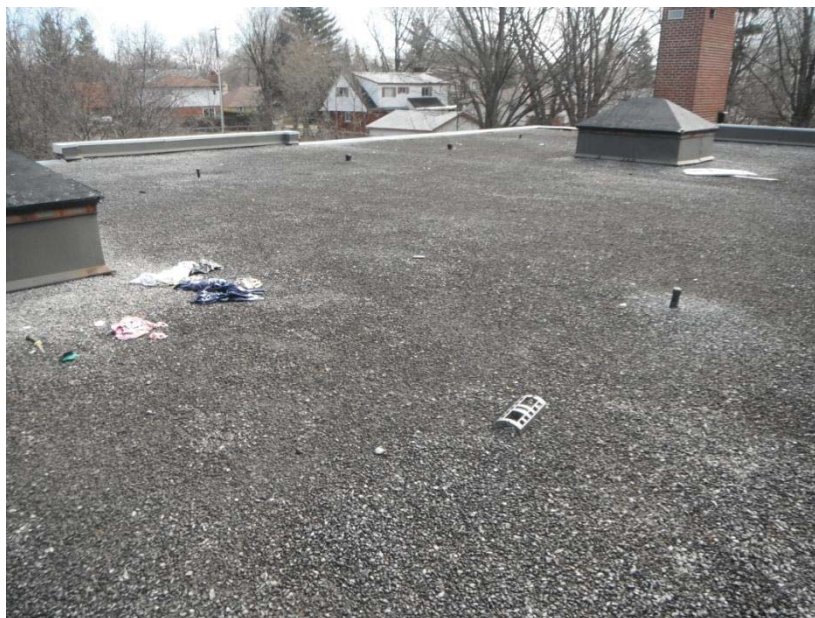
**Photo 15:** View of Representative Annex Building Main Roof (Core Sampled), Annex Building, Exterior, Sample Set: RC-X.

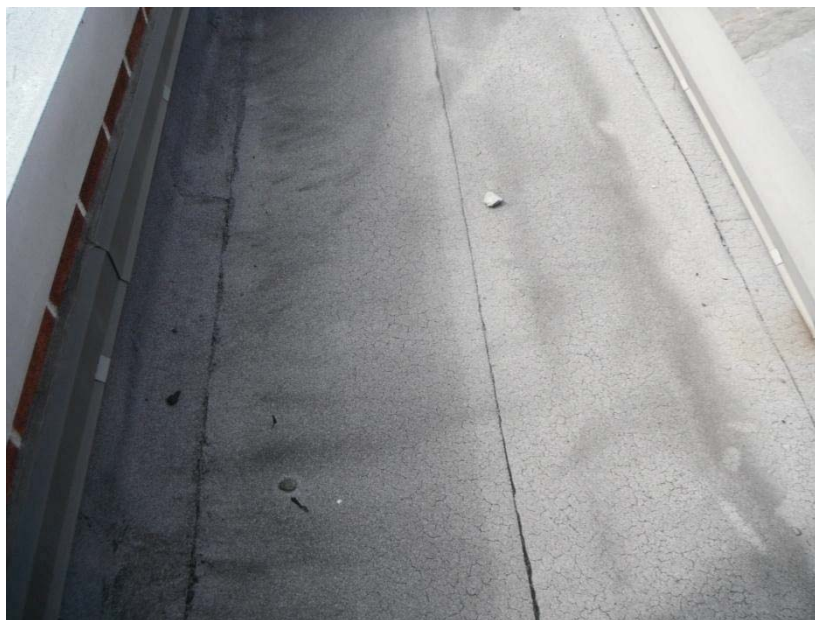
**Photo 16:** View of Representative Asphalt Shingles, Annex Building, Entrance Roof, Sample Set: AS-X.

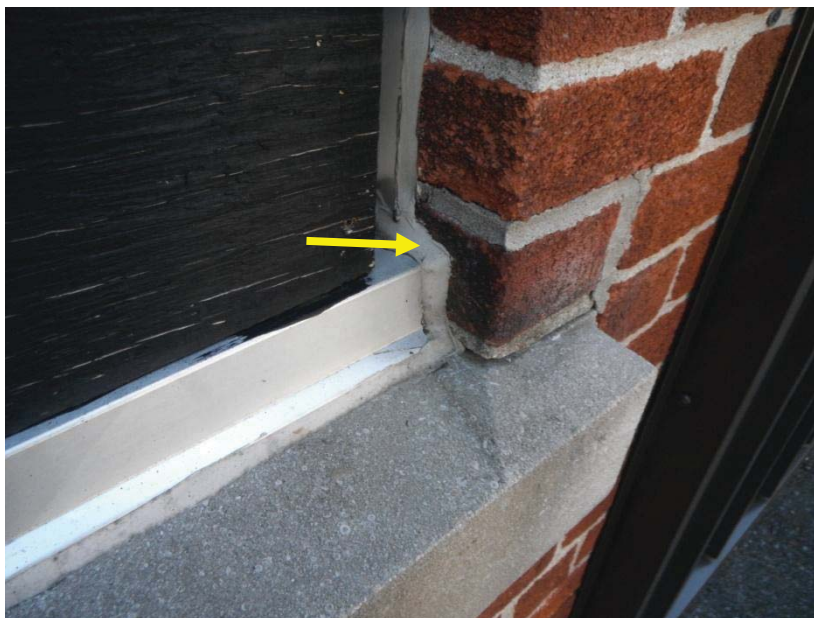
**Photo 17:**

View of Representative Beige Caulking, Annex Building, Exterior, Sample Set: CA-2-X.

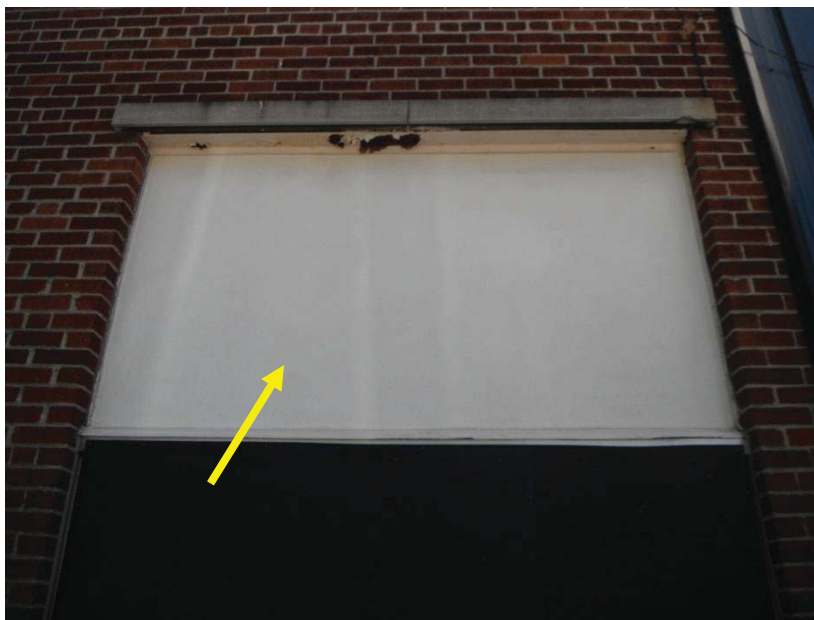
**Photo 18:**

View of Representative Trowelled Cementitious Material, Annex Building, Exterior, Sample Set: TC-X.

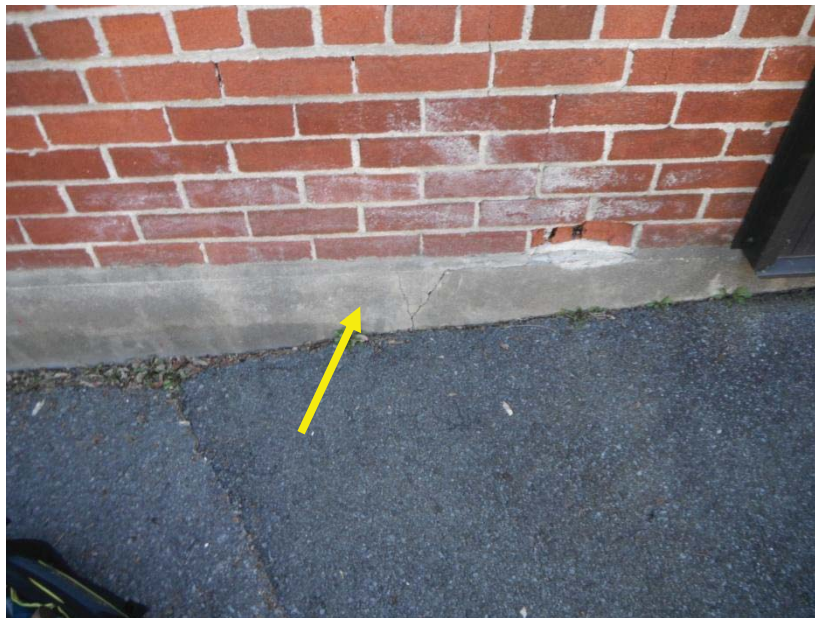
**Photo 19:** View of Representative Foundation Parging, Annex Building, Exterior, Sample Set: FP-1-X.

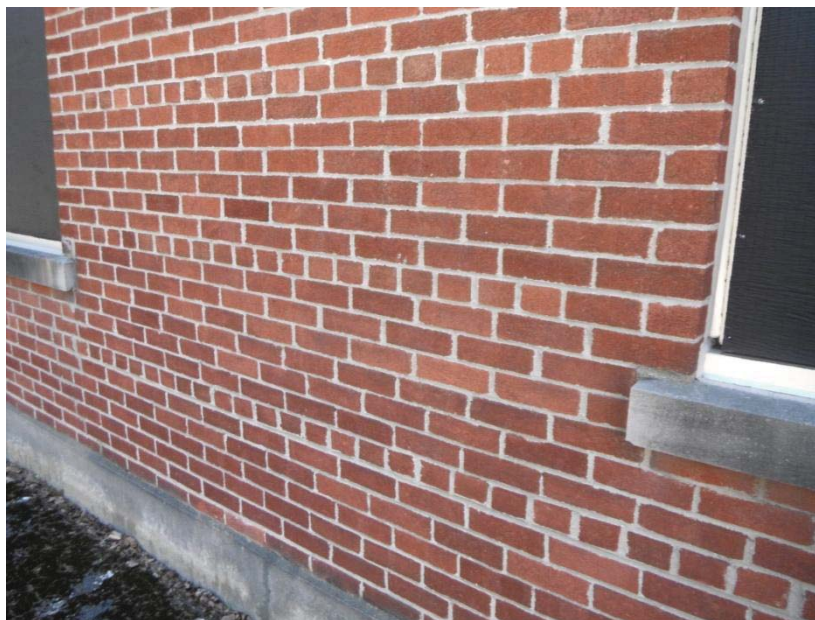
**Photo 20:** View of Representative Brick Mortar, Annex Building, Exterior, Sample Set: MR-1-X.

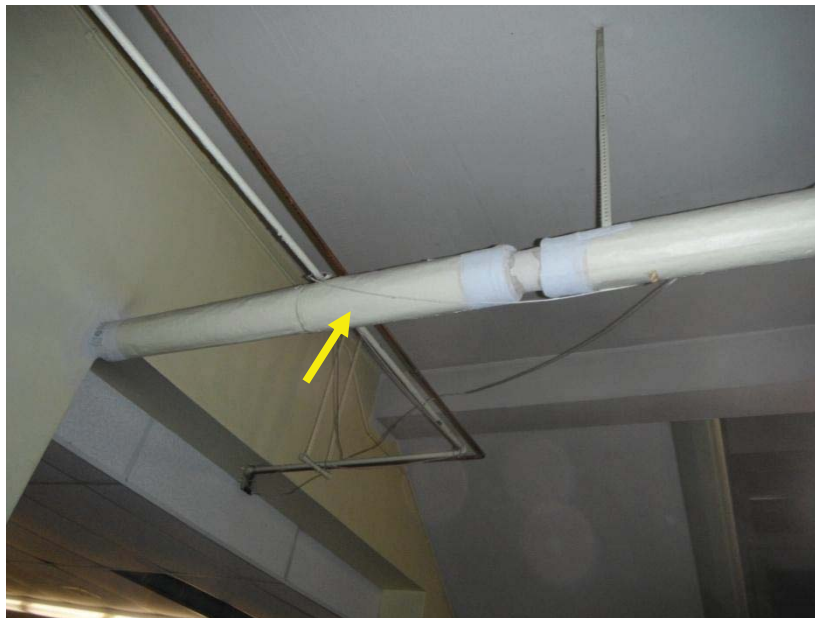
**Photo 21:**

1. **Pipe Straight Insulation, Corrugated Cardboard (Aircell)** – Approximately 490 linear feet of friable asbestos containing aircell insulation was observed throughout the Site in lunch room 018 and adjacent corridor, kitchen, library, 002, lunch room 017, gymnasium, room outside of fan room, boiler room and adjacent rooms, 009, 008, 006, 006A, and 005. See Photo 21.

View of Representative Asbestos Containing Pipe Straight Corrugated Cardboard Insulation, Main Building, Lunch Room 018, Sample Set: PS-2-X.

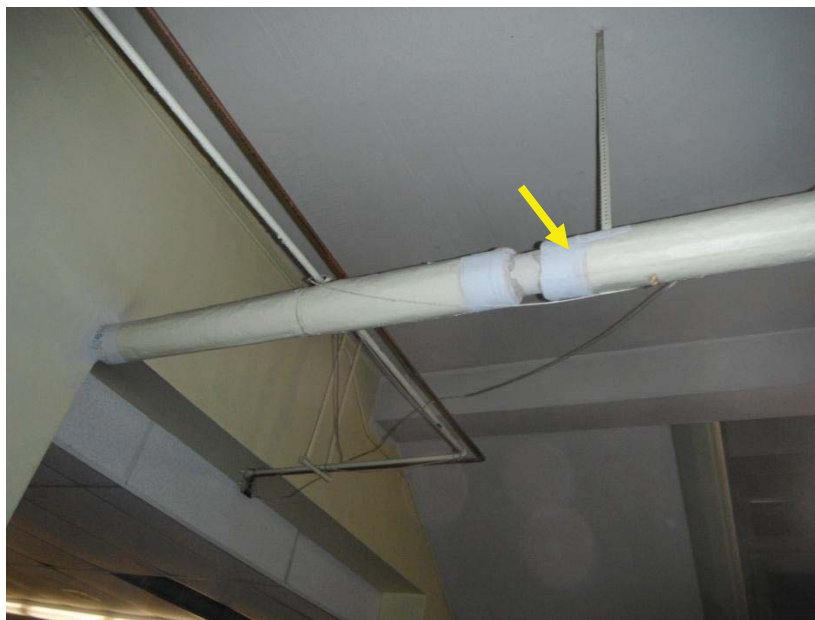
**Photo 22:**

2. **Pipe Fitting Parging Insulation** – Approximately 95 fittings insulated with friable asbestos containing parging were observed throughout the Site in lunch room 018 and adjacent corridor, kitchen, library, 002, lunch room 017 and adjacent corridor, gymnasium, room outside of fan room, boiler room and adjacent rooms, and 005. See Photo 22.

View of Representative Pipe Fitting Parging Insulation, Main Building, Lunch Room 018, Sample Set: PR-2-X.

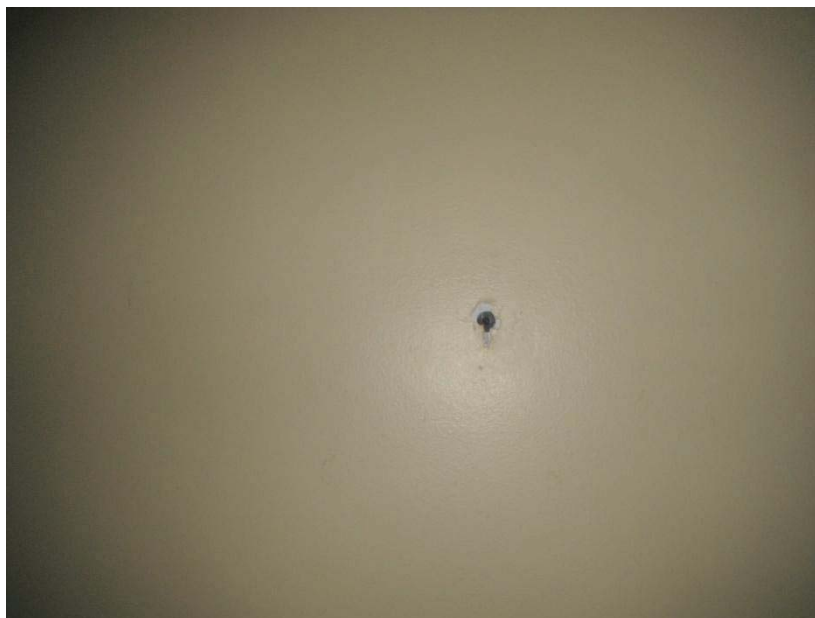
8. **Plaster** – Non-friable asbestos containing plaster is located throughout walls and ceilings at the Site. See Photo 29.
9. **9”x 9” Grey Vinyl Floor Tile Mastic** – Approximately 4,527 square feet of non-friable asbestos containing floor tile mastic is located throughout the Site in rooms 009, 007, 005, 014, 013, 012, 011, and 010. See Photo 31.

**Photo 29:** View of Representative Asbestos Containing Plaster, Main Building, Ground Floor Corridor, Sample Set: PL-3-X.

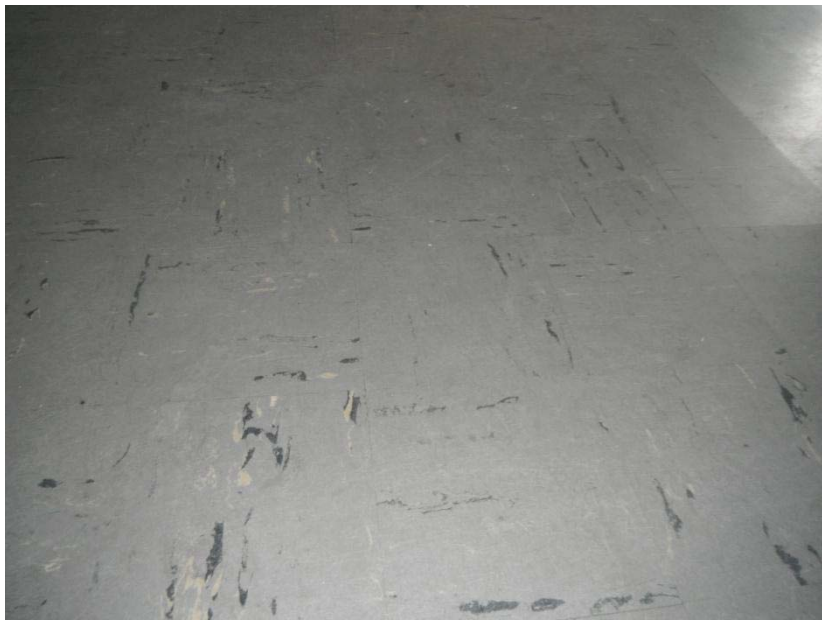
**Photo 31:**

View of Representative 9"x 9" Grey Vinyl Floor Tile with Asbestos Containing Mastic, Main Building, Room 009, Sample Set: VT-6-X.

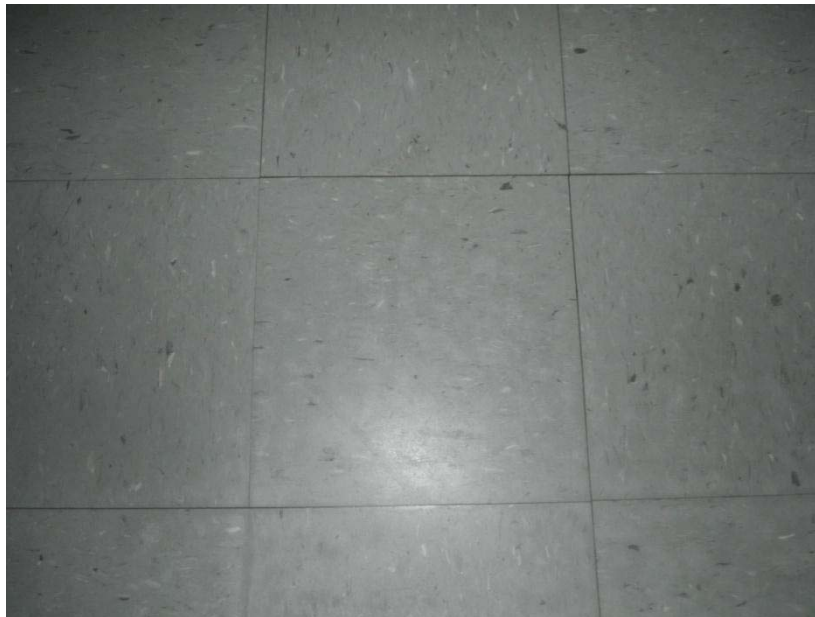
10. **1’x 1’ Grey/Blue Vinyl Floor Tile Mastic** – Approximately 621 square feet of non-friable asbestos containing floor tile mastic is located in room 008. See Photo 33.

**Photo 33:** View of Representative 1' X 1' Grey/Blue Vinyl Floor Tile with Asbestos Containing Mastic, Main Building, Room 008, Sample Set: VT-8-X.

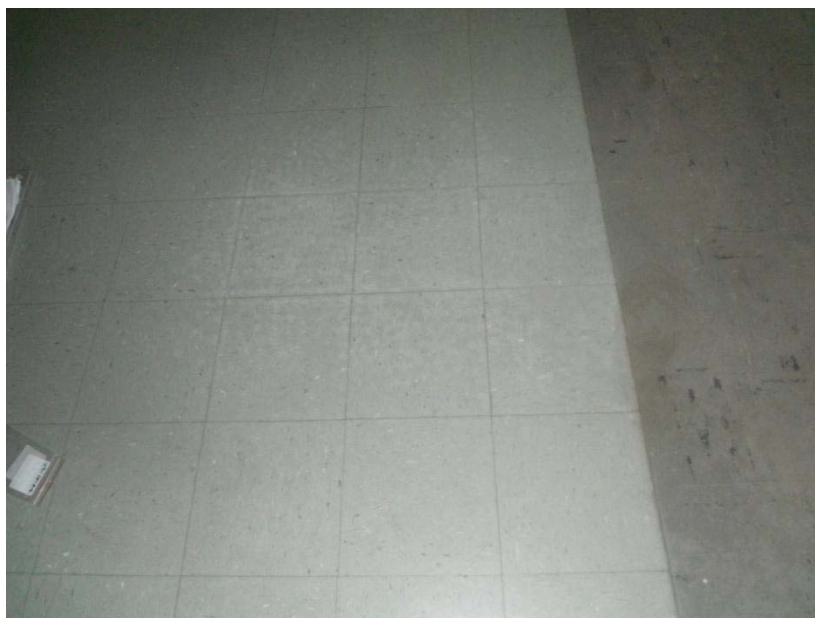
11. **Grey Patterned Vinyl Floor Tile Mastic** – Approximately 110 square feet of non-friable asbestos containing floor tile mastic is located in room 007. See Photo 34.

**Photo 34:** View of Representative 1' X 1' Grey Patterned Vinyl Floor Tile with Asbestos Containing Mastic, Main Building, Room 007, Sample Set: VT-9-X.

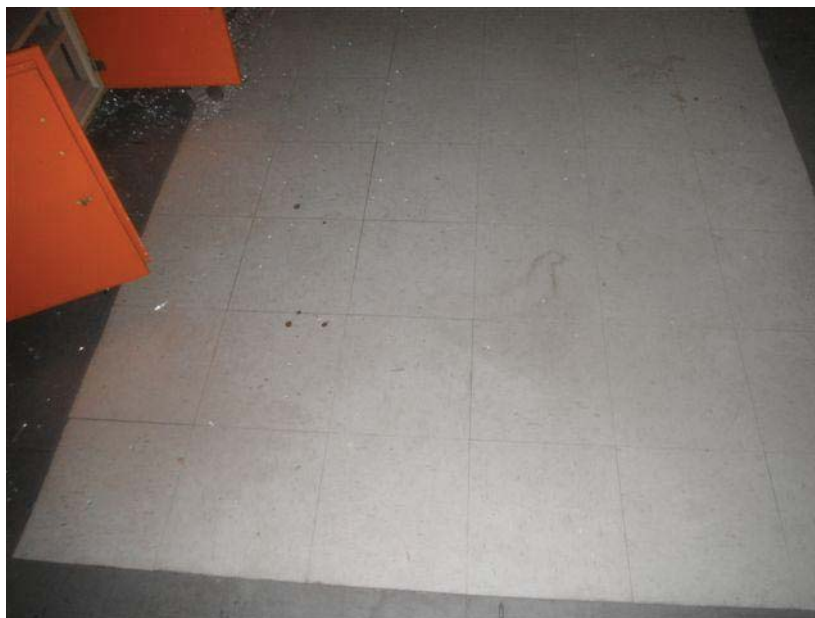
12. **1’x 1’ White Vinyl Floor Tile Mastic** – Approximately 80 square feet of non-friable asbestos containing floor tile mastic is located in room 007. See Photo 35.

**Photo 35:** View of Representative 1' X 1' White Patterned Vinyl Floor Tile with Asbestos Containing Mastic, Main Building, Room 007, Sample Set: VT-10-X.

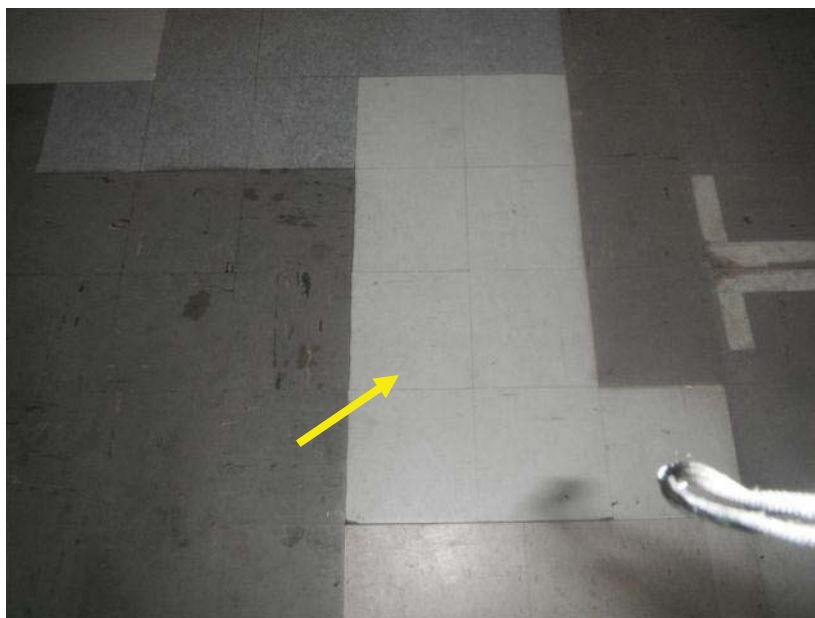
13. **9”x 9” White Vinyl Floor Tile Mastic** – Approximately 15 square feet of non-friable asbestos containing floor tile mastic is located in room 007. See Photo 36.

**Photo 36:** View of Representative 9" x 9" White Vinyl Floor Tile with Asbestos Containing Mastic, Main Building, Room 007, Sample Set: VT-11-X.

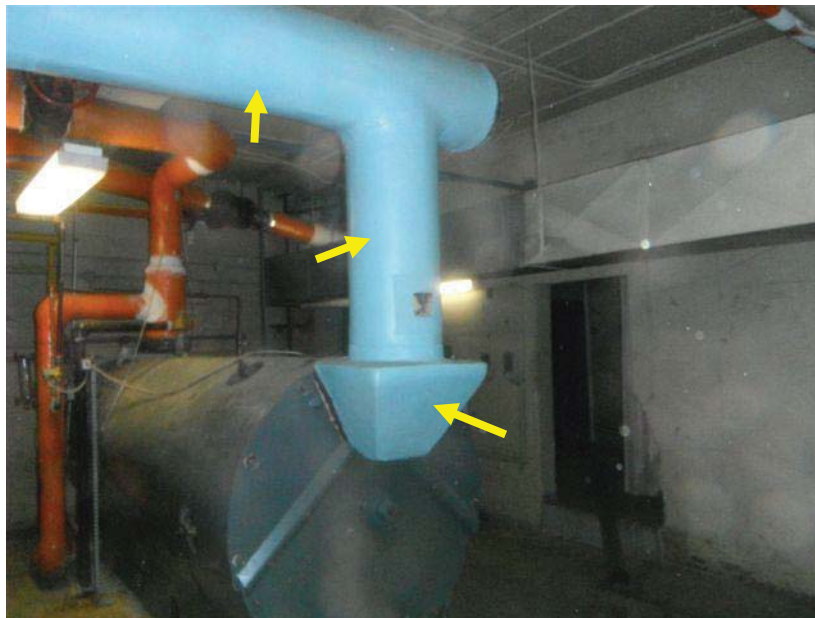
14. **Boiler Insulation, Mag Block** – Approximately 30 square feet of friable asbestos containing mag block insulation is located on the boiler duct work in the boiler room. See Photo 37.

**Photo 37:** View of Representative Asbestos Containing Thermal Insulation (Mag Block), Main Building, Boiler Room, Sample Set: MB-1-X.

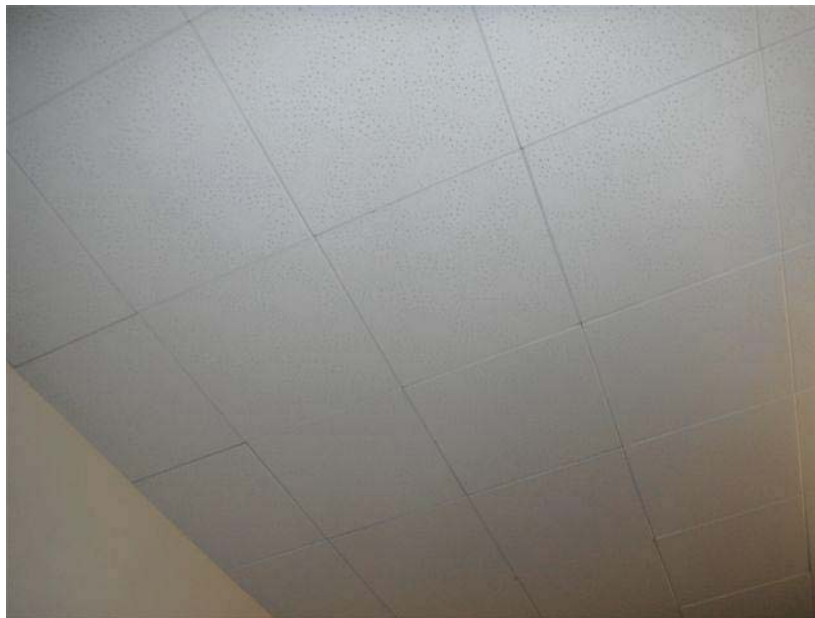
15. **1’x 1’ Ceiling Tile** – Approximately 210 square feet of non-friable asbestos containing ceiling tile is located in room 006. See Photo 39.
16. **1’x 1’ Beige Vinyl Floor Tile** – Approximately 35 square feet of non-friable asbestos containing floor tile is located throughout the Site in rooms 006 and 007. See Photo 40.

**Photo 39:** View of Representative Asbestos Containing 1'x 1' Ceiling Tile, Main Building, Room 006, Sample Set: CT-6-X.

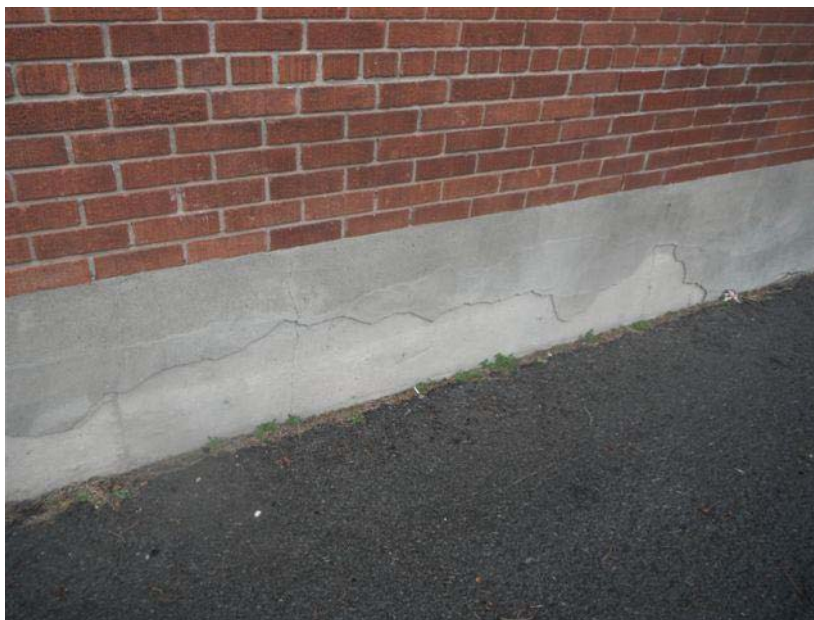
**Photo 42:**

View of Representative Foundation Parging, Main Building, Exterior, Sample Set: FP-2-X.
