Hazardous Building Materials Assessment

Hello Future Stage 2 Renovation
100 Portsmouth Avenue,
Kingston, Ontario

March 13, 2017

Pinchin File: 202867

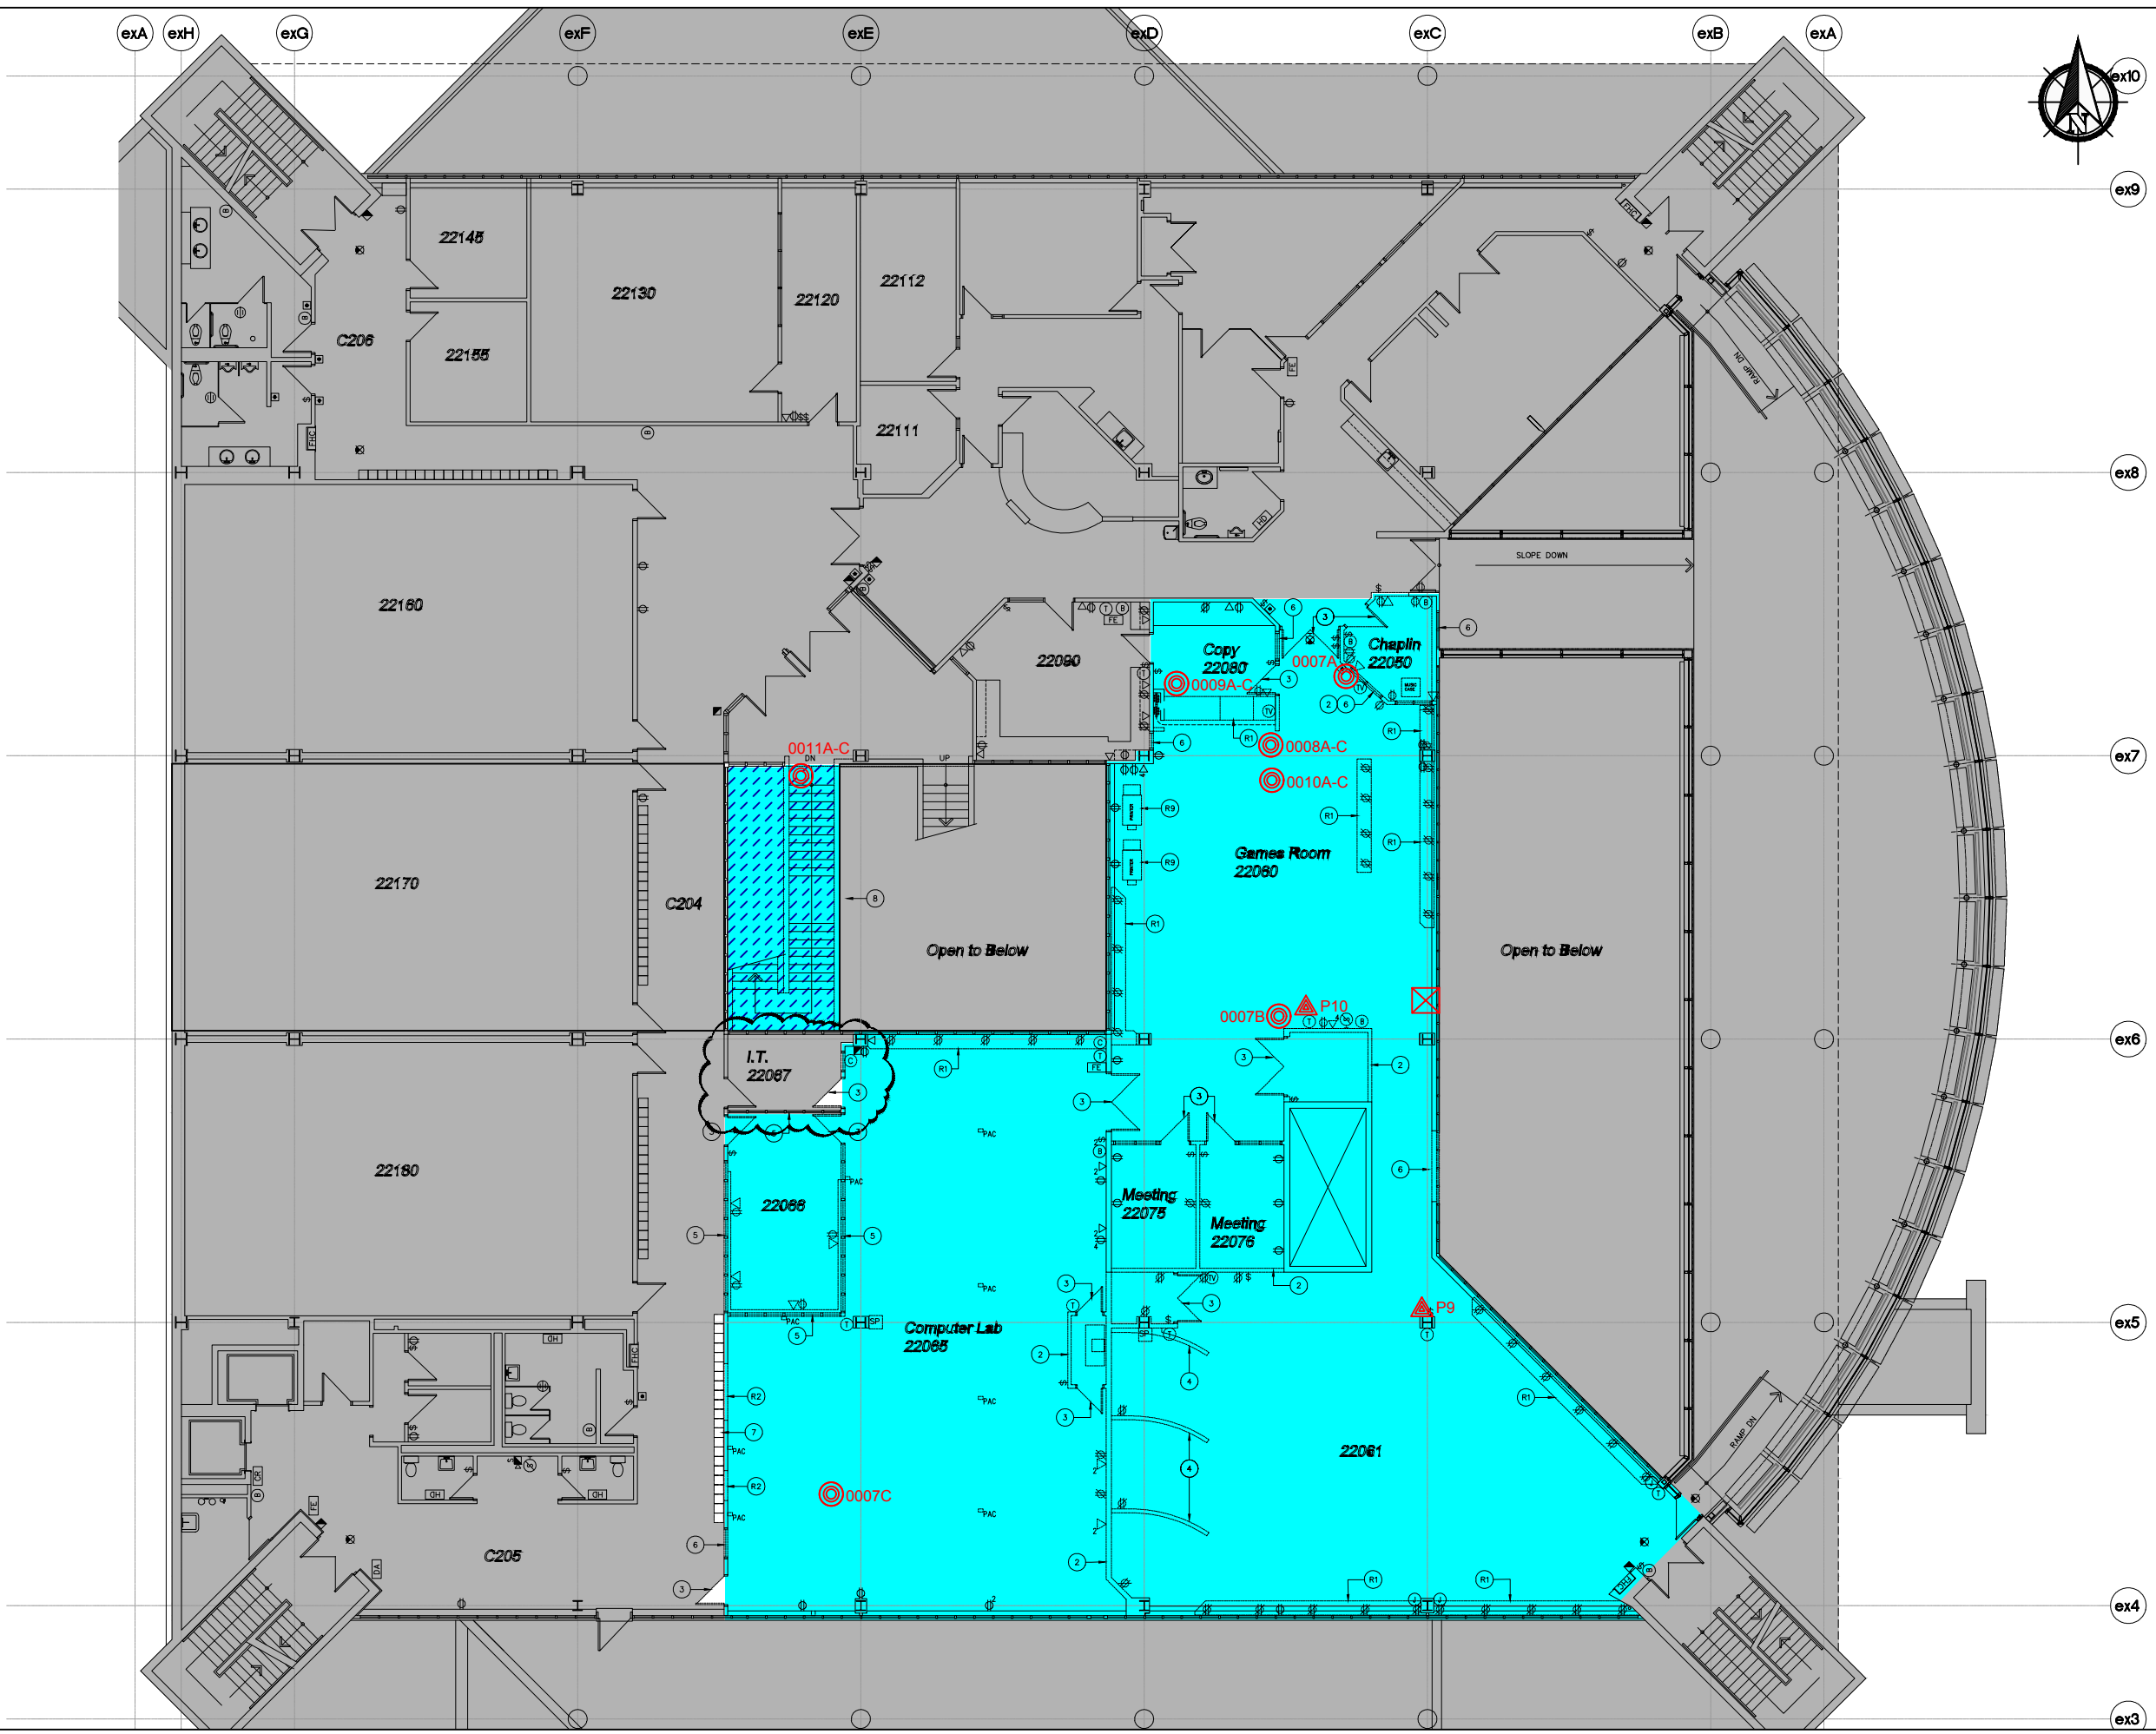
Texture finish, containing chrysotile asbestos, is present on the drywall ceiling above the stairwell on the second floor (samples 0011A-C). There is approximately 200 square feet of texture finish. Texture finish is friable, is in good condition and is painted.
