**REPORT
DESIGNATED SUBSTANCES SURVEY REPORT
FOR Navan Memorial Centre & Arena**

1295 Colonial Road
Navan, ONTARIO

**DRAFT REPORT
DESIGNATED SUBSTANCES SURVEY**

REF: 216.08771.00

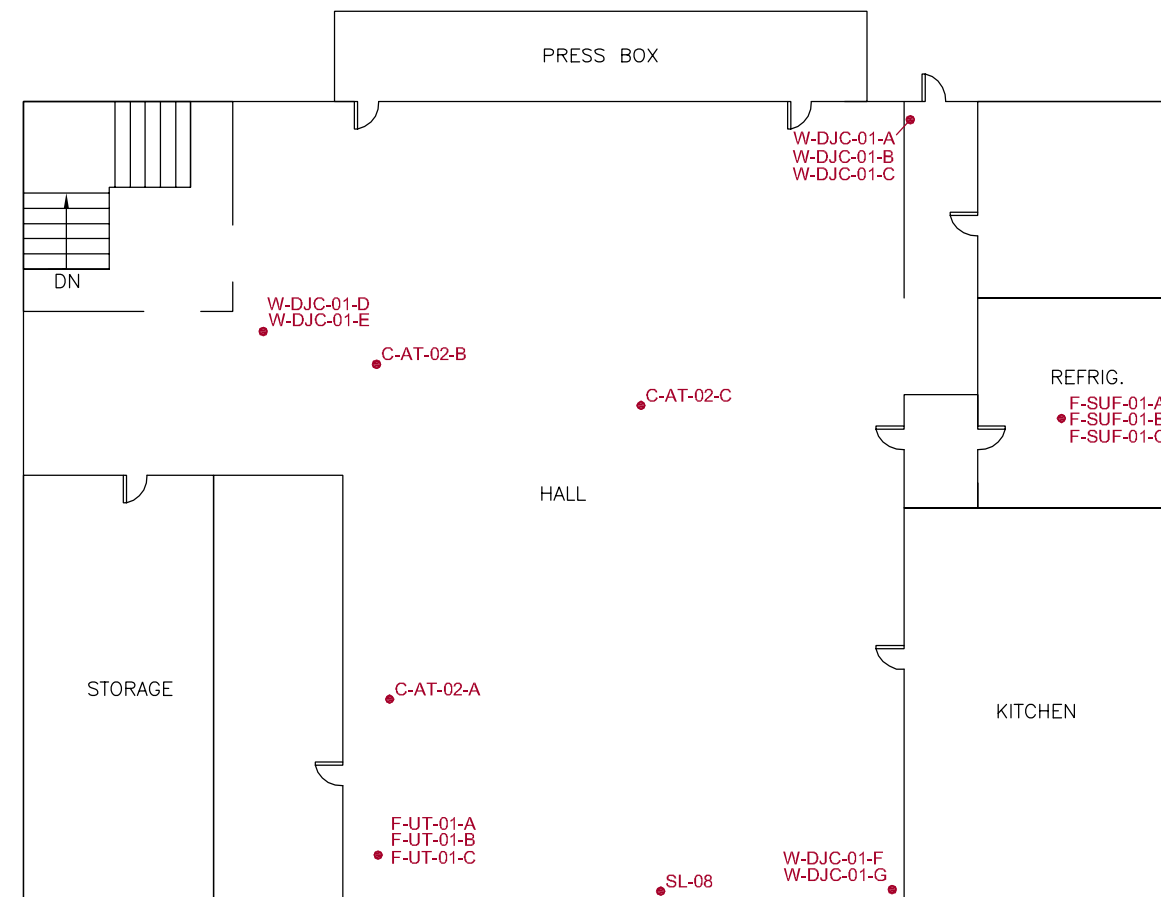
- ASBESTOS SAMPLE LOCATION
- SL LEAD PAINT SAMPLE LOCATION
