August 23, 2015

### Millwork - Waterford - Southway

ORA Kitchens - Waterford Retirement - Phase 2 - Shop Drawings - LOUNGE - 151, COFFEE BAR - 152

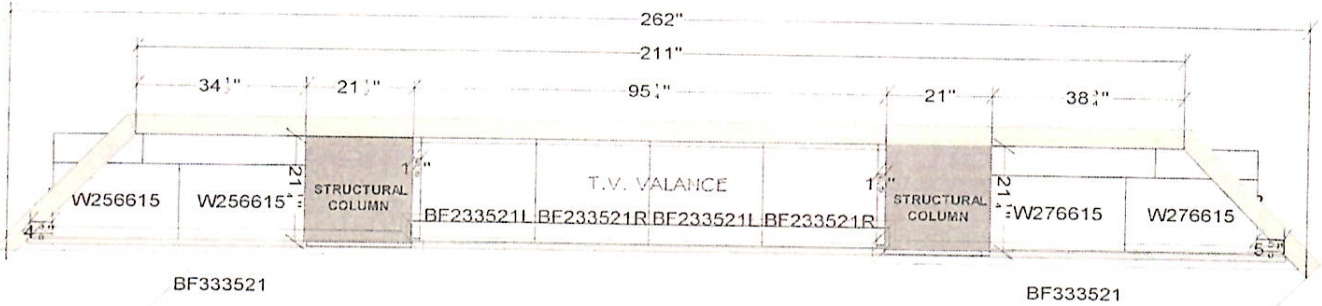
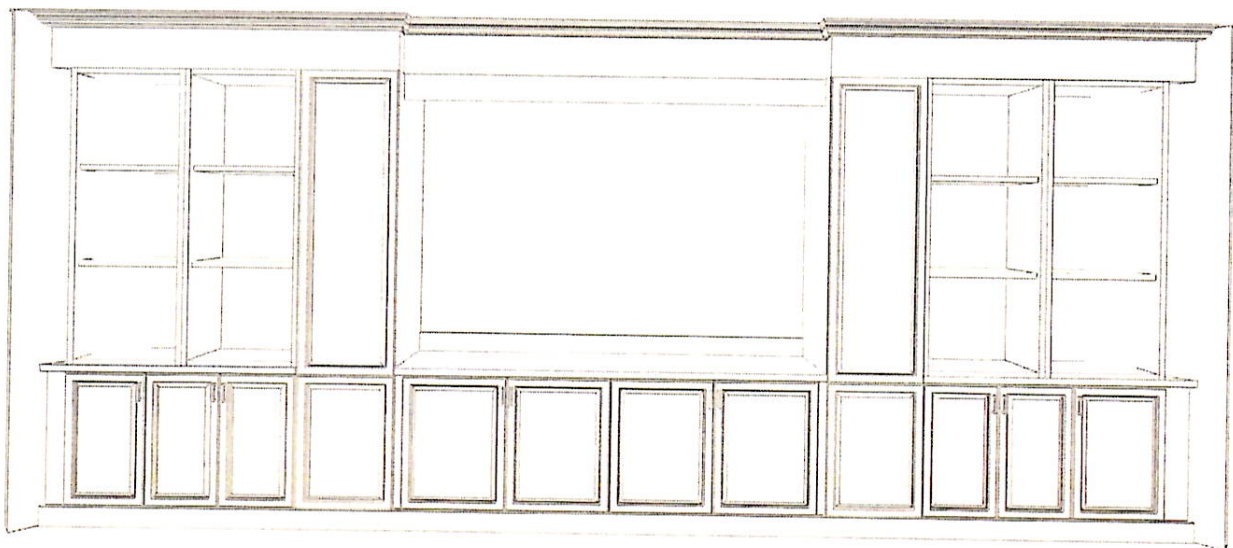
# LOUNGE - B70

DOOR: 62MAP  
STAIN: BRANDY

COUNTER: Maple Wood to Match Cabinetry  
PROFILE: 1 1/4" - Wood Ogee

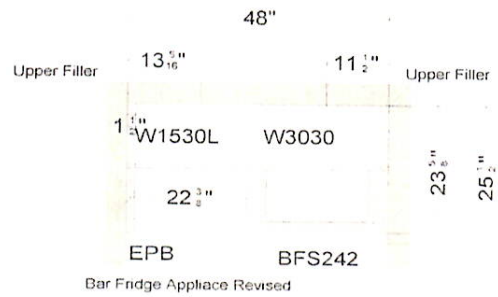
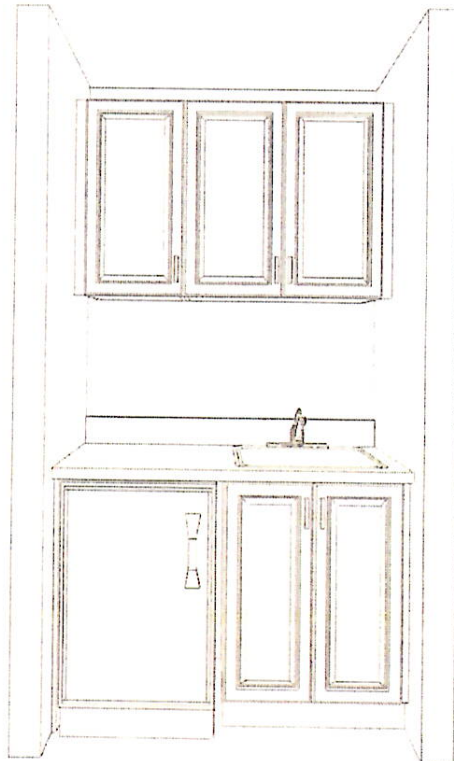
## COFFEE BAR

DOOR: 62MAP  
STAIN: BRANDY

COFFEE BAR COUNTER: Giallo Ornamental Granite  
PROFILE: Double Bevel - 3CM

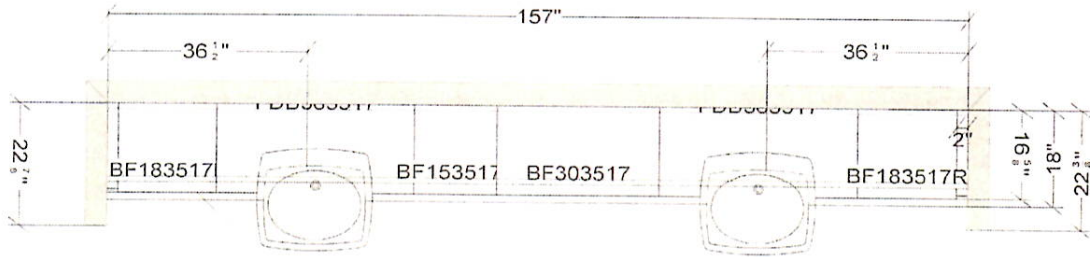
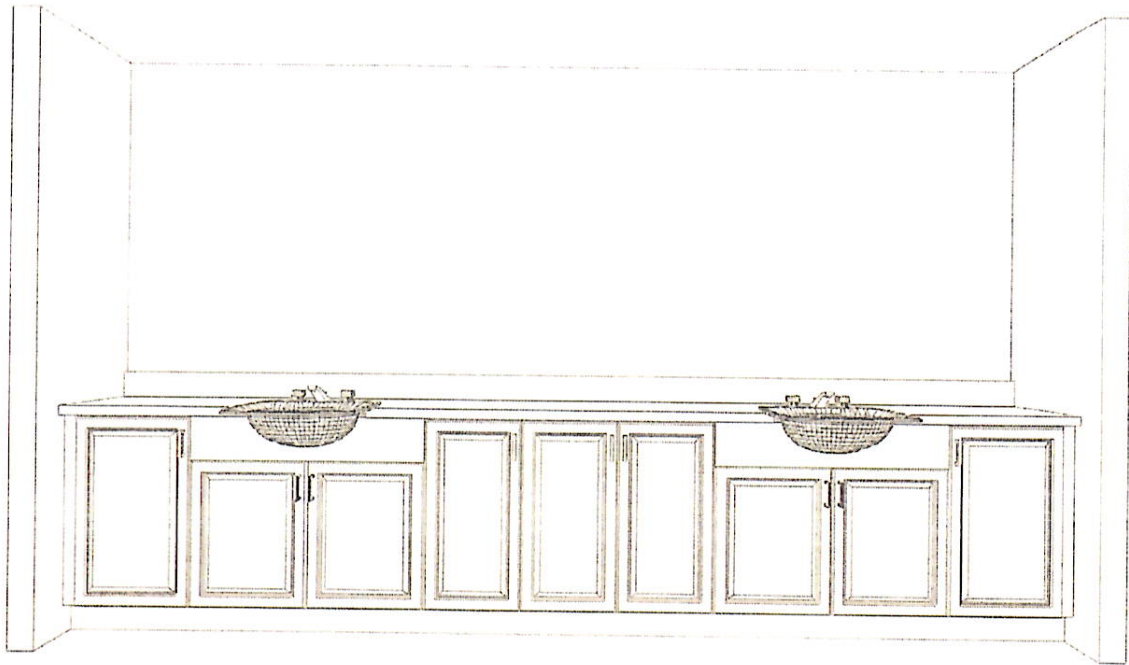
## WASHING STATION

DOOR: 62MAP  
STAIN: BRANDY

WASHING STATION COUNTER: Milano Quartz Quarry # 4726-52  
PROFILE: Contessa

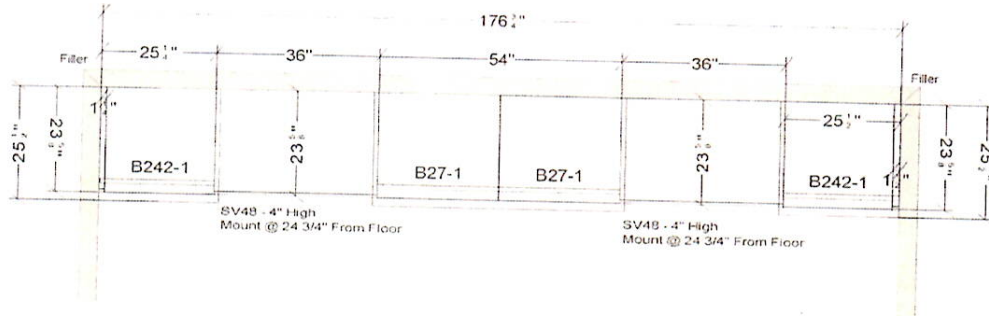
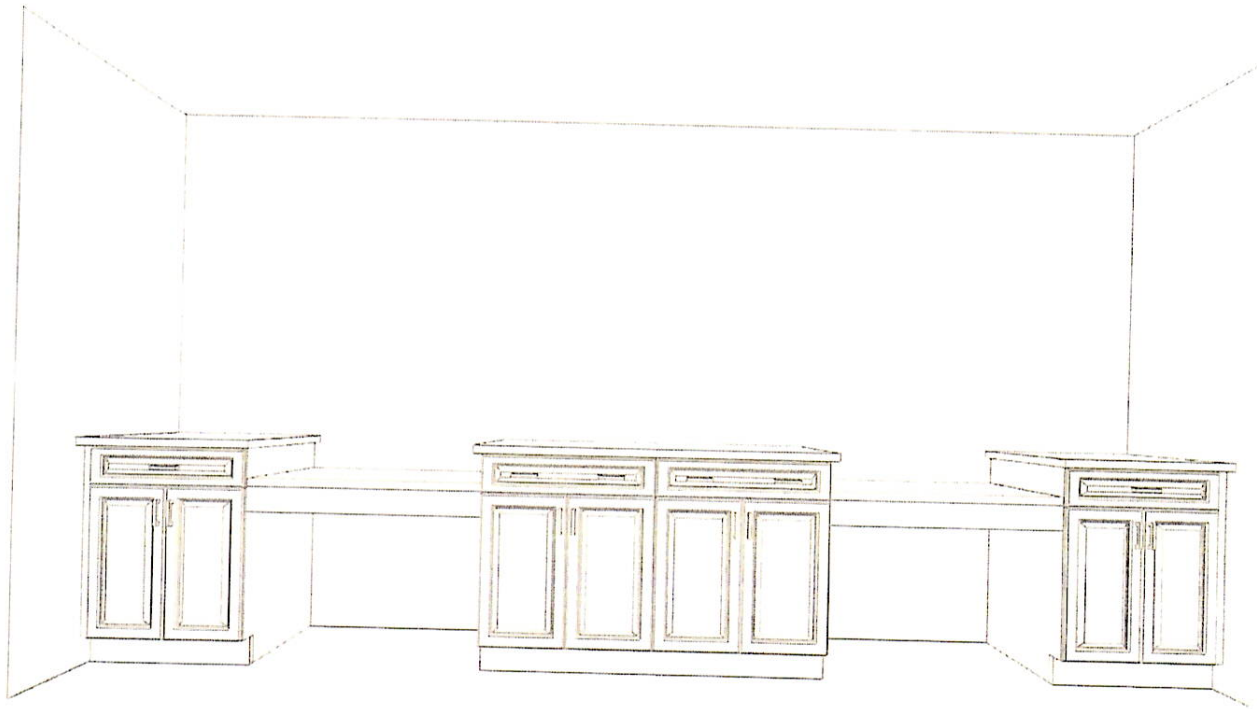
## STYLING STATION

DOOR: 62MAP  
STAIN: BRANDY

STYLING STATION COUNTER: Milano Quartz Quarry # 4726-52  
PROFILE: Contessa

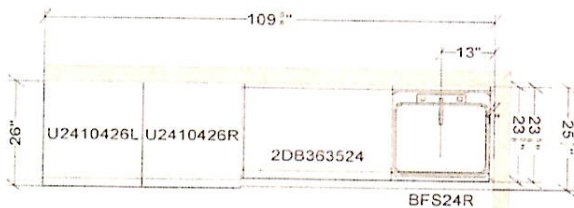
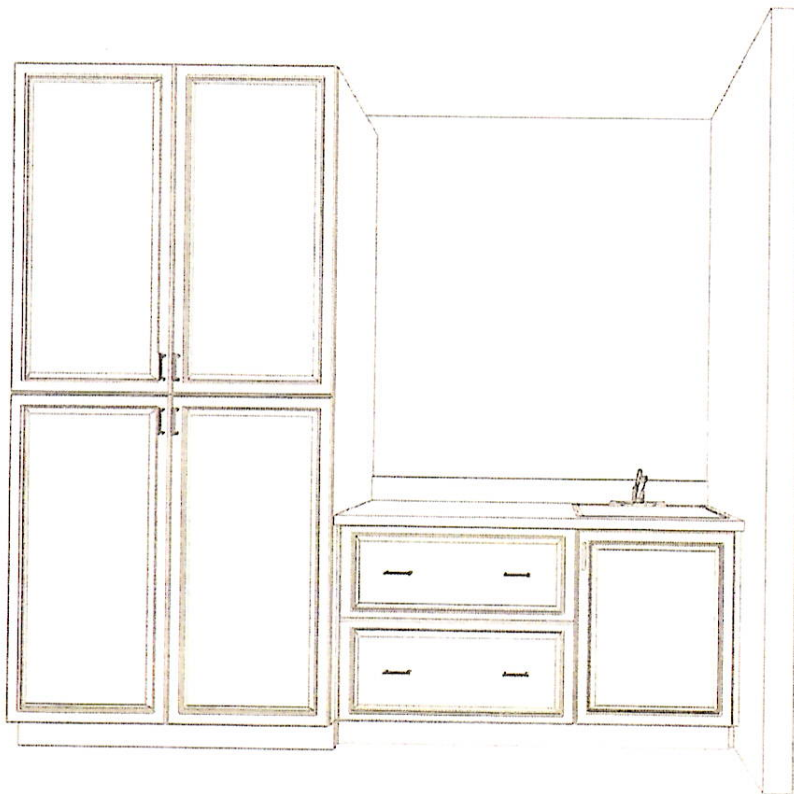
# WELLNESS ACTIVITY ROOM - 266

DOOR: EL00, Primo  
COLOUR: Antique White

Wall Location to be on Right side, not Left like Previous Drawing

COUNTER: Milano Quartz Quarry # 4726-52  
PROFILE: Contessa

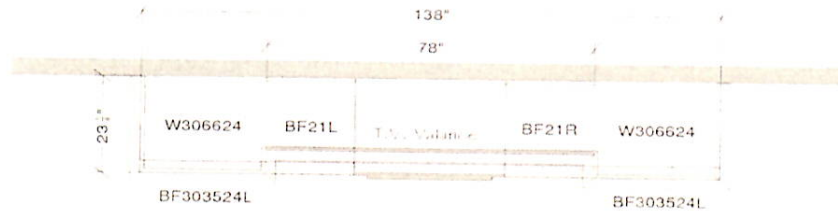
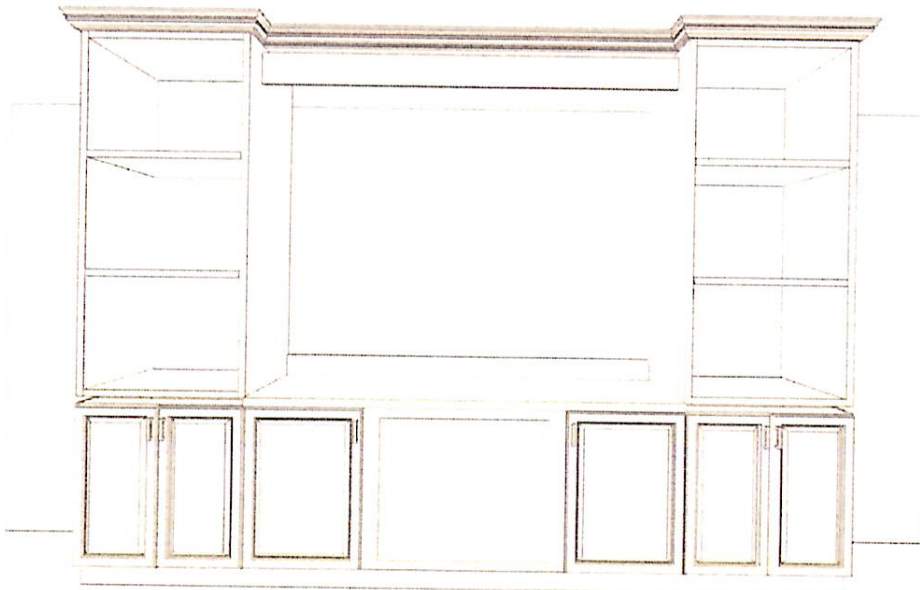
# DEMENTIA COMMON ROOM - T.V. UNIT - 178

DOOR: 62MAP  
STAIN: BRANDY  
COUNTER: Maple Wood Counter Top  
PROFILE: 1 1/4" - Ogee

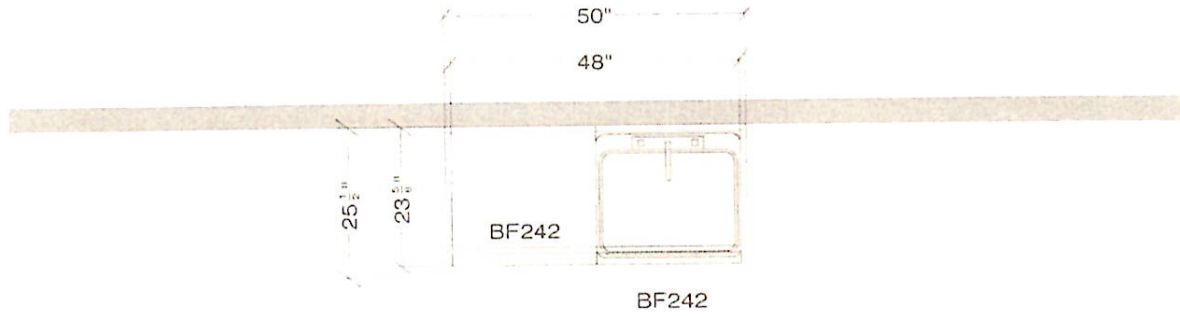
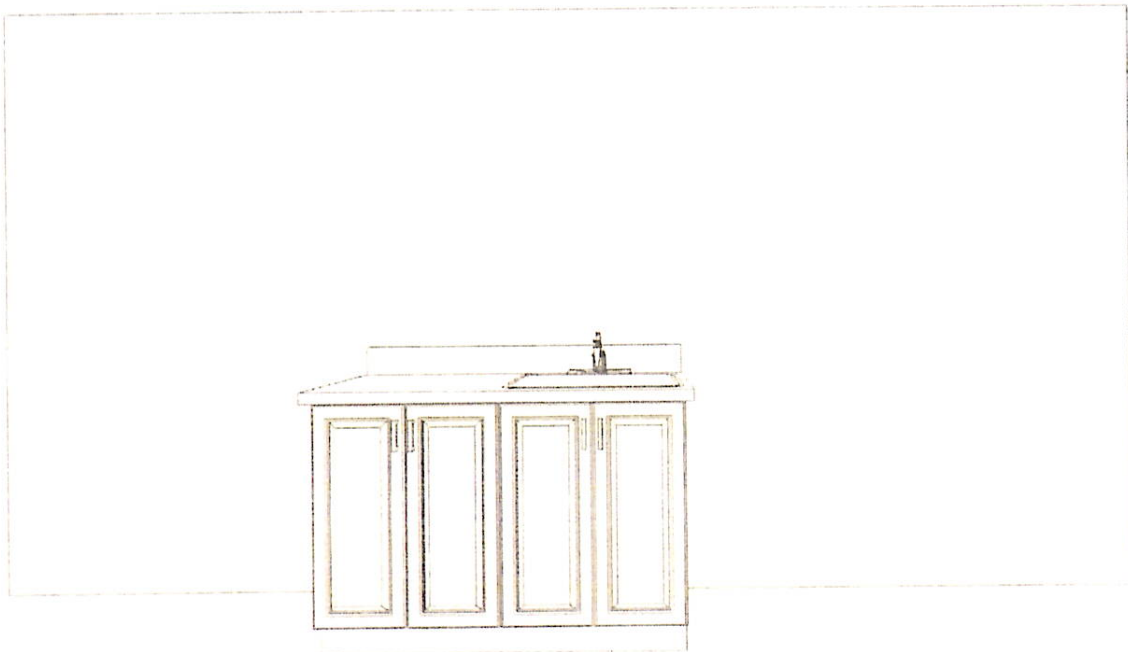
# LAUNDRY ROOM - 258

DOOR: B07, Bellini  
COLOUR: Antique White

LAMINATE COUNTER: Milano Quartz Quarry # 4726-52  
PROFILE: Contessa

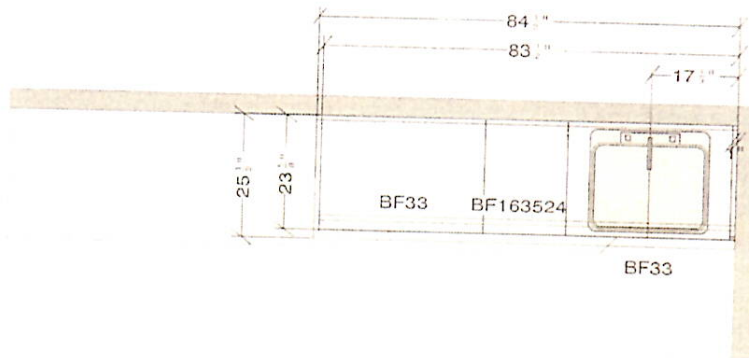
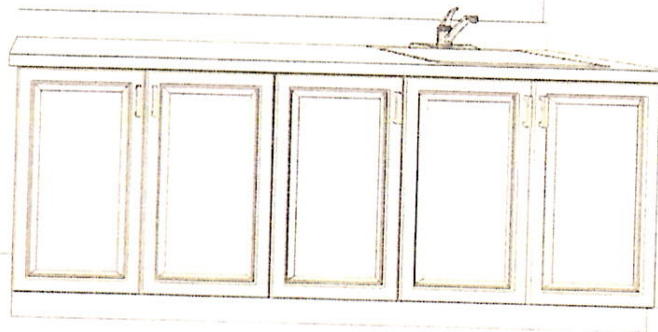
# LAUNDRY ROOMS - 353, ~~453~~, ~~553~~

DOOR: B07, Bellini  
COLOUR: Antique White

LAMINATE COUNTER: Milano Quartz Quarry # 4726-52  
PROFILE: Contessa

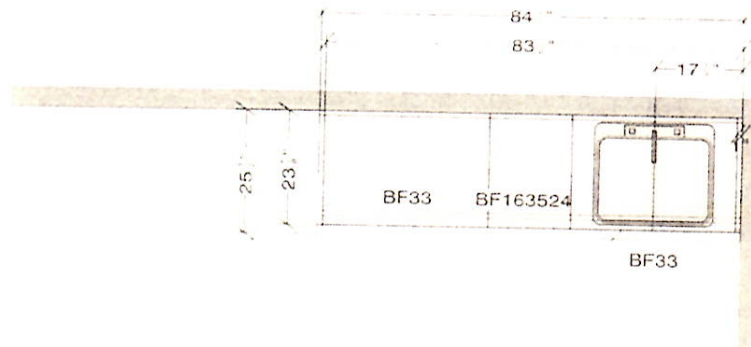
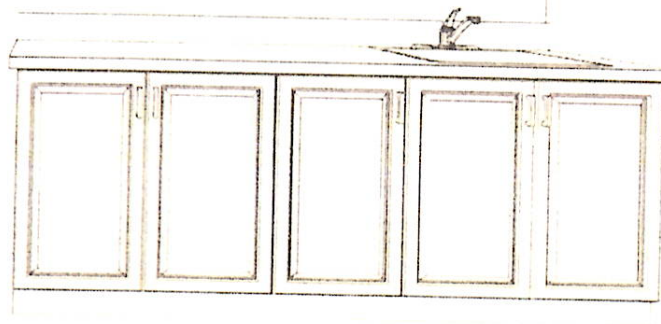
# LAUNDRY ROOMS - ~~353~~, 453, ~~553~~

DOOR: B07, Bellini  
COLOUR: Antique White

LAMINATE COUNTER: Milano Quartz Quarry # 4726-52  
PROFILE: Contessa

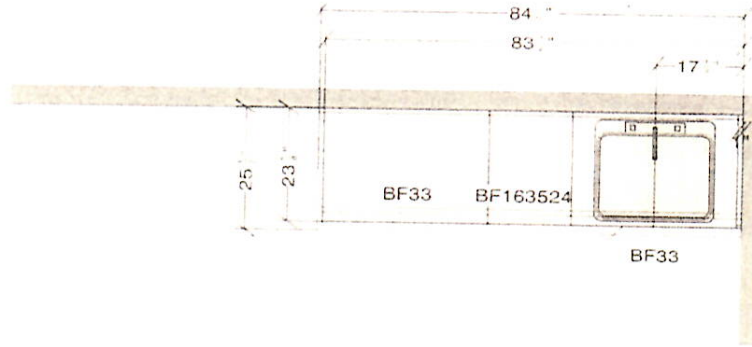
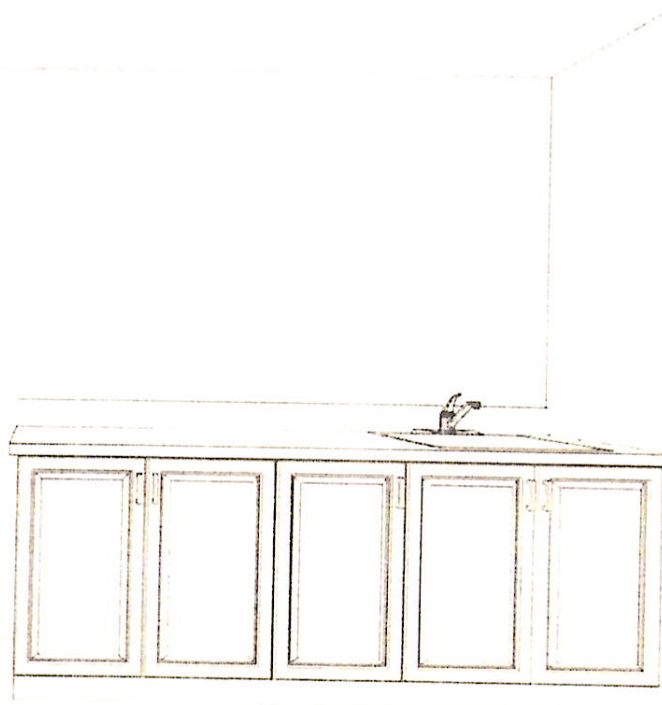
# LAUNDRY ROOMS - ~~353, 453, 553~~

DOOR: B07, Bellini  
COLOUR: Antique White

LAMINATE COUNTER: Milano Quartz Quarry # 4726-52  
PROFILE: Contessa

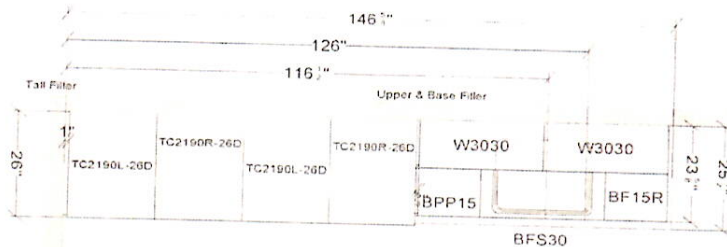
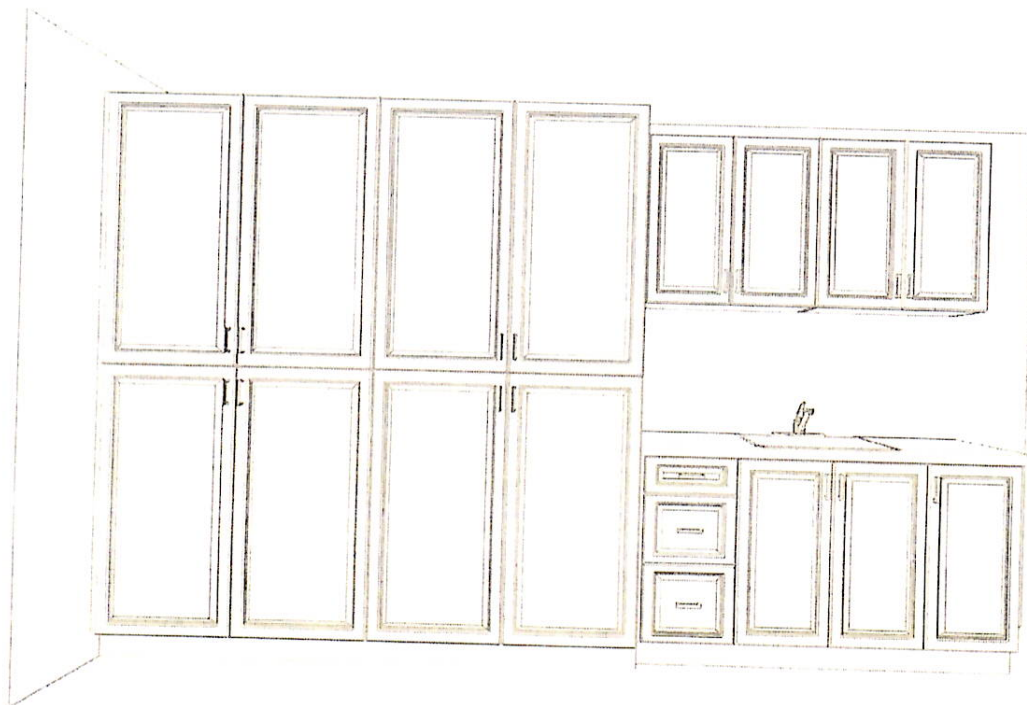
# CRAFT / ACTIVITY ROOM - CRAFT AREA - B66

DOOR: B07 Bellini  
COLOUR: Wild Apple  
COUNTER: Gallo Ornamental Granite  
PROFILE: Double Bevel - 3CM

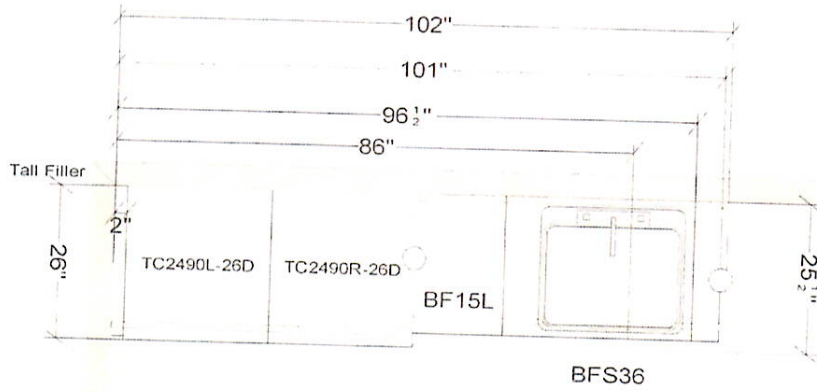
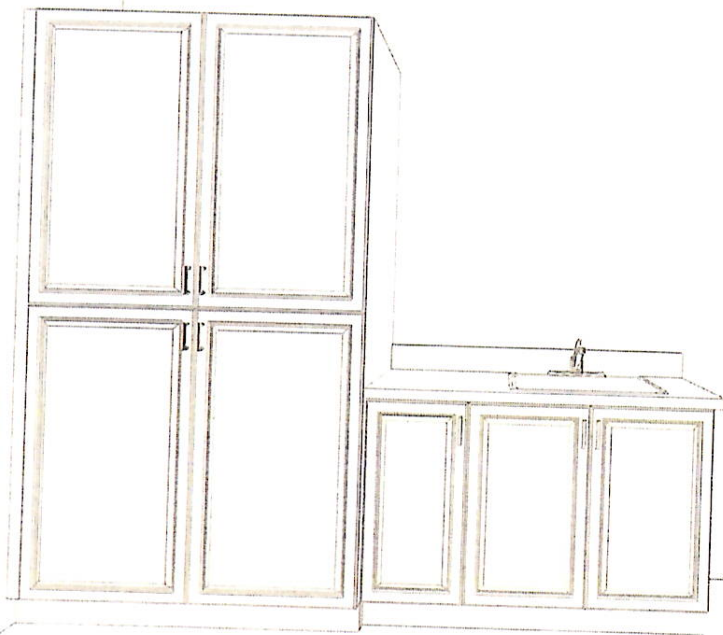
# FITNESS - B57

DOOR: EL00 Primo  
COLOUR: Antique White

LAMINATE COUNTER: Milano Quartz Quarry # 4726-52  
PROFILE: Contessa

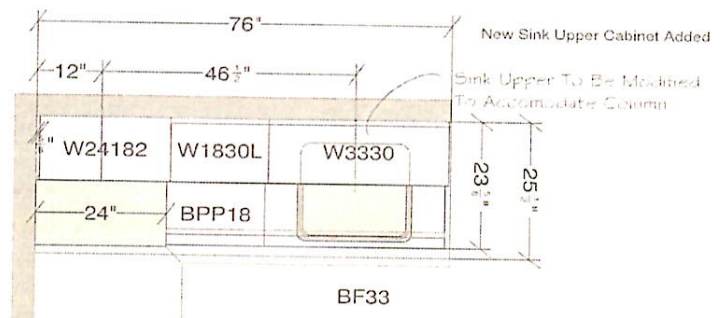
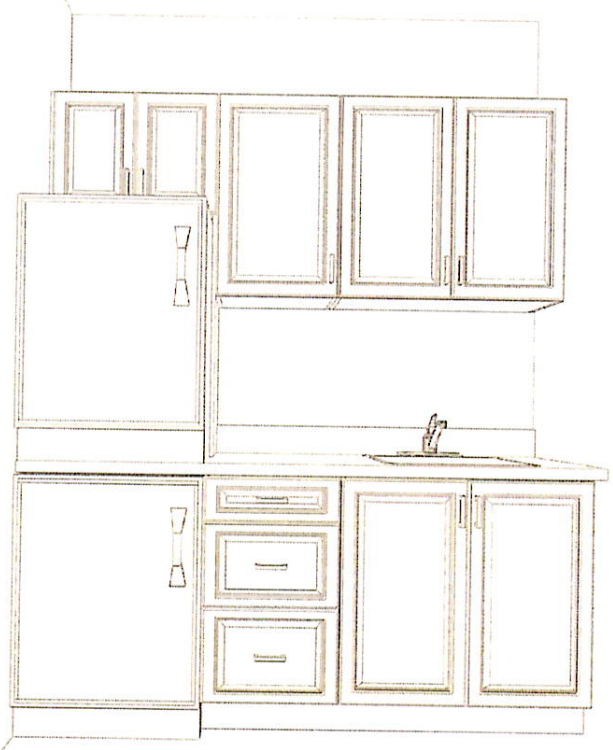
# OFFICE KITCHENETTE - 262

DOOR: EL00, Primo  
COLOUR: Antique White

LAMINATE COUNTER: Milano Quartz Quarry # 4726-52  
PROFILE: Contessa

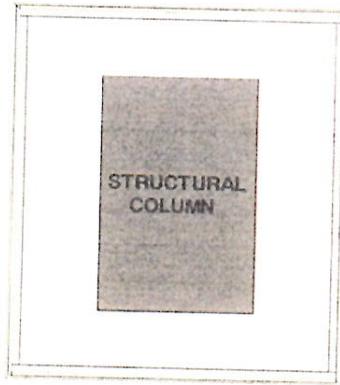
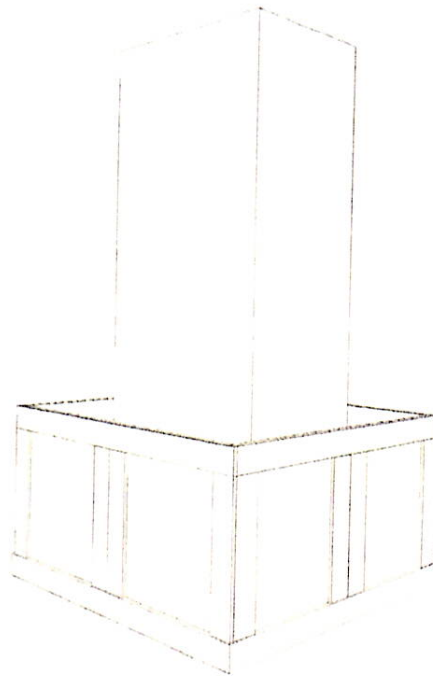
# LOBBY POST - 166

Millwork Cladding Around Planter Box

MATERIAL: Maple  
STAIN: BRANDY
