HYDROGEOLOGICAL ASSESSMENT  
HIGHLAND PARK CEMETERY VISITATION CENTER  
2037 MCGEE SIDE ROAD  
OTTAWA, ONTARIO

July 2010

Our ref: 10-025

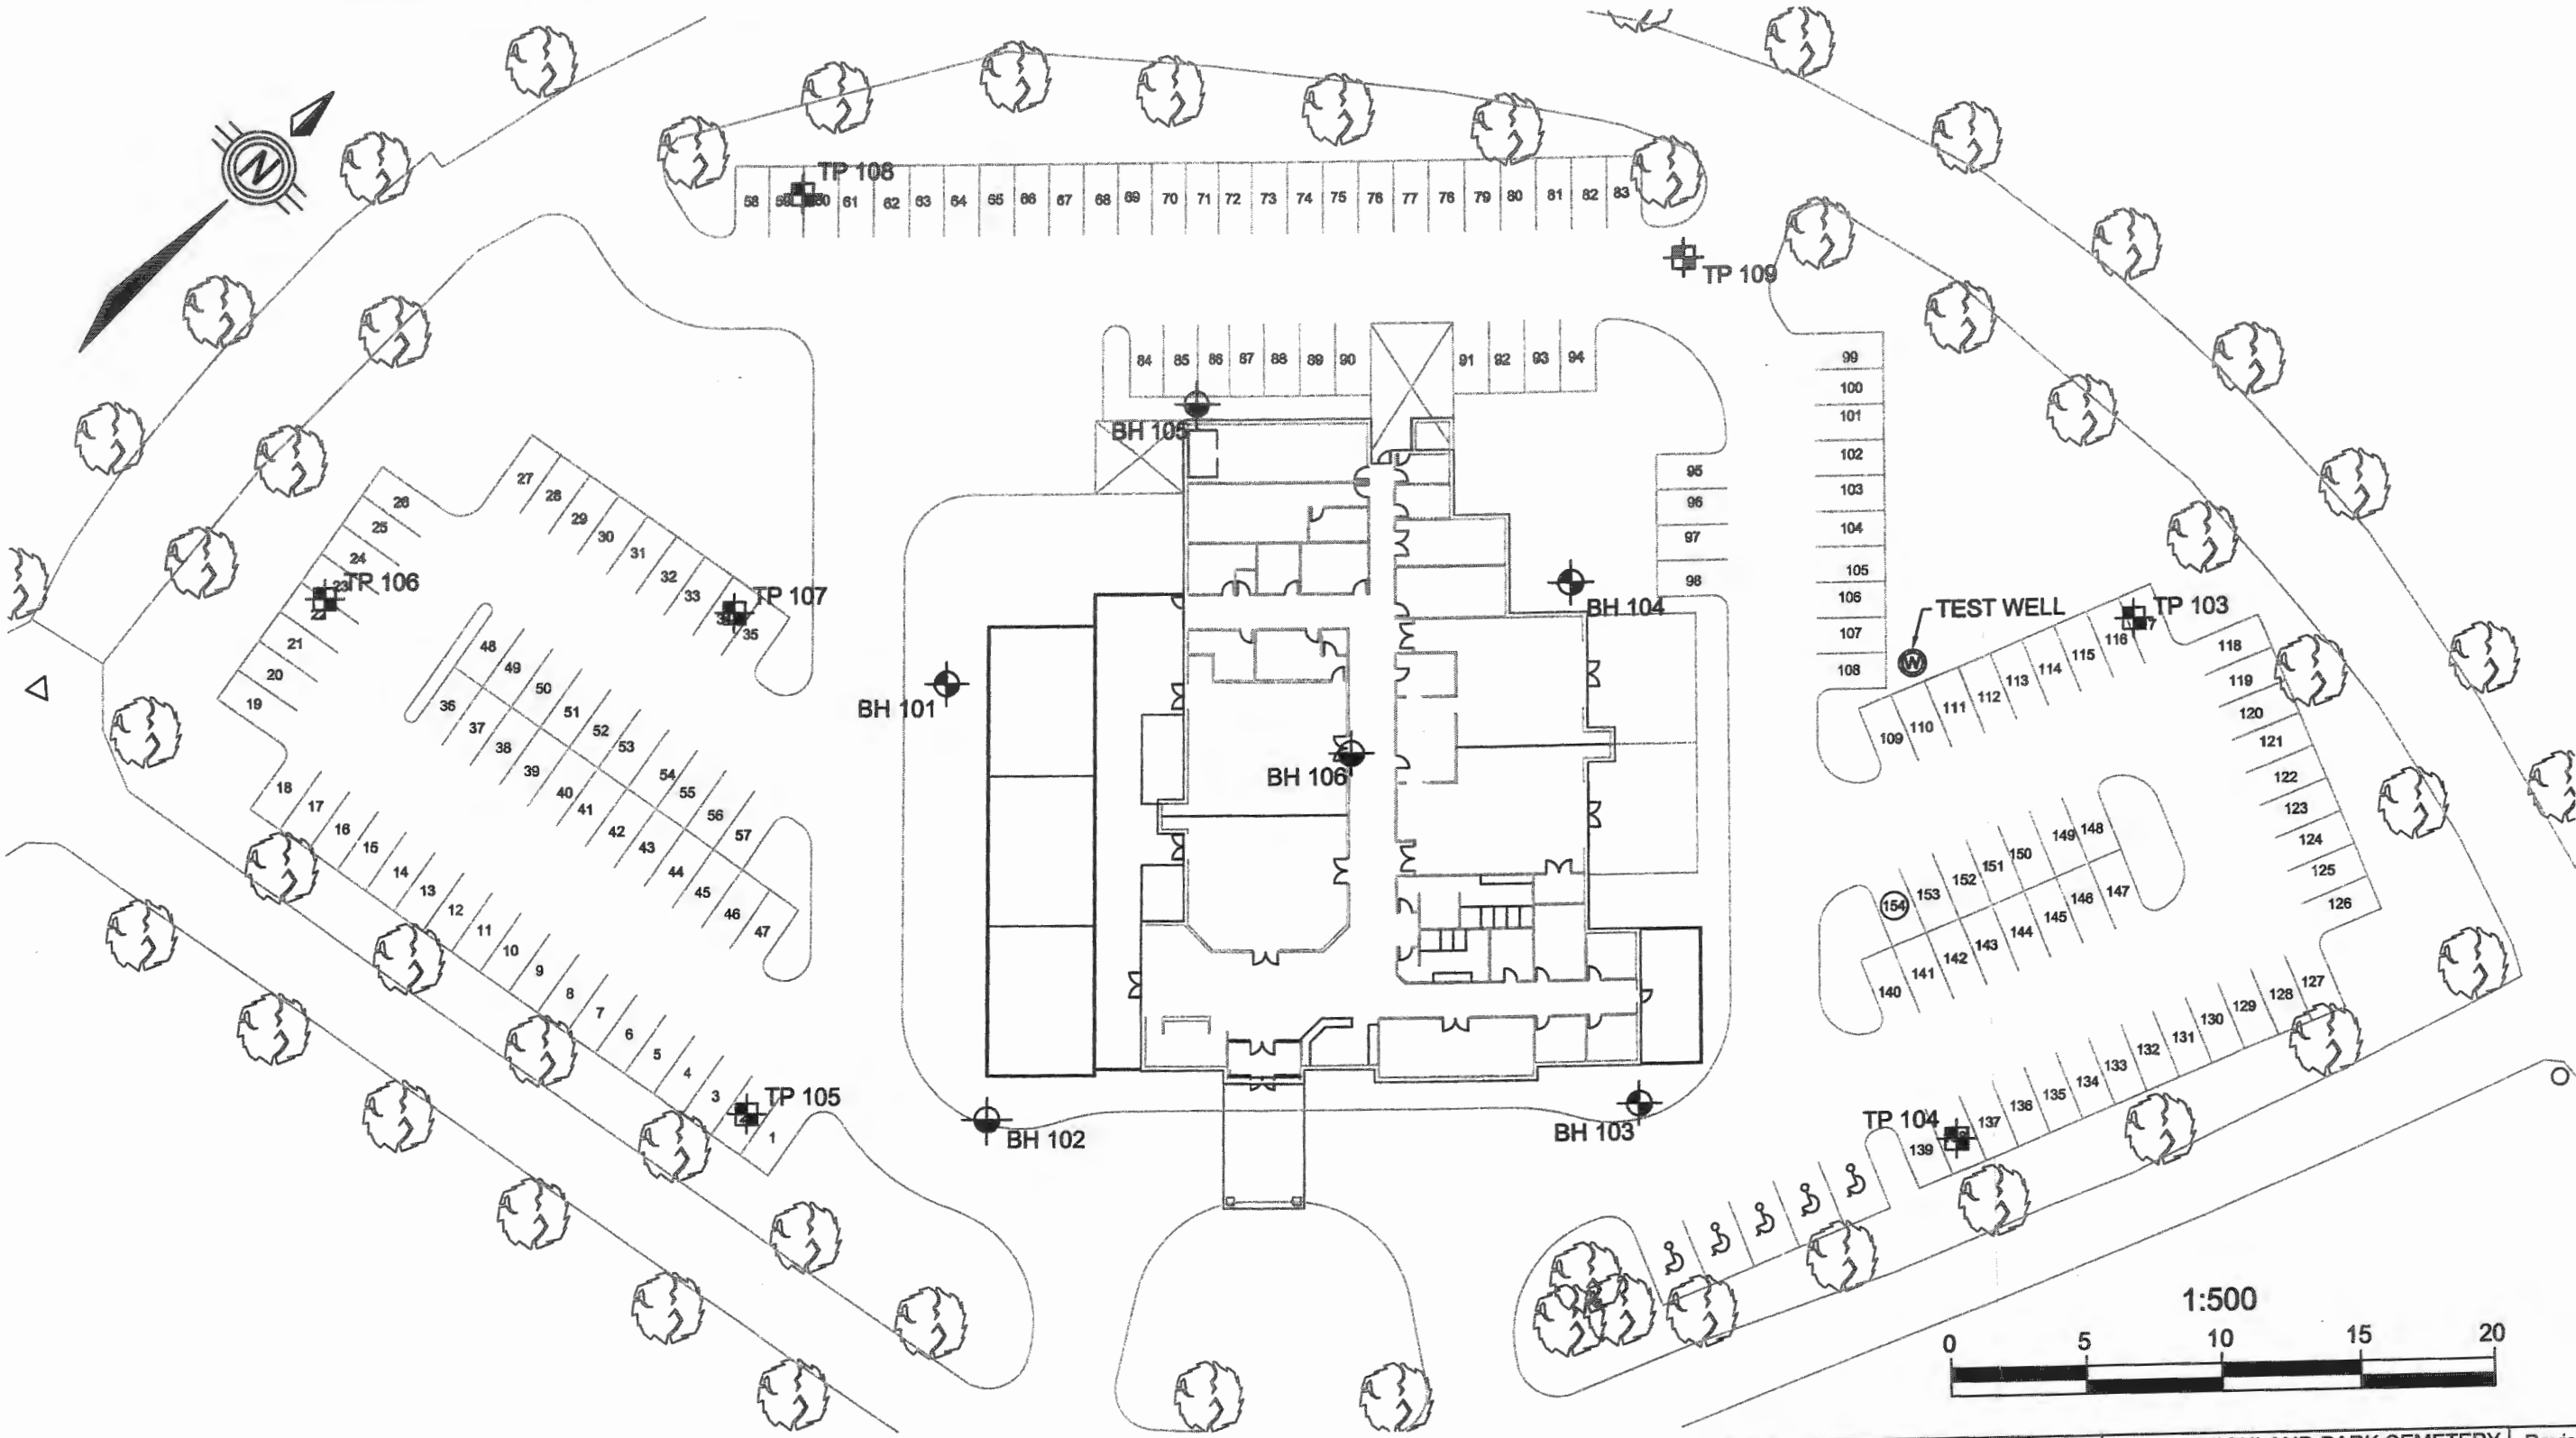
Client	PINECREST REMEMBRANCE SERVICES LTD.	Location	HIGHLAND PARK CEMETERY 2037 MCGEE SIDE ROAD OTTAWA, ON	Revision	1
Drawn by	D.J.R.	Approved by	S.M.G.	Project No.	10-025-2
		Title		TEST WELL, BOREHOLE AND TEST PIT LOCATION PLAN	
		Date	July 2010	FIGURE 2

TP #	APPROXIMATE TEST PIT LOCATION IN PLAN
	BH #	APPROXIMATE BOREHOLE LOCATION IN PLAN
	BH #	BOREHOLE WITH MONITORING WELL INSTALLATION

The approximate locations of the boreholes and test pits advanced as part of the geotechnical investigation are shown on the Test Well, Borehole and Test Pit Location Plan, Figure 2. An aerial photograph of the overall area of the subject site is provided on the Site Plan, Figure 3. Descriptions of the subsurface conditions logged in the boreholes and test pits are provided in the geotechnical report.

The approximate location of the test well is shown on the Test Well, Borehole and Test Pit Location Plan, Figure 2. An aerial photograph of the overall area of the subject site and area of proposed development are provided on the Site Plan, Figure 3. The MOE Water Well Record for the test wells is provided in Appendix E and the geographical reference for the test well is provided in the MOE Water Well Record.

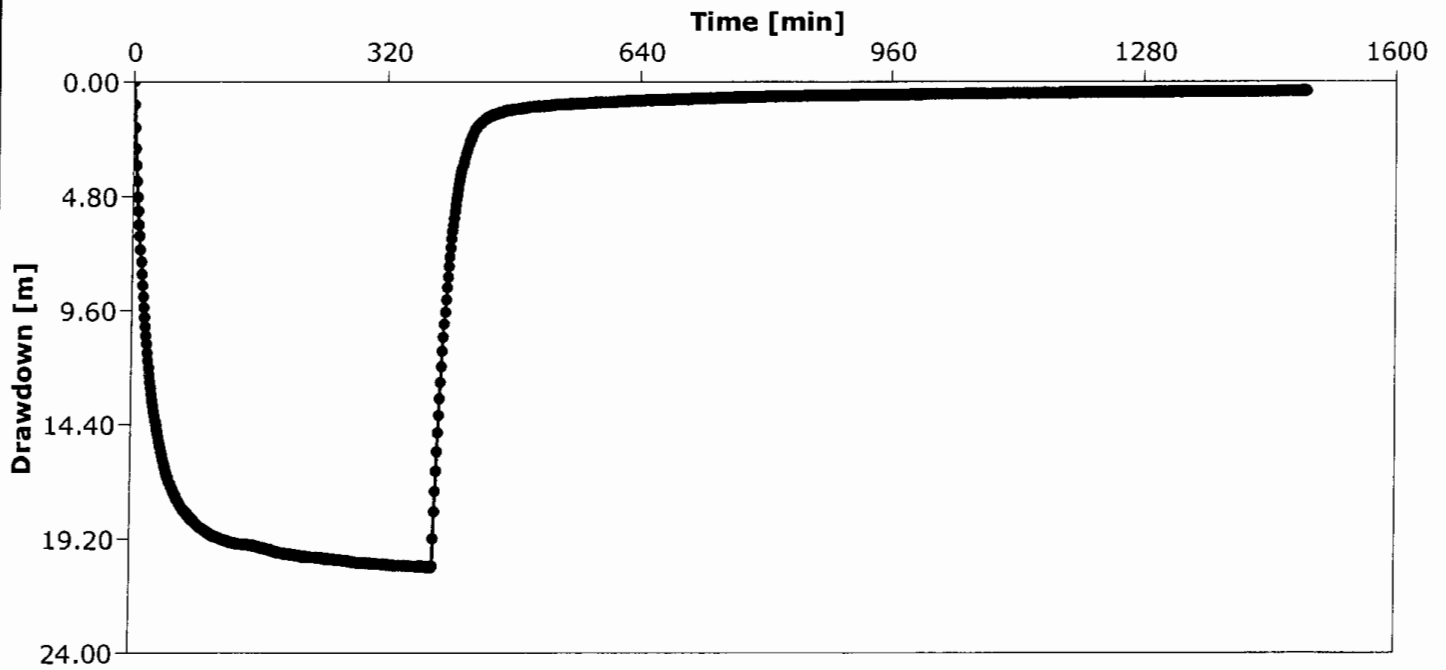
<b>Pumping Test Analysis Report</b>
Project: Highland Park Hydrogeological Assessment
Number: 10-025-2
Client: Pinecrest Remembrance Services Ltd.

Location: 2037 McGee Side Road, Ottawa, Ontario	Pumping Test: Pumping Test 1	Pumping Well: TW1
Test Conducted by:		Test Date: 5/27/2010
Analysis Performed by: JM	Drawdown vs. Time	Analysis Date: 5/27/2010
Aquifer Thickness:	Discharge: variable, average rate 0.0043434 [m <sup>3</sup> /min]

Parameter	Test Well
Pumping Duration (minutes)	381
Flow Rate (L/min)	22.8
Static Water Level (m BGS)	8.26
Well Depth (m BGS)	138.67
Available Drawdown (m)	130.09
Water Level at End of Pumping (m BGS)	28.64
Observed Drawdown at End of Pumping (m)	20.38
Drawdown Utilized (%)	15.7
Specific Capacity (m <sup>3</sup> /day•m)	1.6

As per MOE Procedure D-5-5, the test well was pumped at a flow rate greater than 13.7 litres per minute over a minimum of 6 hours. The maximum drawdown observed was 20.38 metres which is equivalent to approximately 15.7 percent of the available drawdown in the test well.

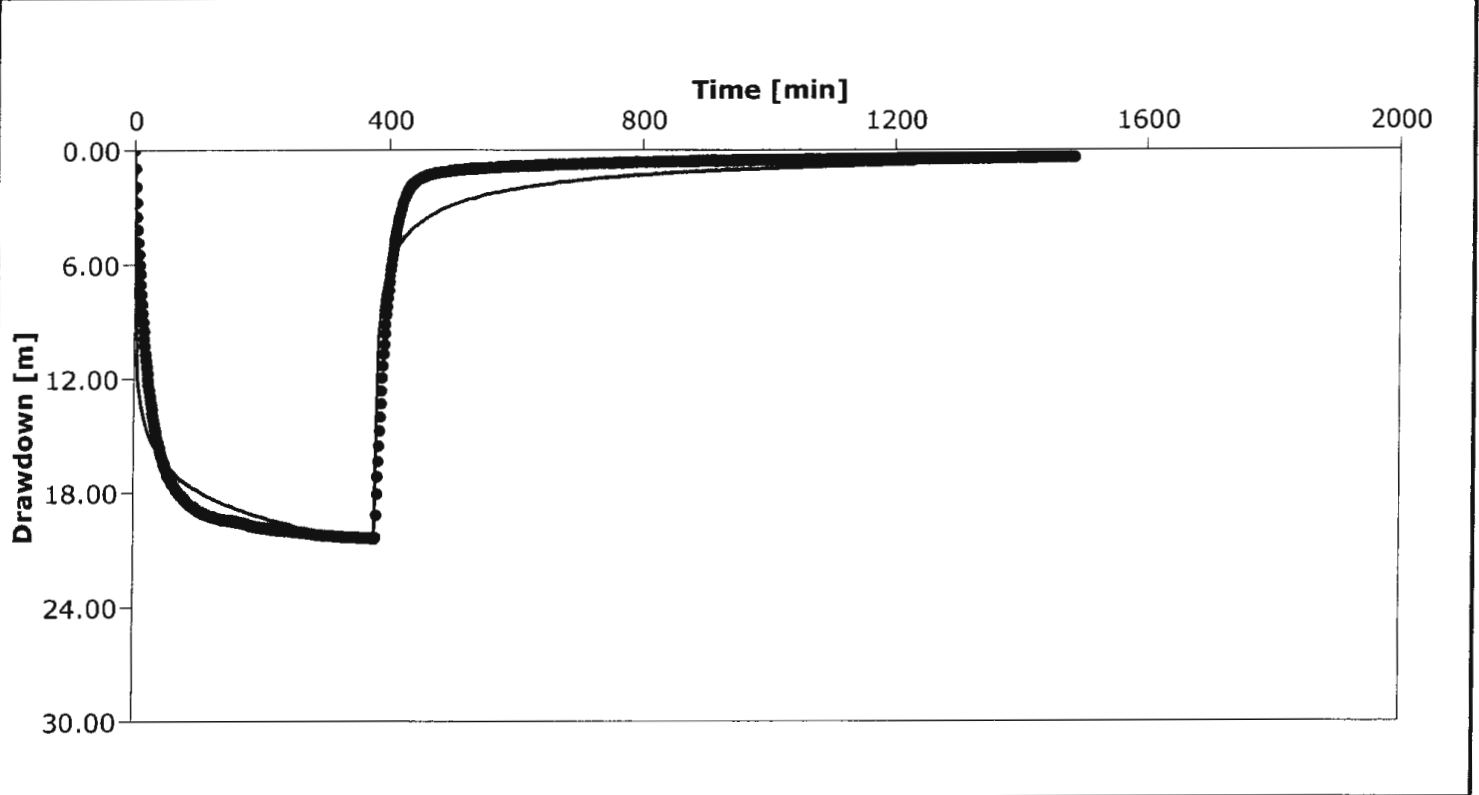
<b>Pumping Test Analysis Report</b>	
Project: Highland Park Hydrogeological Assessment	
Number: 10-025-2	
Client: Pinecrest Remembrance Services Ltd.

Location: 2037 McGee Side Road, Ottawa, Ontario	Pumping Test: Pumping Test 1	Pumping Well: TW1
Test Conducted by:		Test Date: 5/27/2010
Analysis Performed by: JM	This Analysis	Analysis Date: 5/27/2010
Aquifer Thickness:	Discharge: variable, average rate 0.0043434 [m <sup>3</sup> /min]

Calculation after Theis				
Observation Well	Transmissivity [m <sup>2</sup> /d]	Storage coefficient	Radial Distance to PW [m]	
TW1a	$1.31 \times 10^0$	$1.15 \times 10^{-3}$	0.15
